CARRAN CHURCH
SITE ASSESSMENT REPORT

Prepared by
Zena Hctor
December 2014
(Updated February 2015 to include Visitor Survey data)

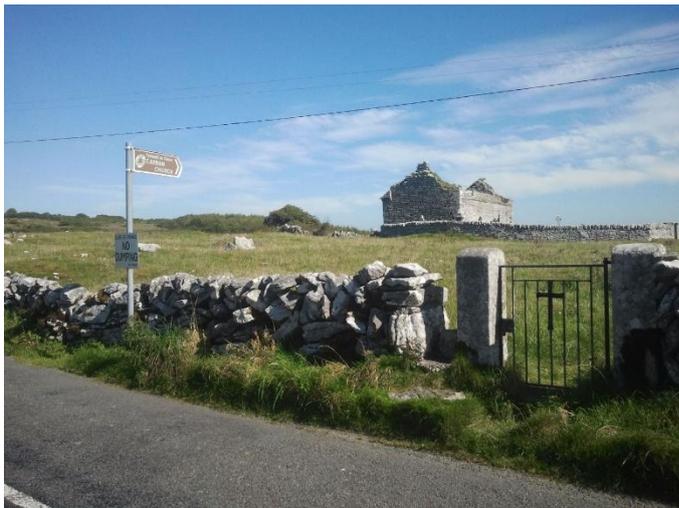
Photo 1: View of Carran Church from roadside entrance

It was noted during the visitor observation study carried out at this site in September 2014 as part of this report (Appendix I) that several visitors were unsure as to where the entrance to the site was, as the signpost is quite a distance from the available parking space. This confusion led to several visitors entering through a gateway and onto a private access lane to the north of the church site.

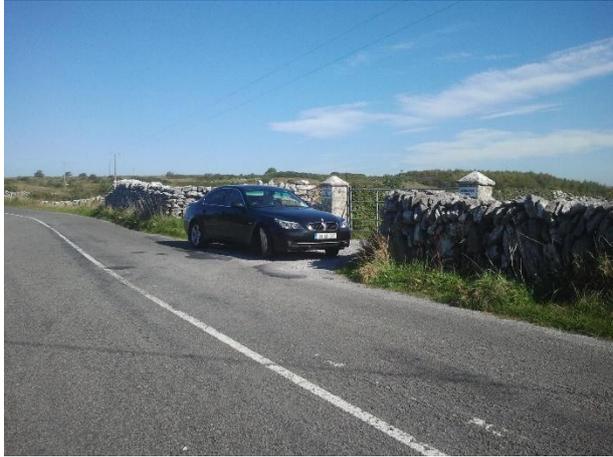
Also during this study, it was noted that some visitors approaching from the north (Ballyvaughan direction) parked in the roadside gateway entrance to the north of the church, thereby blocking the entrance to a private dwelling access laneway.

Photo 2: Car parked in private access gateway to north of Church

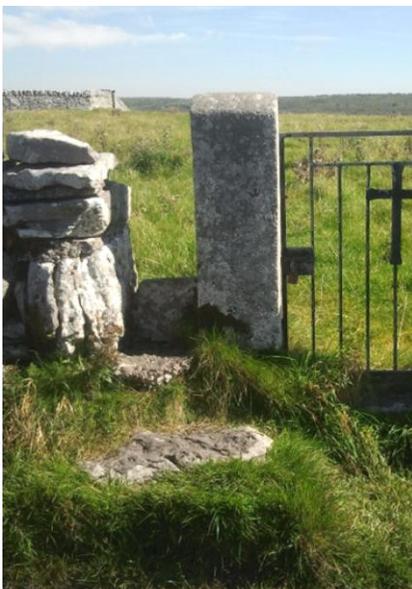
Photo 3: Roadside entrance

The site is entered over a stone stepped stile adjacent to a small iron gate, approximately 50m to the south of the parking lay-by. The gate is kept locked, except when burials are taken place within the graveyard.

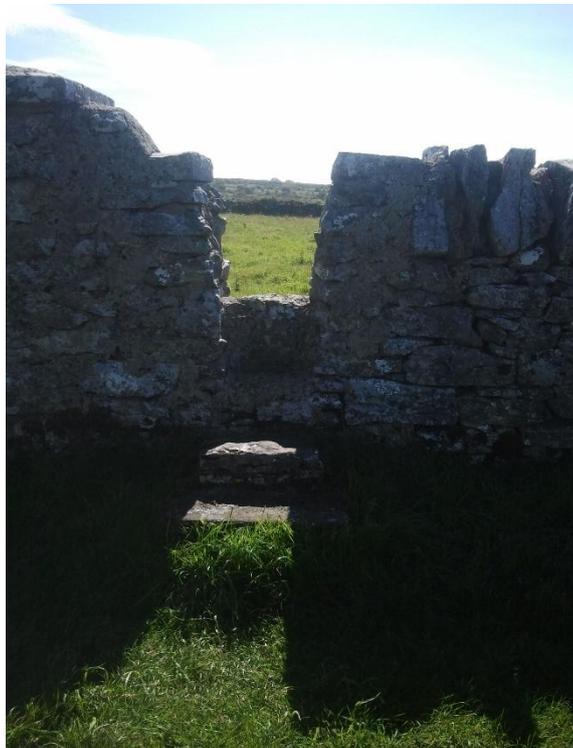
A slightly worn grass trail leads from the gateway to the graveyard boundary wall. At this point the visitor enters the graveyard over a high stepped stone stile. The adjacent gate in the graveyard boundary wall is locked, except when burials are taking place. During the observation study, it was noted that the height of the step into this stile caused problems for some visitors.

Photo 4: Entrance stile to graveyard from interior

- The entrance to the site field and to the graveyard are both via a stone stile within their respective boundary walls. Both stiles are stepped with a narrow gap. This stile design causes access difficulty for the less abled bodied visitor.

Difficulty of entry for some visitors due to stile design	A universal stile design should be researched and developed for installation at the road entrance to the site and at the graveyard entrance.
Potential of increased visitor movement through site	A fixed-point photography monitoring system should be developed and implemented to measure any increase in erosion that may occur along the trackway from the road entrance to the Church due to potential increased visitor usage.

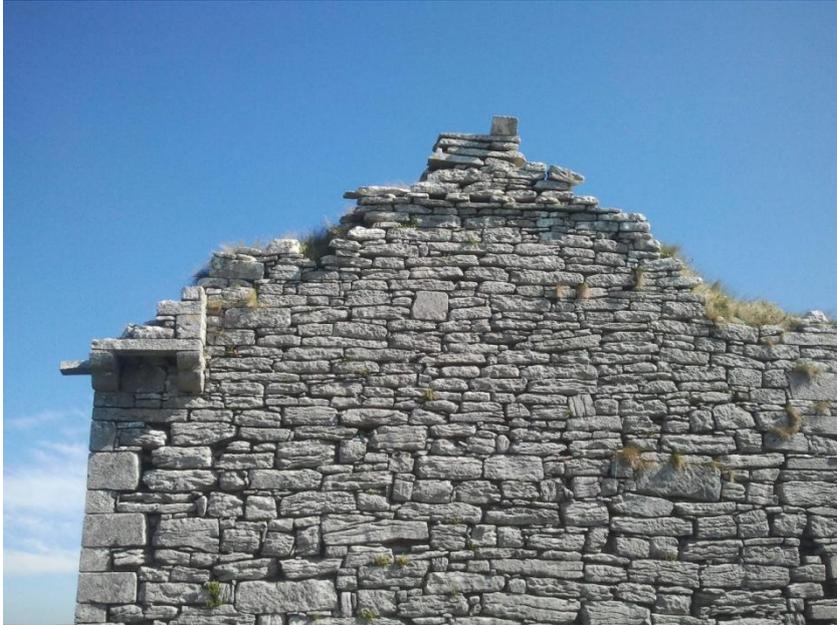
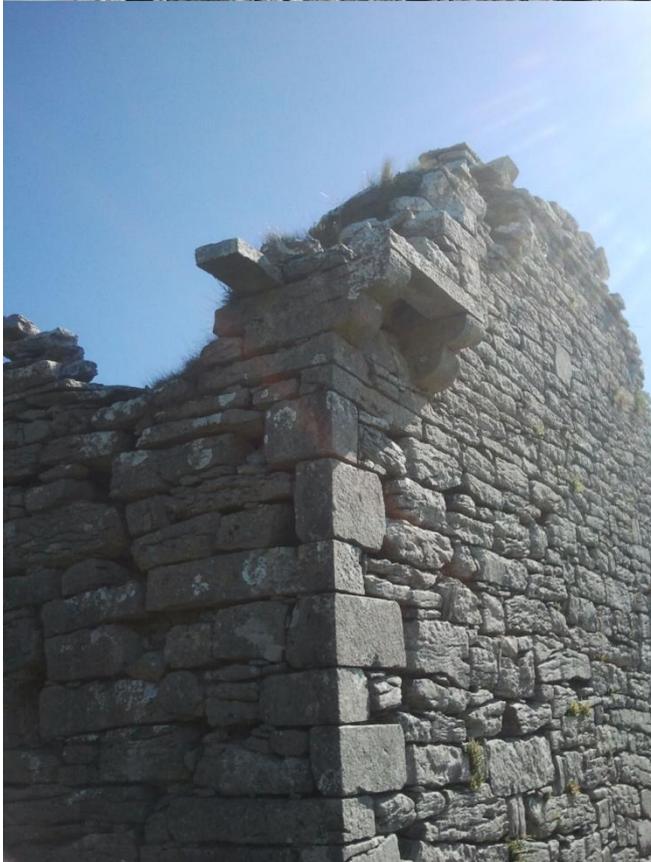
The ruins of the Medieval church are in a deteriorating condition. There has been significant structural movement in the NW corner beneath a machicoulis and it would appear that this structure is in danger of collapse. There are several stones lying in the field beneath this corner. Mortar has been washed out of joints of the walls in several areas. Stones in the north-east corner wall have been pushed outwards.

Photos 5 & 6: Cracks in wall in NW corner shows structural movement.

- The church building has some structural areas of concern especially in the NW corner which would appear to be in danger of collapse.
- The only available parking space is the hard shoulder outside the front boundary wall of a residential home. This is not an official parking area and when in use it can accommodate a maximum of three cars parked parallel to the roadside. There is no available parking area for coach traffic. Car parking also takes place on occasion in the private entrance gateway to the north of the site causing blockages to this private entrance laneway which leads to a residential home.

ISSUES	RECOMMENDED ACTIONS
Deteriorating condition of church building	It is recommended that a Conservation Engineers report be commissioned and consolidation work carried out on the north-west corner of the Church which is in danger of collapse and is a safety hazard in terms of visitor access.
Unrecorded monuments	The inclusion of all the archaeological monuments identified under the NUI study on the RMP should be discussed to provide statutory protection.
Lack of parking	A feasibility study should be undertaken to determine the possibilities for parking provision at the site.
Outdated signage and interpretation. Visitor confusion as to entry point to site.	The directional finger post sign to the site should be updated and a similar second sign, indicating the direction of the stile/gate entry, provided opposite the current parking area. The interpretive panel located within the graveyard should be removed and an updated version installed.

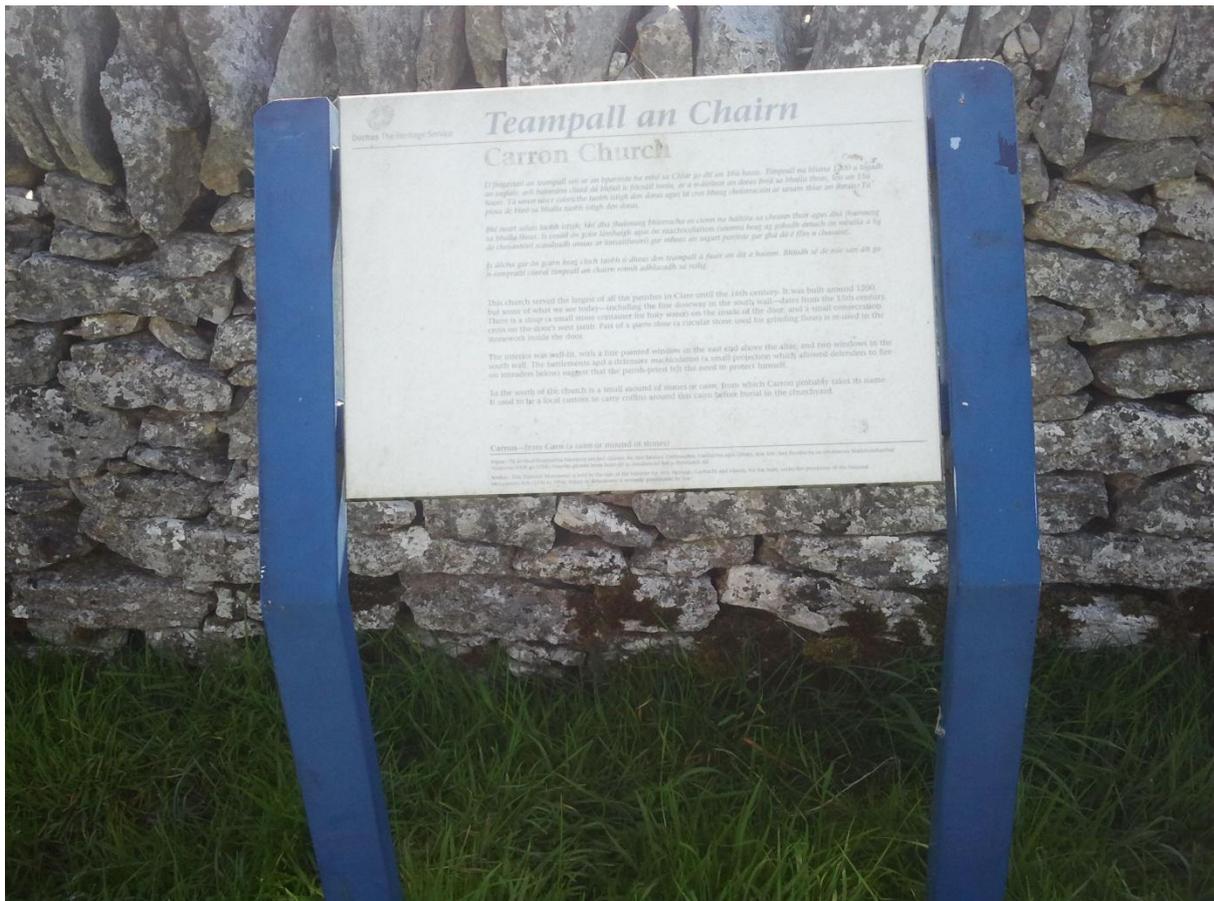
The text and graphics of the panel are faded. This site is not managed by the OPW, but by Clare County Council and this panel may have been placed here in error.

Photo 7: Interpretive Panel at Carran Church

- Within the graveyard is an interpretive panel which describes the features of the medieval church. The text and illustrations are faded and difficult to read. The panel was installed by Dúchas, the Heritage Service, an agency that is no longer in existence and who have no management responsibilities for this site.

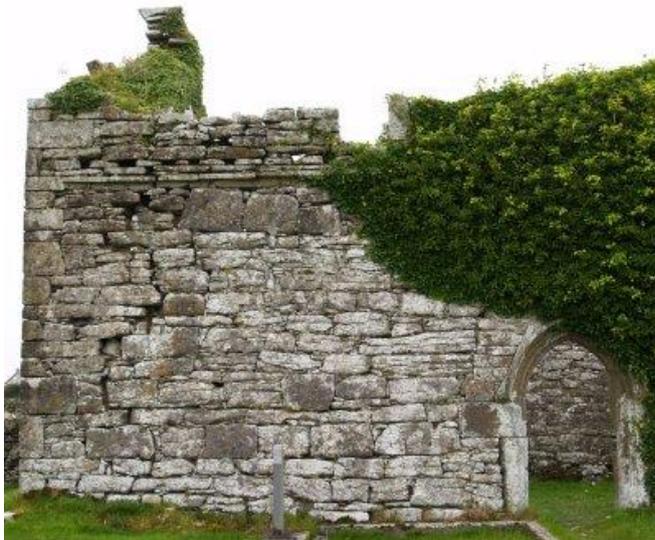
The deteriorating condition of the church building was highlighted in a report by Risteard UaCróinín, Conservation Officer with Clare County Council in 2005

Photo 8: Ivy growth over south doorway and cracks in wall 2005

With permission from the National Monuments Service and under the guidance of Clare County Council's Conservation Officer, supervised cutting back of ivy was carried out in August and September 2009. The building was subsequently assessed as part of the Burren Heritage Sites Report (Burren Connect, 2009) by the firm *Architectural Conservation Professionals, Murroe, Co. Limerick* to determine the methods and materials required to carry out immediate remedial works to conserve the ruin into the future.

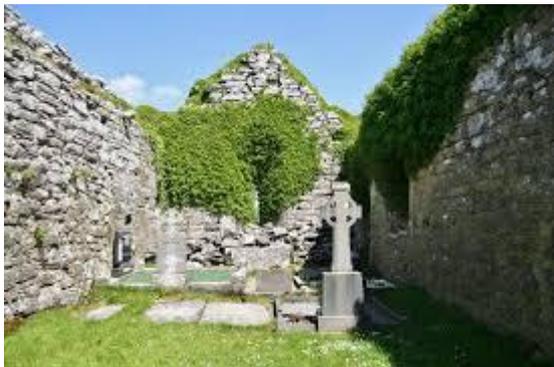
Photo 9: Ivy obscuring east window 2005
