**Report on  
Excavation and completion of conservation works.**

**Carran Mediaeval Church, Poulacarran, Carran, Co. Clare.**

Monument Number: CL009-075001

15 December / Nodlaig 2017

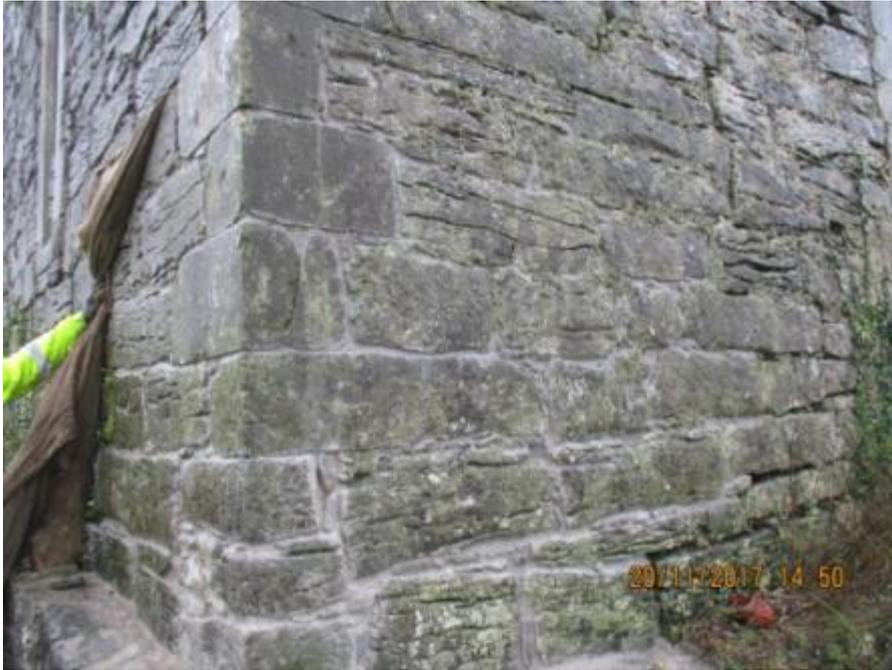
South east corner. Works completed.

When works to the interior and exterior of the NW corner were completed, some of the original grass sods were replaced, (to reduce the amount of water lodging on the wall tops). Works then commenced on the exterior of the SE corner which had been partially undermined. The voids were grouted with a 3.5NHL mortar and foundation stones re-instated. The corner was then re-pointed with a similar mix to the NW corner.

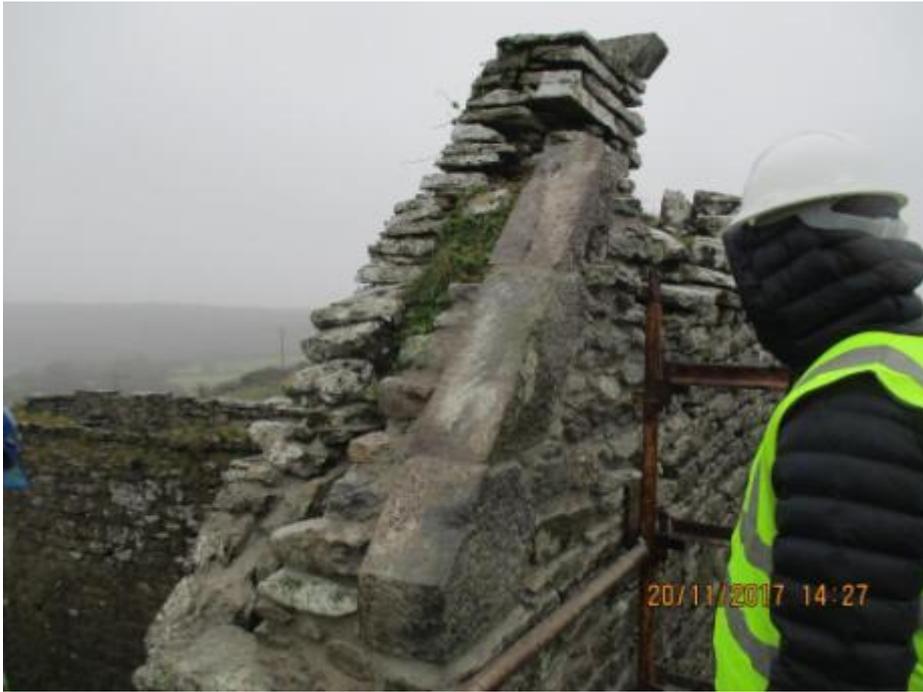
**Barge stones re-instated. West Gable.**

During the removal of the pile of stones at the NW gable architectural fragments were discovered, which had fallen from the corner. These contained some dressed limestone blocks, three dressed barge stones and a barge-stop. Also discovered were a lot of broken, limestone rubble fragments. (Report: Appendix 3 Excavation Report)

It was agreed that the architectural fragments, including the barge stones would be re-erected on the external gable, from whence they came, originally. The angle-rake of the barge was calculated from that of the inner gable which had remained intact. It was also agreed that the rubble fill could be re-used to fill voids, where required. These works served to re-instate collapsed masonry, reduce the amount of imported material required and partially re-instate the original appearance of the gable.

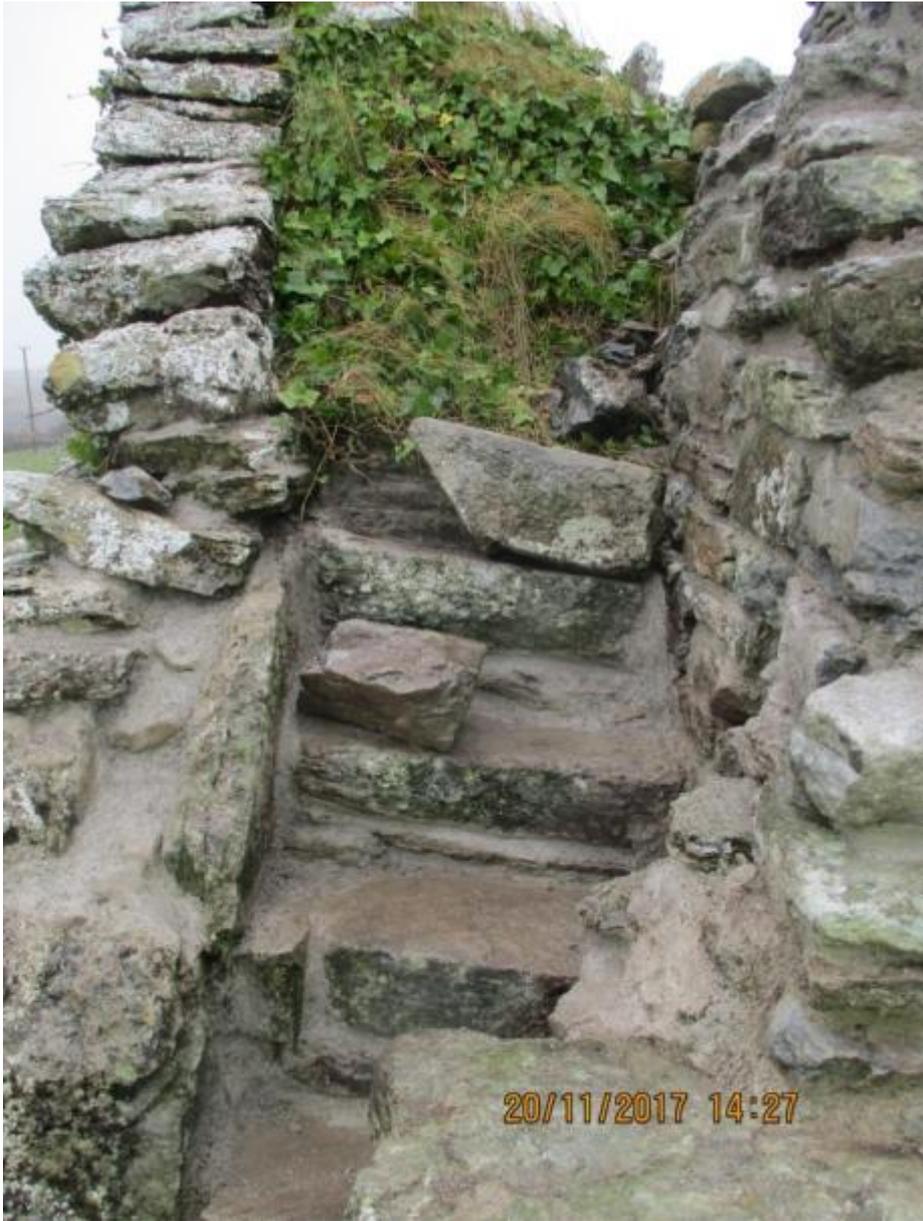
**Gable steps re-pointed.**

Removing the grass sods on top of the wall revealed that a short flight of steps existed between the machicoulis and gable-ridge, between an inner and outer gable, providing a

continuous wall-walk over the gable and it was agreed that these would be cleaned and re-pointed, in situ.

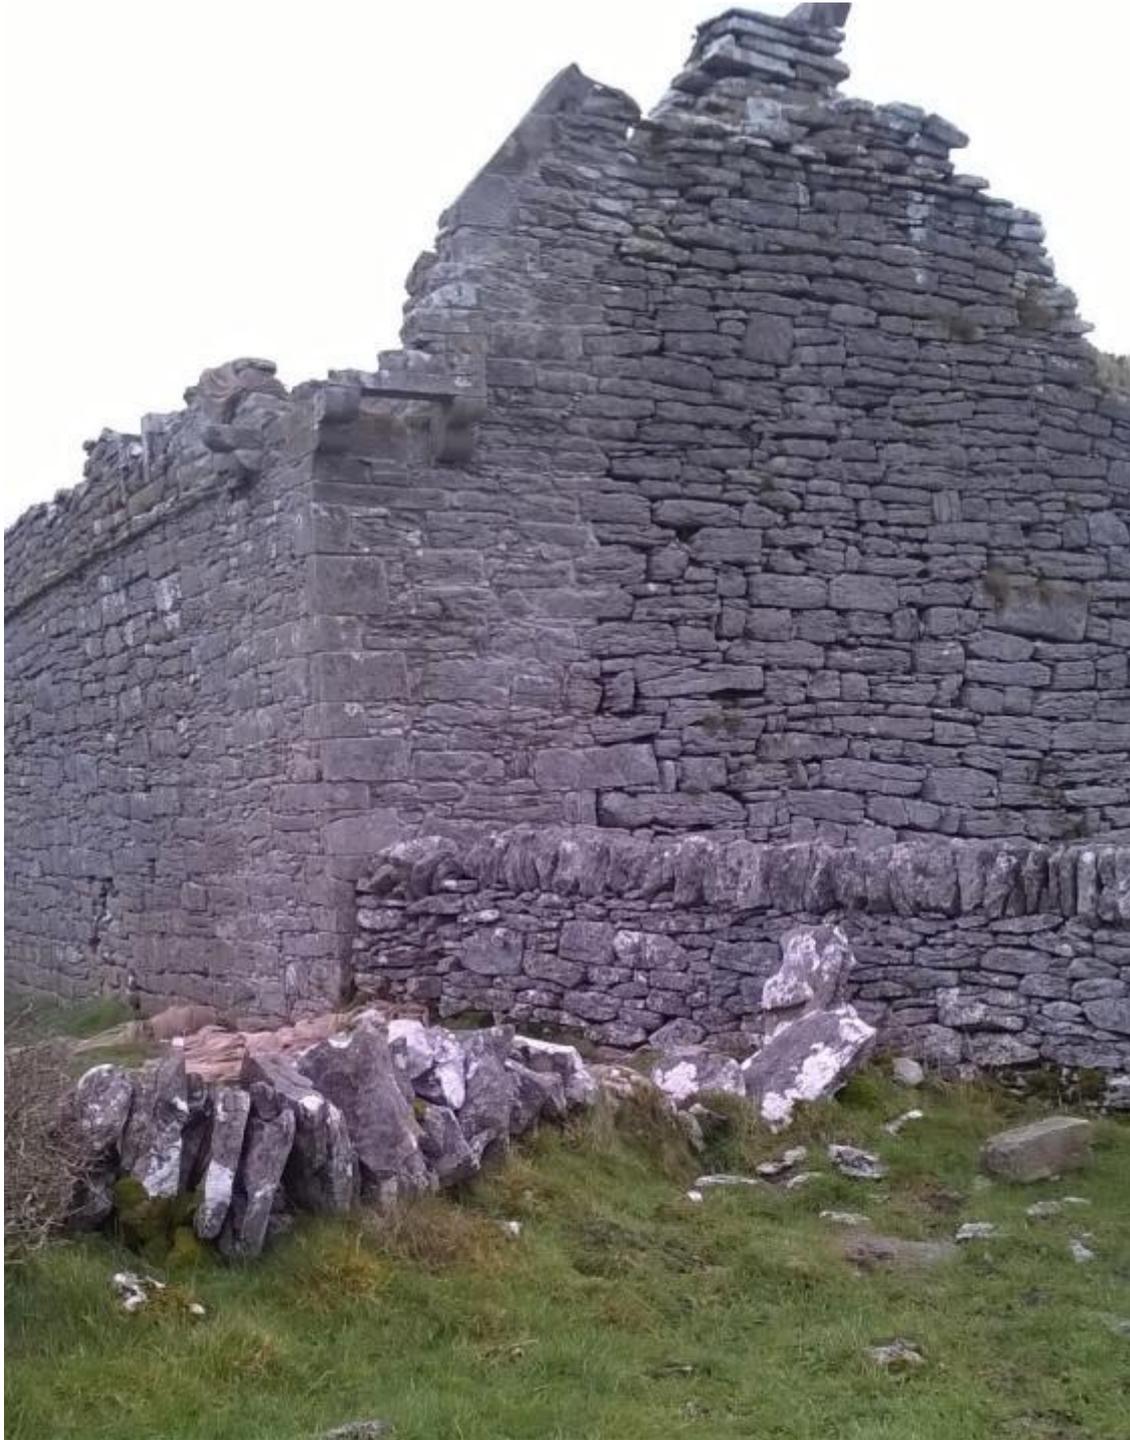
**North West corner completed.**

Carran Church is a Demonstration Site under the GeoparkLIFE programme (LIFE 11 ENV/IE/922). It was proposed to carry out essential repairs consolidate the building and make it safe for visitors. Repairs were required to the NW corner of Carran mediaeval church due to structural cracking. The condition of the corner was assessed by ACP Ltd. consulting conservation engineers in 2015 and National Monuments Service was notified. Ministerial consent was granted under certain conditions.

Mr. O’Leary pointed out that grouting the interior of the wall would have little beneficial effect as the location or extent of the internal voids could not be determined. He proposed using more Helifix Helibar rods in the joints at the NW corner. This was discussed and agreed. As there would be a significant saving the ACO proposed that further works might be carried out at the opposite SE corner where foundation stones had become dislodged and posed a risk of collapse to that corner of the building. It was agreed that this work was appropriate and could be carried out for the same cost.

Over the next three weeks, the work of consolidating the NW and SE corners progressed, when the weather permitted. A sample of mortar pointing was inspected by the ACO who found that the texture, aggregates, colour and finish, satisfactorily replicated the original and permission to proceed was given. A 3.5NHL mortar, with sand and stone dust aggregate was used.

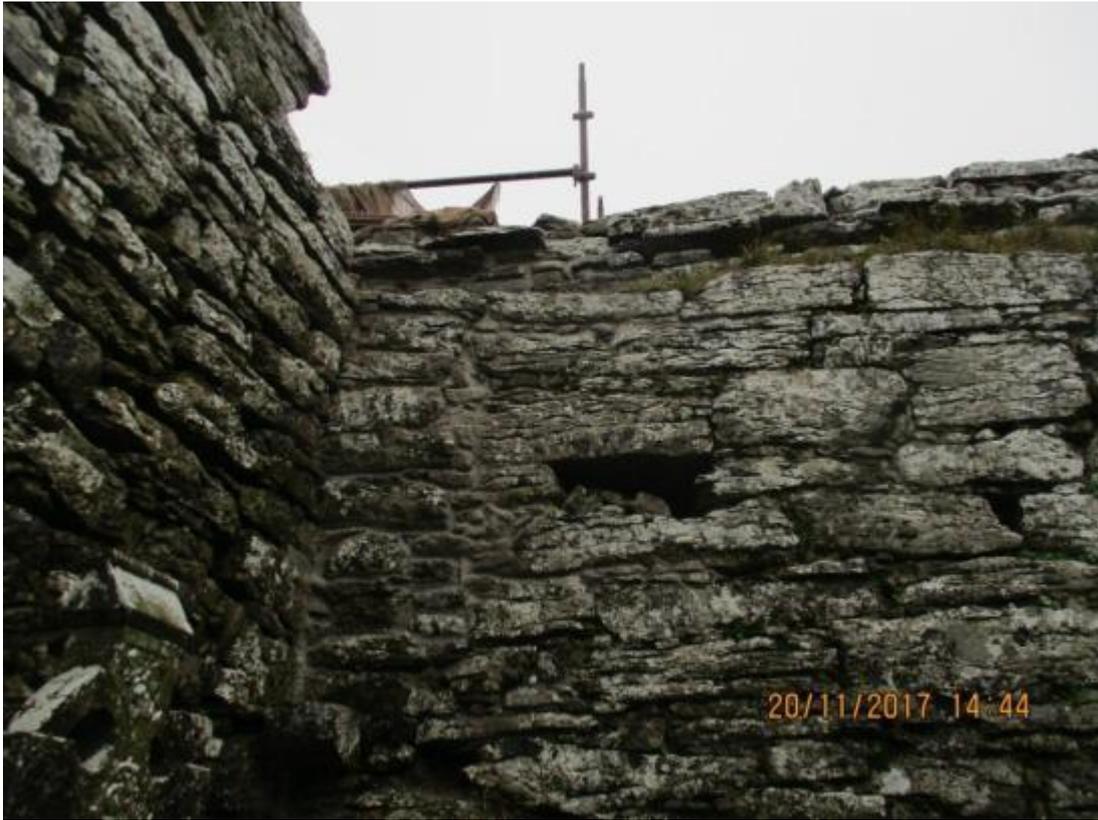
**North west corner, completed (interior).**

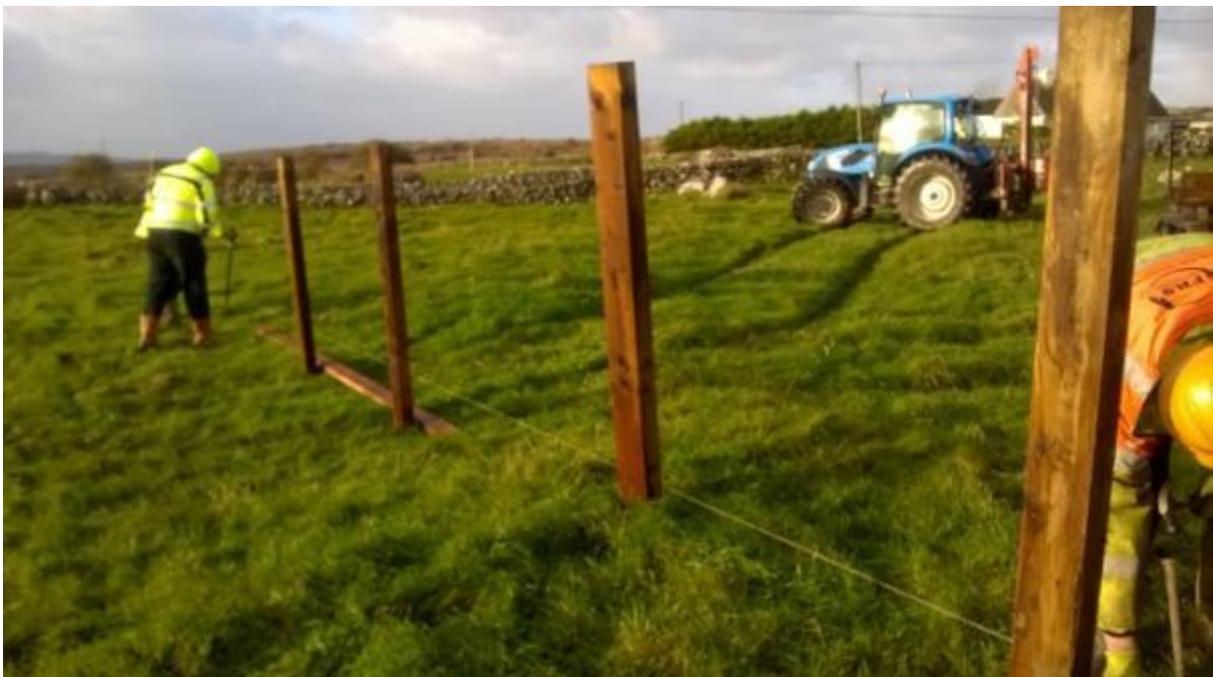
**Marking out the wooden fence.**

In October 2017 The National Monuments Service was notified that Burren Geopark intended to erect a wooden fence at each side of the grass path from the public road to the churchyard. Details were included and permission was granted, on condition that any ground disturbance would be monitored by the licensee.

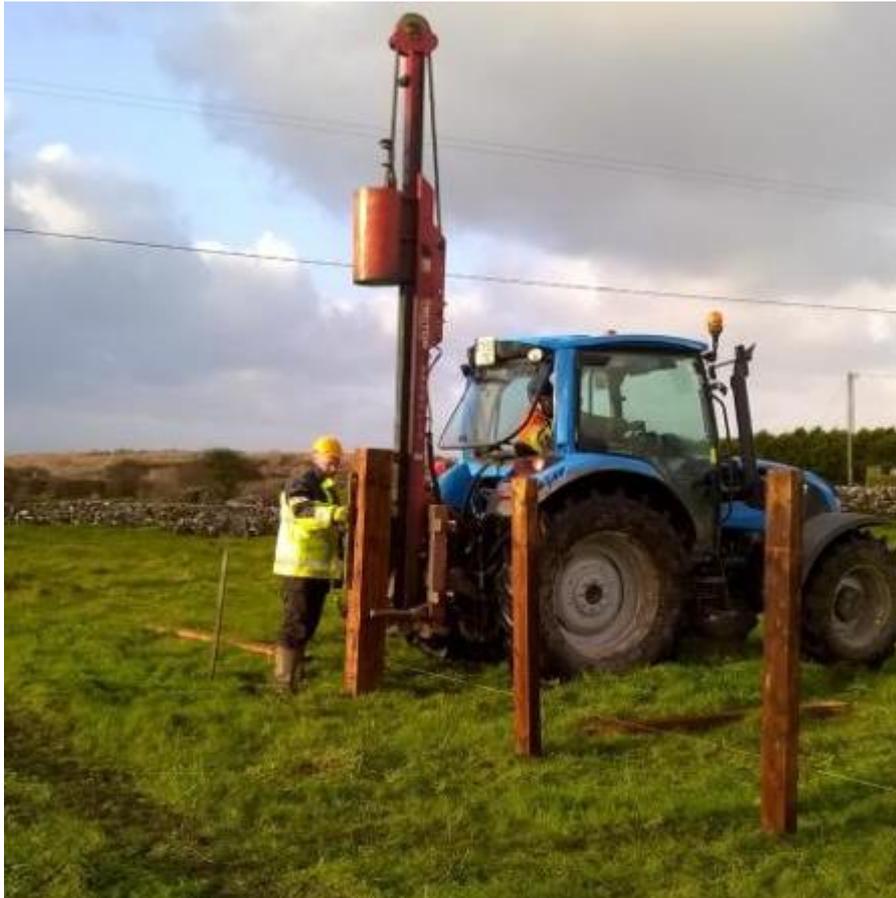
**Driving the posts.**

On the 13<sup>th</sup> December 2017 the ACO Risteard UaCroinin monitored the erection of the wooden posts. As the bedrock here is very close to the surface the posts were driven with some difficulty. The spaces between the posts were not always regular as the erectors had to find the location of subsurface grikes, in the limestone, using iron probes. However by the end of day the work was completed successfully, without the need for digging, rock breaking or concrete foundations.

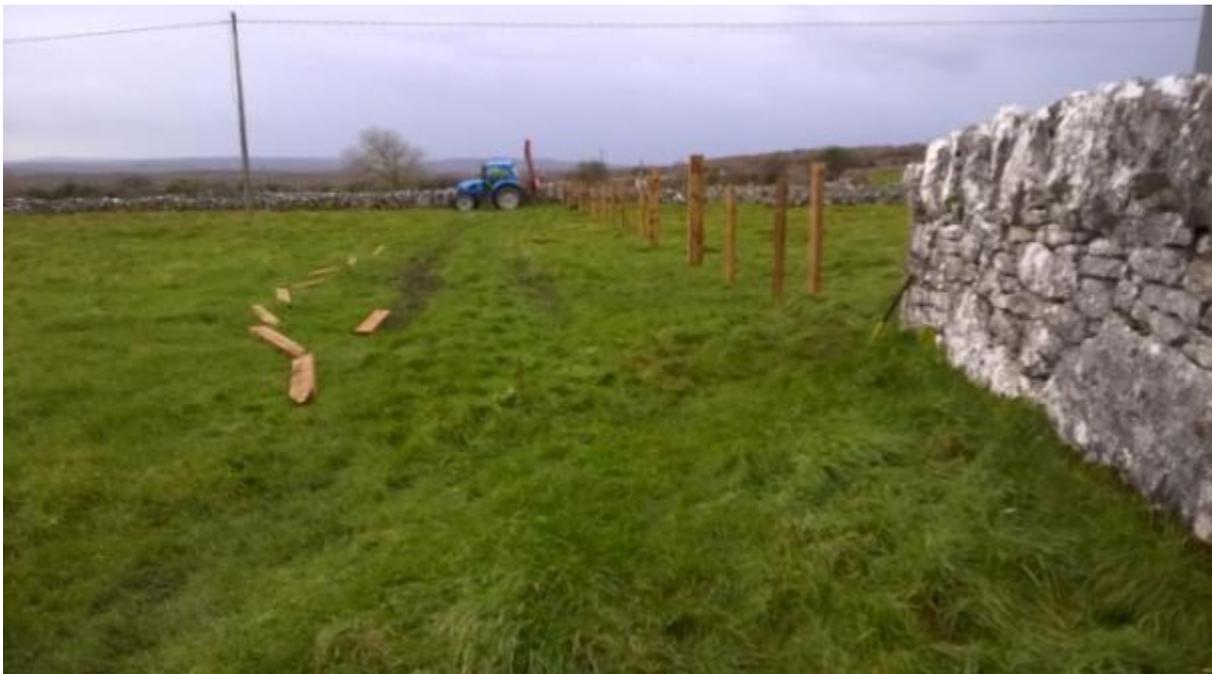
**Finished north side of rail.**

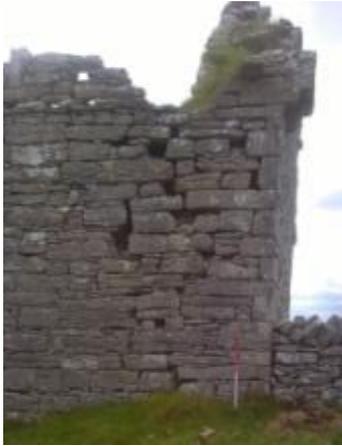
NW corner showing machicoulis and parapet,  
prior to works.
