Visitor Management Proposal

An Rath - Cahermore

GeoparkLIFE:
Tourism for Conservation

May 2018.

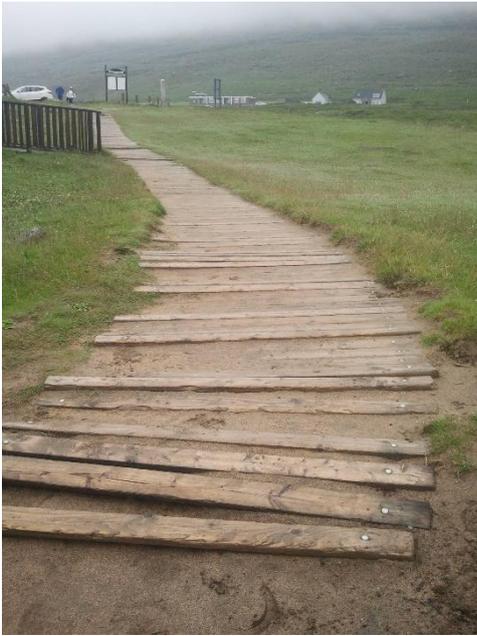
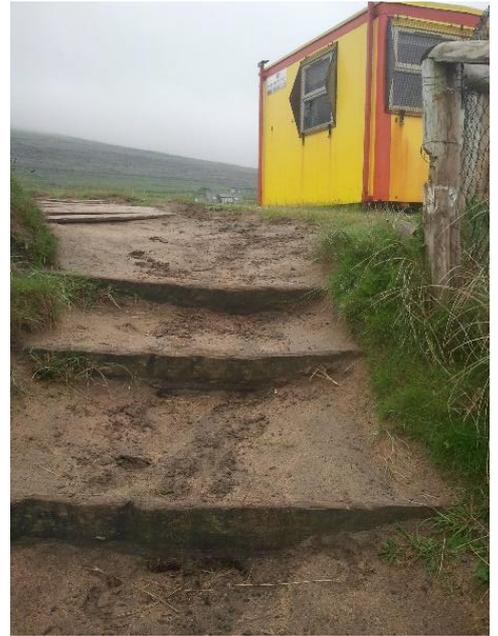
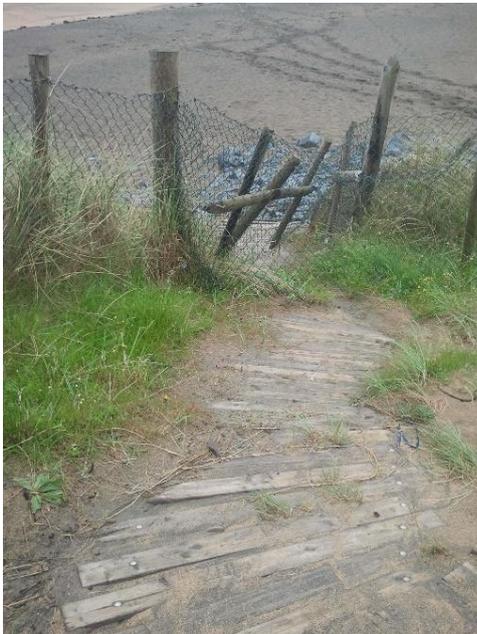
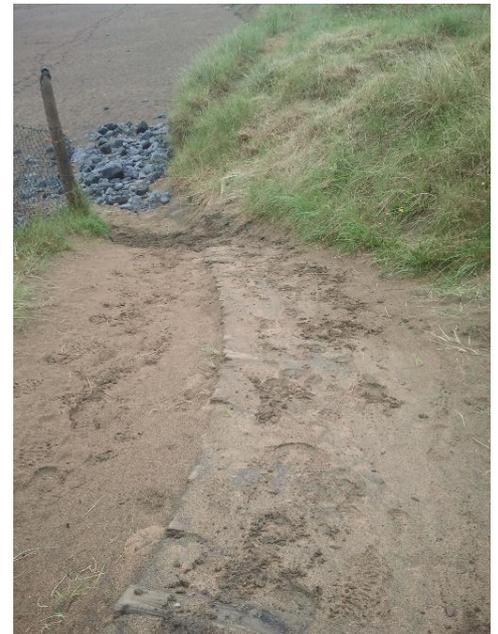
Photographs 4-7: Boardwalk and sand ladder access to Fanore Beach (13-6-2014)

The access boardwalk to Fanore Beach is worn and several of the boards are misshapen or missing in places causing a trip hazard. The sand ladder has been damaged in recent years due to storm events and natural wear. Repairs or replacement of the structures are now urgently required.

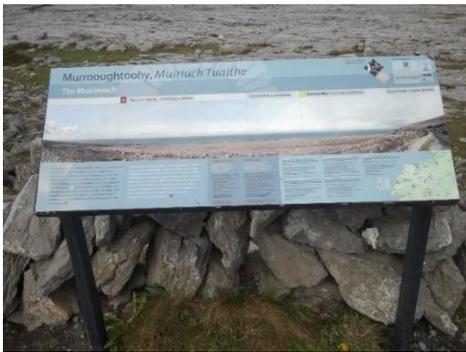
Murrooghtoohy Viewing Point

A lectern style interpretive panel at Murrooghtoohy viewing point provides a panoramic image of the seascape, with points of interest highlighted and named in both English and Irish. Interpretation of the local placenames is provided and the Burren Code in several languages. This panel was erected under the Burren Connect project. The sign has damage in the top right hand corner and is scratched in places.

Type of sign	Location (ITM E; ITM N)	Damage description	Source of Damage	Action Required	Timescale for Action
Burren Connect panoramic interpretive panel at Murrooghtoohy viewing point	514612 710752	Worn damage in top right hand corner and scratching on surface	Human	Update and replace with GeoparkLIFE/Geosite panel	6-12 months
Information signs inside entrance gate to Fanore Beach	514119 708335	Top two of three signs are damaged with text and symbols scratched out. Blank panel on second pole	Human	Revise signage and duplication of information provided. Replace with rationalised signage. Remove blank panel and pole.	6-12 months
Conservation signs on fence boundary opposite toilet block	513886 708341	The No camping or overnight parking sign is damaged with yellow paint smeared on the sign	Human	Replace sign	6-12 months
County Council bye-laws and penalties for non-compliance sign	513800 708178	This sign is badly damaged with most of the symbols scratched out.	Human	Replace sign	Immediate

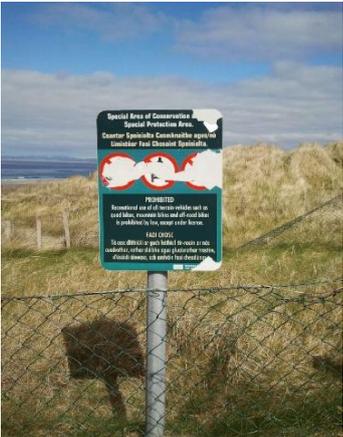
Close to the board walk entrance to the beach is a pole mounted sign indicating that this is a Special Area of Conservation and use of all-terrain vehicles is prohibited. This sign is badly damaged. It carries the NPWS name and logo.

NPWS Special Area of Conservation sign	513797 708184	This sign is badly damaged with text obliterated.	Human	Remove and explore necessity of the information on this sign and whether it requires replacement	Immediate

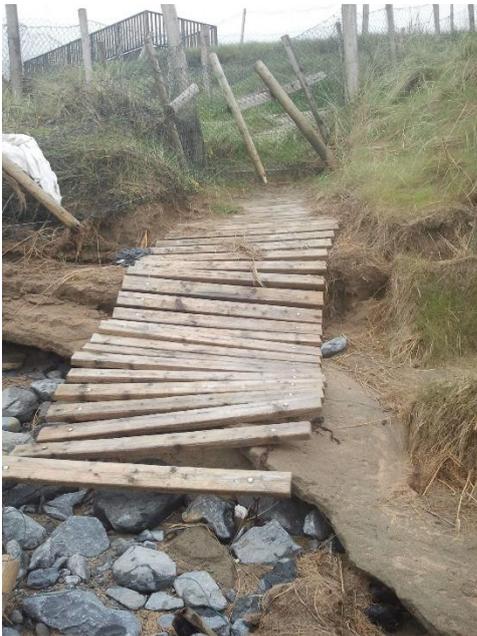
Photograph 24: View of bottom section of sand ladder following storm damage in Jan 2014 (photo taken 13-6-2104)

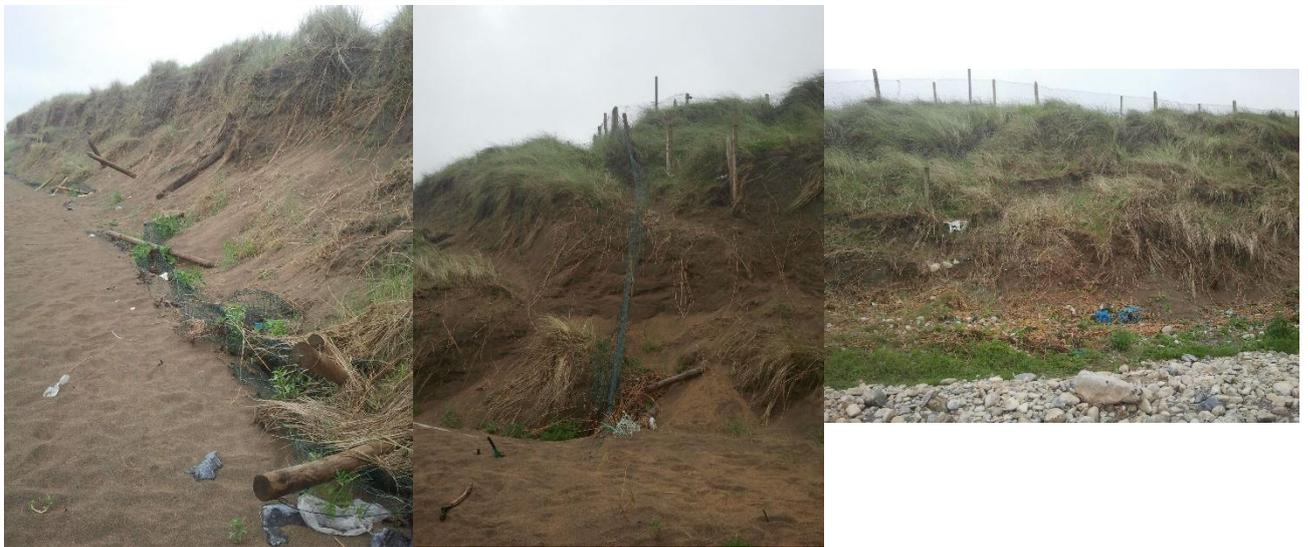
Photographs 27-29: Damaged fencing at Fanore Dunes (13-6-2014)

The condition and effectiveness of the measures which were put in place for the conservation of the dune system at Fanore and visitor access need to be monitored and analysed on a regular basis. The results of the monitoring programme should then be used to inform a proactive management strategy and plan. The current approach to conservation and visitor management at Fanore beach is reactive and piecemeal.

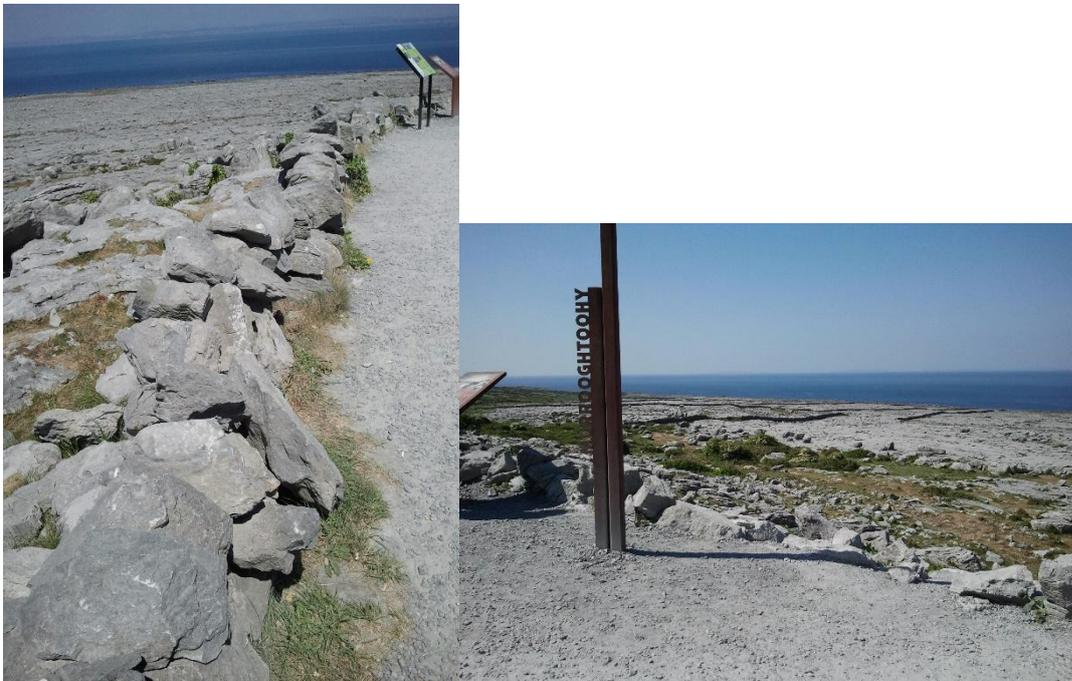
Due to the large number of passing visitors who stop at Murroogtoohy Viewing point and then walk across the pavement to the sea edge and up onto the lower slopes of Blackhead, there is some footfall impact at this site and damage to the drystone boundary wall of the viewing point has caused collapse along its length.

The boundary wall of the Viewing Point at Murrooghtoohy has been badly damaged due to visitor impact and has largely collapsed along its length.

Photographs 30-31: Collapsed wall at Murrooghtoohy Viewing Point

Due to the popularity of this viewing point it is necessary to provide a boundary wall that is fit for purpose. There is a 1m to 2m drop inside the wall; therefore this work is intended to keep the tourist safe while viewing the area. The wall also deters tourists from jumping down onto the Limestone pavement at this location. The current unstable wall needs to be dismantled and replaced with a secure semi-dry wall using the original stone.

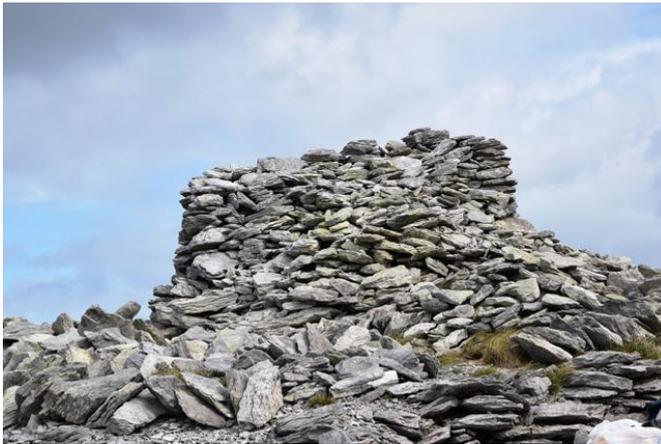
Photograph 44: Upper cairn before repair (August 2017)

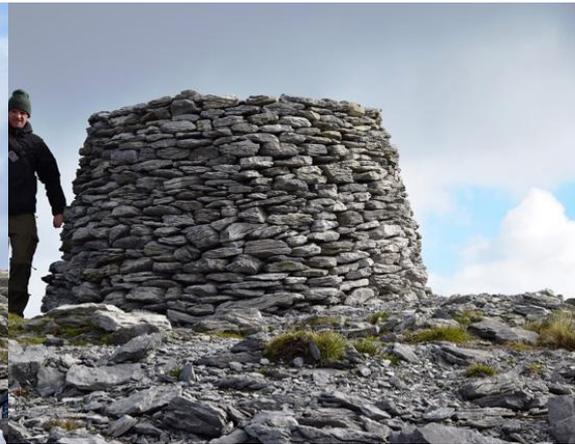
Photograph 45: Upper cairn after repair (September 2017)

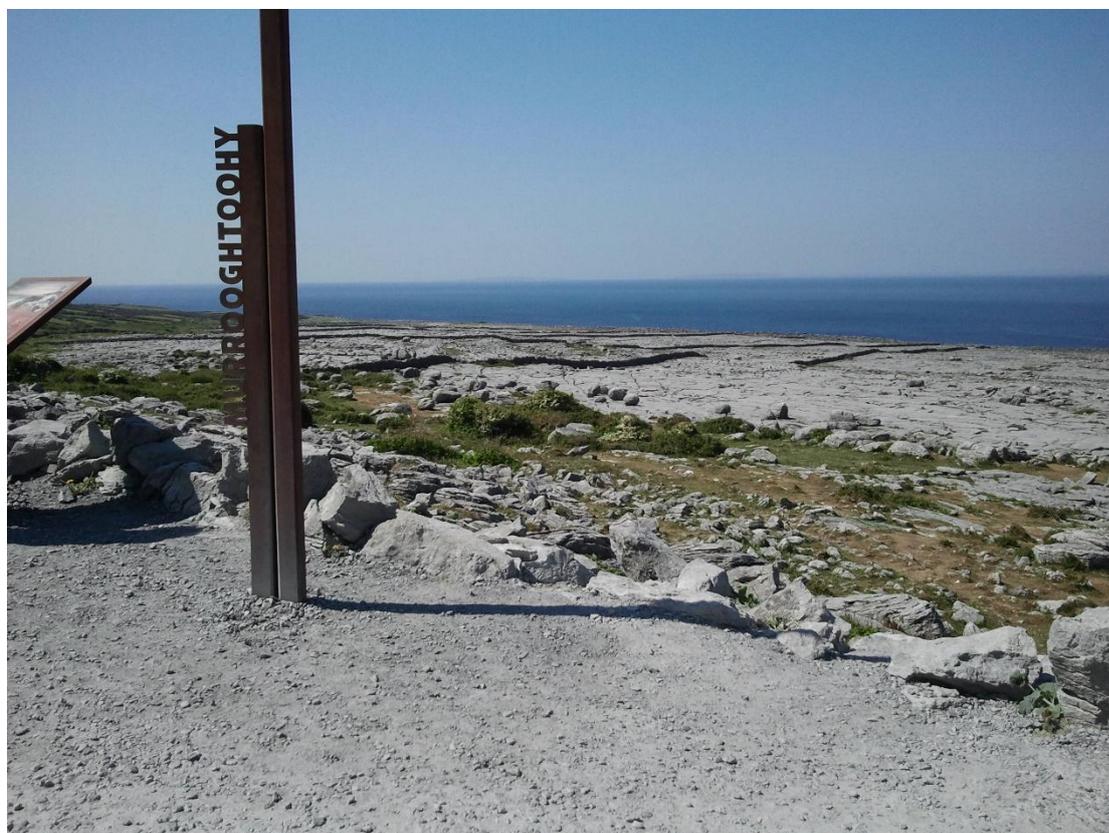
Photograph 47: Murroghtoohey wall before repair (May 11, 2017)

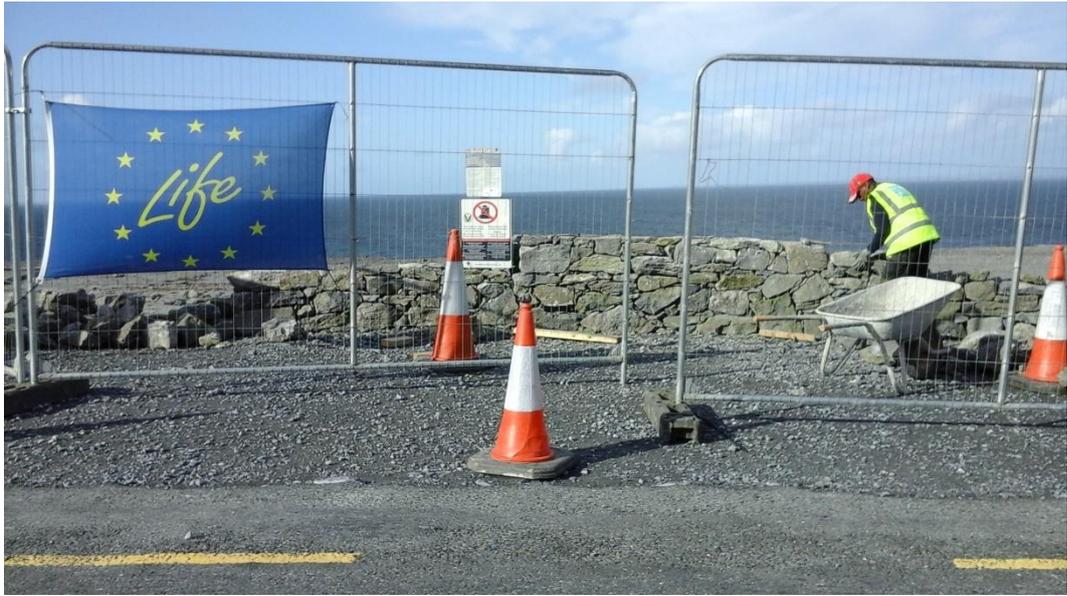
Photograph 48: Murrooghtoohey Wall under repair (October 17, 2017)

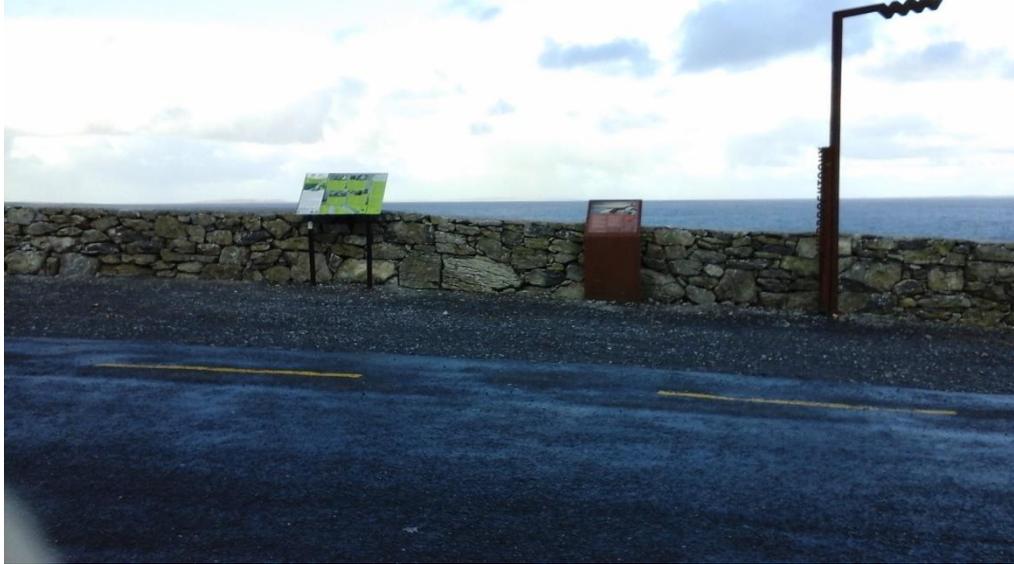
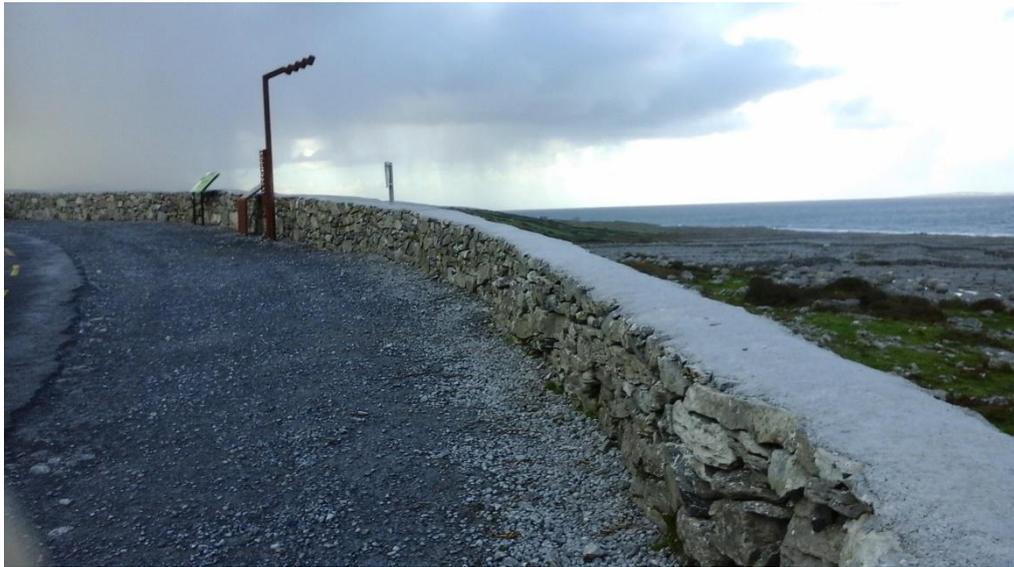
Photographs 49-50: Murrooghtoohey wall after repair (November 7, 2017)
