# Visitor Management Proposal

## Carran Church

**GeoparkLIFE:**  
Tourism for Conservation

**May 2018.**

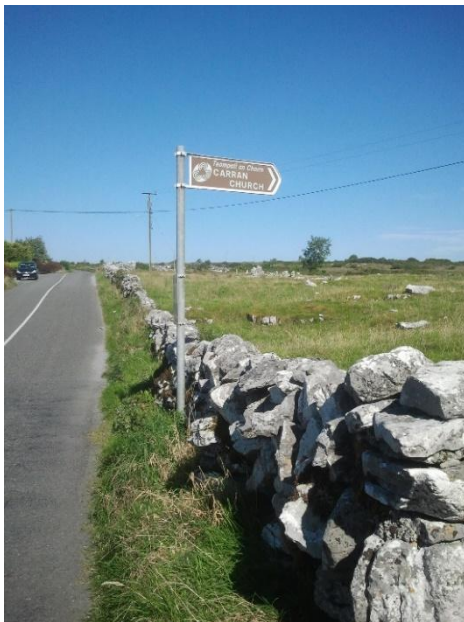
Photograph 4: Road site entry sign

There is no damage to the road site sign but it carries the symbol of the state management agency 'Dúchas' which is no longer operational. The sign needs updating.

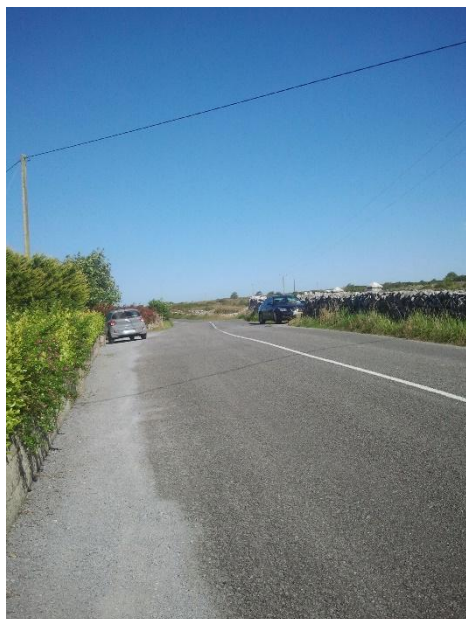
Photograph 5: Unofficial roadside parking at Carran Church

Limited and unofficial parking occurs along the road verge, in front of the Fitzgerald's family home, which is on the opposite side of the road from the Church. This pull in area can accommodate 3-4 cars. If coaches park here they create traffic congestion. However it is very unusual for coaches to park at this site. Occasionally visitors approaching from the north (Ballyvaughan direction) park in a roadside gateway entrance to the north of the church, thereby blocking the entrance to a private dwelling access laneway.

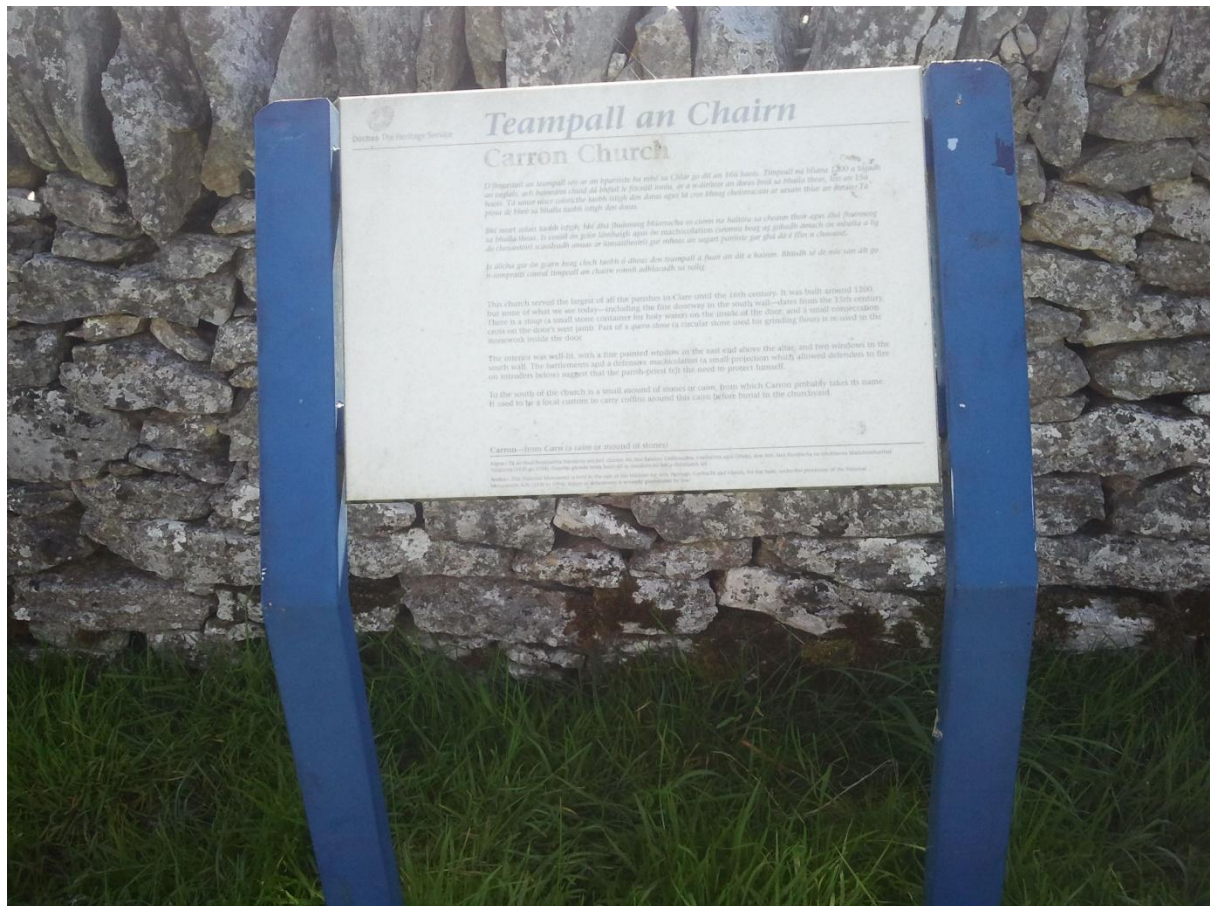
Type of sign	Location (ITM E; ITM N)	Damage description	Source of Damage	Action Required	Timescale for Action required
Interpretive	523960 697392	Text is faded and sign is discoloured	Natural	Replacement of sign with updated interpretation	2-6 months

Photograph 6: Interpretive sign at Carran Church

The current directional road signage to the site and the interpretive panel both carry the 'Dúchas' symbol. The amalgamation of state agencies that operated under the name 'Dúchas' is no longer operational and the site is not managed by any state agency. Both signs should be replaced and the correct management logo (i.e. Clare County Council) inserted.

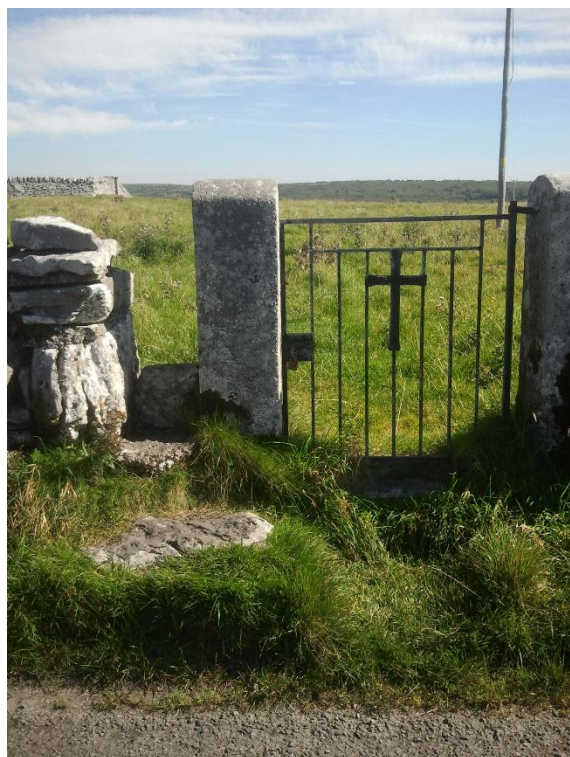
Description of restriction on access	Location (ITM E; ITM N)	Difficulty caused	Action Required	Timescale for Action
Narrow stepped stile at road entrance	523911 697358	Difficult for less abled bodied to enter as adjacent entry gate is kept locked and only opened when burials are taking place.	Unlock gates for continuous entry	Immediate
Narrow stepped stile at graveyard entrance	523964 697392	As above	As above	Immediate

Photograph 7: Stepped stile at road entry

To alleviate the problem with access via the existing stiles, the gate at both the road entrance and graveyard entrance should be unlocked to allow least restrictive access to the site for all visitors.

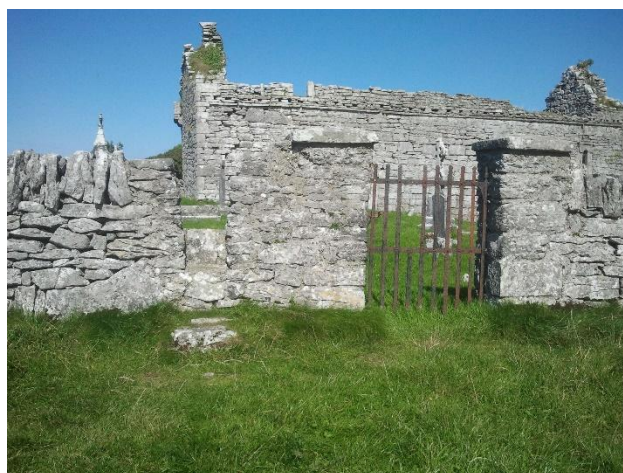
Photograph 8: Stepped stile at graveyard entrance

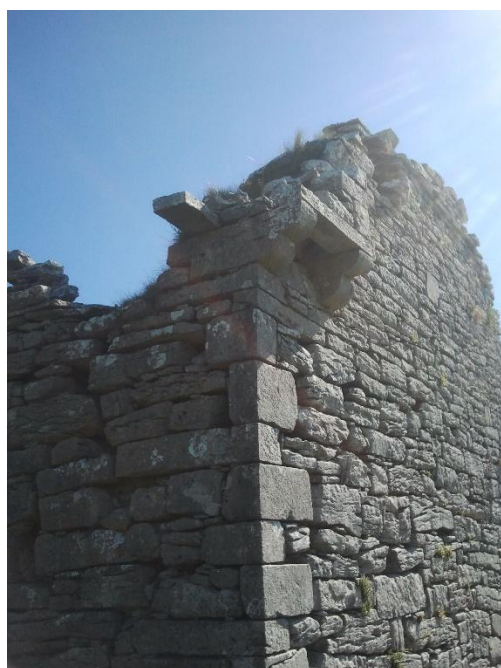
- The North-west corner of the Church is unstable and has been identified as being in danger of collapse. Conservation repairs are required to prevent this occurring and to stabilise the rest of the structure.
- Currently there is no official visitor parking at this site. Parking occurs along the roadside causing potential safety hazards.
- The landowner of the surrounding agricultural field is concerned with visitors accessing the site by climbing over the drystone boundary walls of the field and causing damage. He is also concerned with visitors wander randomly through the field to reach the church while farm animals are grazing.
- Any actions undertaken need to be carefully monitored in terms of their future impact and to inform any adaptive management adjustments which may be necessary to alleviate negative impacts.

Issue	Detail
1a	Deteriorating condition of NW corner of church building	In 2014, the GeoparkLIFE project through its baseline assessment of Carran Church identified that there had been significant structural movement in the NW corner of the Church, beneath a machicoulis which appeared to be in danger of collapse. Several structural stones were located lying in the field beneath this corner. Mortar had been washed out of the joints of the walls in several areas. Stones in the south-east corner wall of the Church had been pushed outwards.
1b	Consent requirements for repair works - Protective Designations	Carran Church is a designated National Monument in the care of the Local Authority (Clare County Council). As such, the prior written <u>consent of the Minister</u> is required for any works at or in proximity to the monument.
2	Outdated directional Signage to the site	The directional road site sign carries the symbol of a management agency 'Dúchas' which is no longer operational. It should be updated.

Photograph 9: NW corner of Carran Church September 2014

<b>Issue 1</b>	<b>Deteriorating condition of NW corner of church building</b>
<b>Agreed Action</b>	Carry out repair work to north-west corner of the Church
<b>Tasks</b>	<ol style="list-style-type: none"> <li>1. Commission Conservation engineers report, method statement and safety plan to carry out required repairs.</li> <li>2. Obtain Ministerial consent to carry out repairs.</li> <li>3. Carry out archaeological excavation to locate original stones.</li> <li>4. Employ contractor to undertake work.</li> <li>5. Sign off on completed works.</li> </ol>
<b>Responsible person/group</b>	Conservation Officer Clare County Council and GeoparkLIFE project
<b>Date Action Completed</b>	November 2017
<b>Results</b>	<ol style="list-style-type: none"> <li>1. Invitation to tender for the Design of Repairs, Preparation and Evaluation of tender documents for the employment of a contractor for the repairs and final report prepared October 2016.</li> <li>2. Architectural Conservation Professionals Limerick contracted for above work March 2017.</li> <li>3. Conservation engineers report, method statement and safety plan completed April 2017.</li> <li>4. Ministerial consent obtained (No. C000793)</li> <li>5. Tender documents for contract work issued and contractor employed August 2017.</li> <li>6. Archaeological excavation report completed September 2017.</li> <li>7. Repair works undertaken September-October 2017</li> <li>8. Report on completion of works December 2017.</li> </ol>

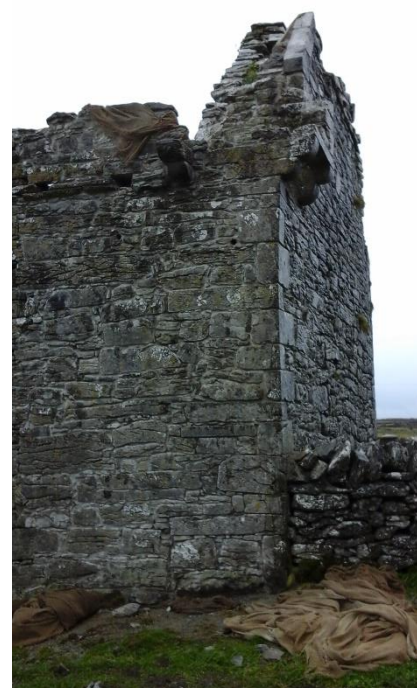
Photograph 10: NW corner of Carran Church following conservation repair  
November 2017

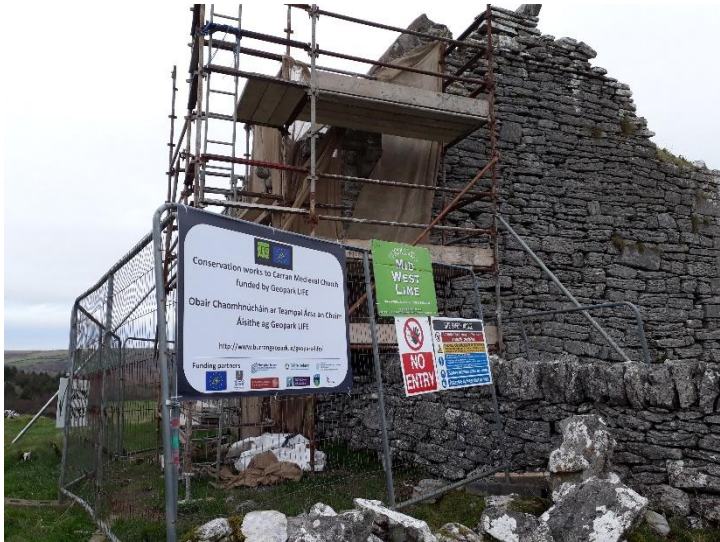
Photograph 11: Conservation repairs underway October 2017

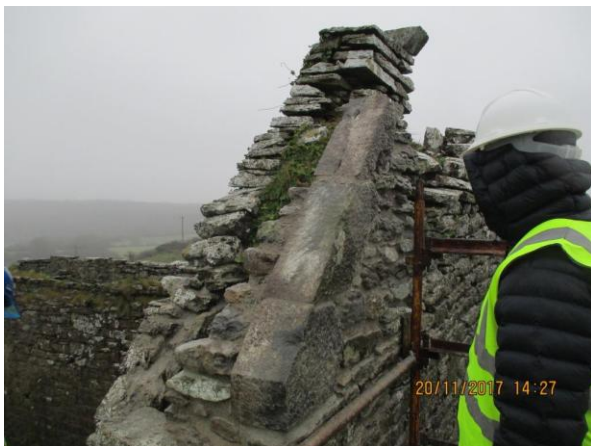
Photograph 12: Repairs to gable barge

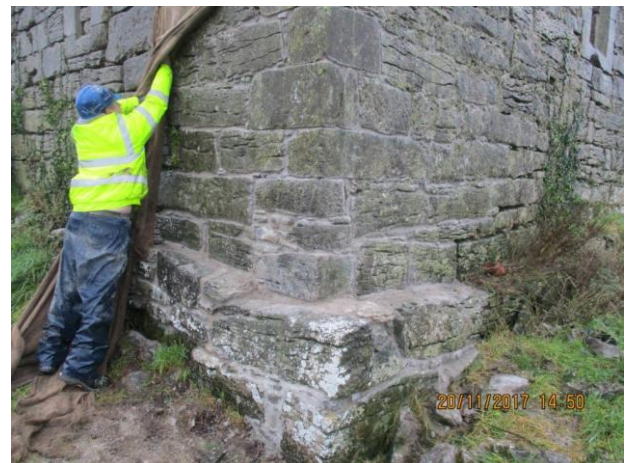
Photograph13: Corner stonework repointed

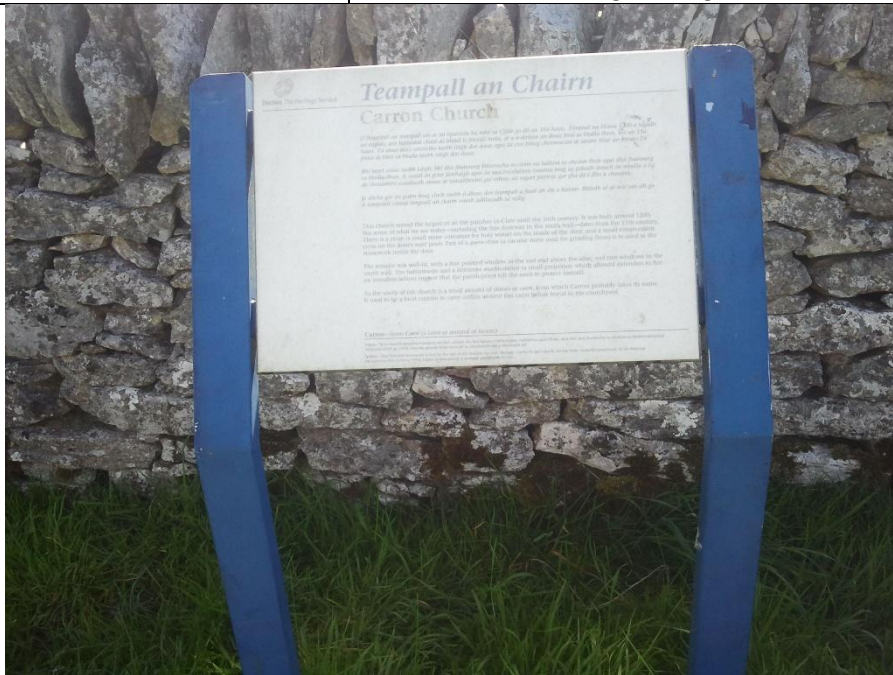
3	Outdated and damaged On-site interpretation	The current interpretive panel located in the graveyard opposite the entrance doorway to the Church is faded and damaged. It carries the 'Dúchas' symbol for a state agency which is no longer in operation. The site is managed by the Clare County Council. The interpretive panel needs replacing and the information needs to be updated.
4	Lack of Parking Facilities	Limited and unofficial parking exists in front of the Fitzgerald's family home, which is on the opposite side of the road from the site. This area can accommodate 3-4 cars. If coaches park here they create traffic congestion. Occasionally visitors approaching from the north (Ballyvaughan direction) park in the roadside gateway entrance to the north of the church, thereby blocking the entrance to a private dwelling access laneway.
5	Restrictions to visitor access	Access to the site via narrow stepped stiles at both the road entrance and graveyard entrance causes difficulty for less abled bodied persons. The adjacent pedestrian entry gates are locked except when burials are taking place on site.

Photograph 13: Dúchas Interpretive Panel at Carran Church September 2017

<b>Issue 2</b>	<b>Damaged and outdated interpretive panel</b>
<b>Agreed Action</b>	The interpretive panel located within the graveyard should be removed and an updated version installed.
<b>Tasks</b>	<ol style="list-style-type: none"> <li>1. Compile text and illustrations for new panel with agreement on content with site managers.</li> <li>2. Agree panel design to GeoparkLIFE universal design template for Burren heritage sites with site managers.</li> <li>3. Commission graphic design</li> <li>4. Commission sign manufacturer</li> <li>5. Complete sign and install on site</li> </ol>
<b>Responsible person/group</b>	GeoparkLIFE
<b>Date Action Completed</b>	October 2017
<b>Results</b>	New updated GeoparkLIFE/Clare County Council branded panel installed on existing supports to minimise ground disturbance to archaeological site. Installing the panel on existing posts did not require ministerial consent to be obtained. Advice was sought through the National Monuments Service.

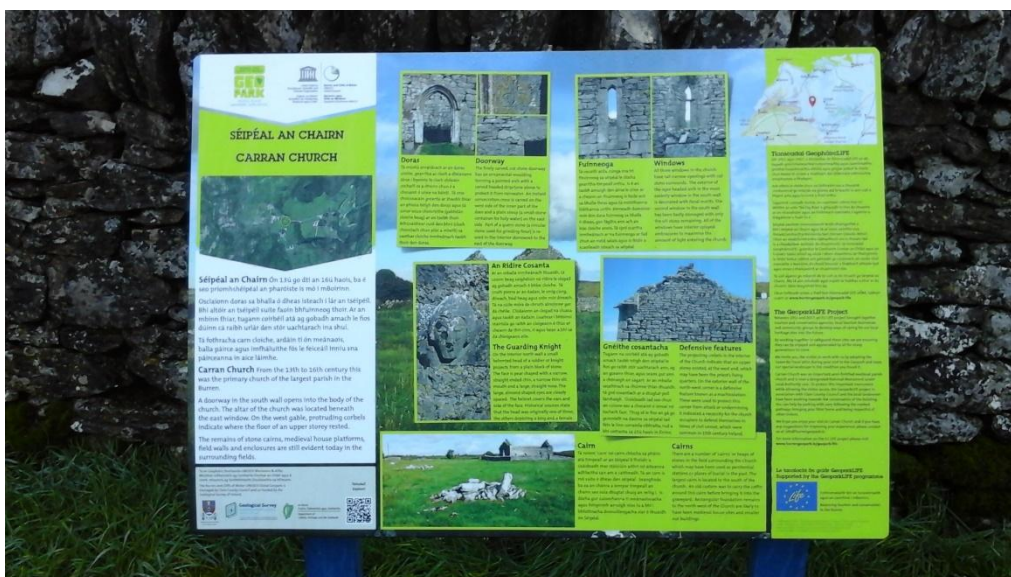
Photograph 14: Replacement GeoparkLIFE Interpretive panel at Carran Church October 2017

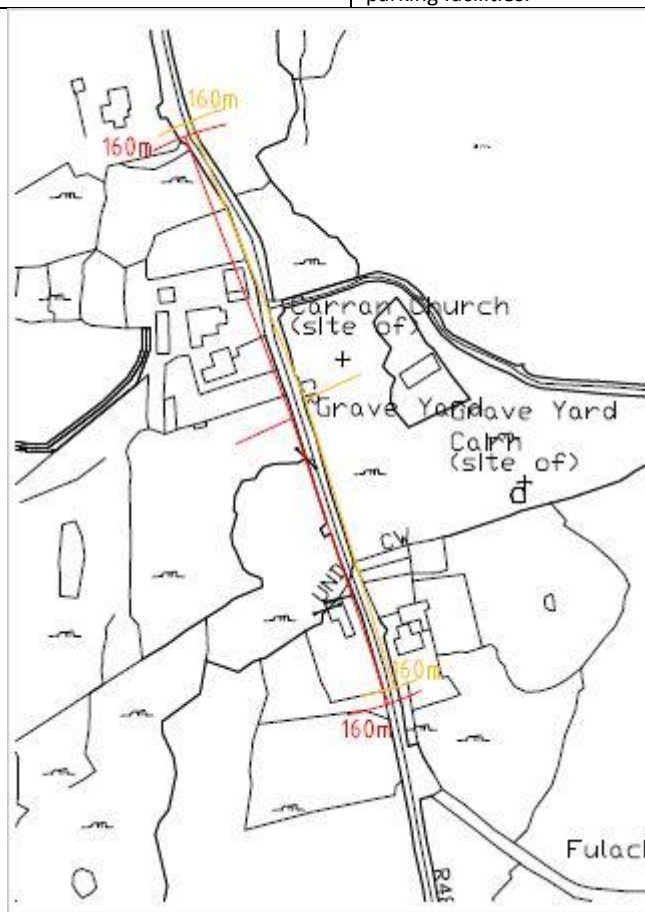
Figure 1: Analysis of Road survey for parking purposes at Carran Church

<b>Issue 4</b>	<b>Lack of parking facilities</b>
Agreed Action	Undertake road survey to determine the possibilities for parking provision at the site.
Tasks	<ol style="list-style-type: none"> <li>1. Carry out road survey</li> <li>2. Analyse data</li> <li>3. Evaluate possibility of location and size of parking area.</li> </ol>
Responsible person/group	Clare County Council
Date Action Completed	June 2016
Results	<p>Road survey analysis was completed by the Road Section Engineer of Clare County Council June 2016.</p> <p>Results show that due to limited sightlines from both approach to the site, it is not currently possible to allow for a parking pull-in or parking bay along this line of road. A clear sightline in either direction was only 160m in distance. Under the Road Safety Act sightlines must have a minimum clearance of 250m for parking facilities.</p>

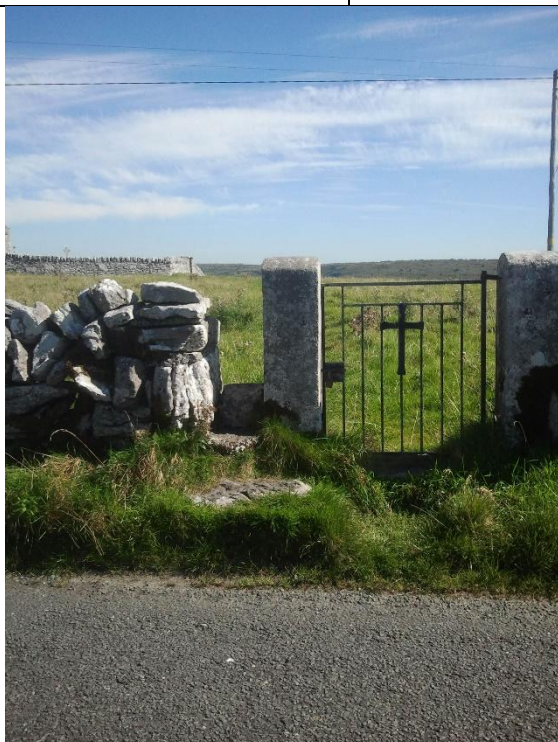
6	Visitor confusion over official entry point and climbing boundary walls to gain entry	The landowner of the agricultural field in which the church is sited, is concerned with regard to visitor's entering site by climbing the boundary walls and causing damage and wandering through surrounding field when livestock present.
7	Potential of increased visitor numbers at site	Monitoring of visitor numbers to the site should be continued using the footfall counters installed under the GeoparkLIFE project. Site assessment as per the methodology used during the GeoparkLIFE project should be undertaken on an annual basis to determine the impact of physical actions undertaken at the site and of visitors to the site. The results of this monitoring will inform the future determination of a carrying capacity for the site and adaptive management decisions.

Photograph 15: Entry to site September 2014

<b>gaining access over stone walls and wandering through surrounding field while livestock present.</b>
Agreed Action	Fence pathway from road entry to graveyard entrance creating a highly visible access route to the Church
Tasks	<ol style="list-style-type: none"> <li>1. Agree fence design and location with landowner.</li> <li>2. Obtain Ministerial consent to install fencing</li> <li>3. Employ contractor to install.</li> </ol>
Responsible person/group	GeoparkLIFE and landowner
Date Action Completed	November 2017
Results	Ministerial consent obtained (October 2017). Wooden post and timber fence (providing visitor access along the existing right of way) incorporating two opposing field gates to allow animal passage across field, when required, installed November 2017.

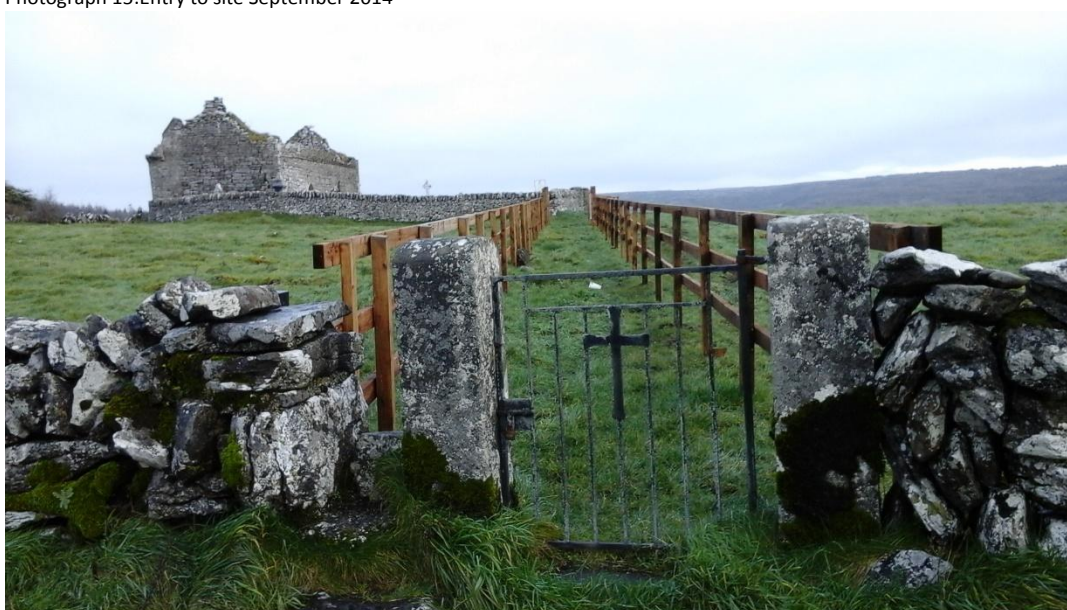
Photograph 16: Fencing installed by GeoparkLIFE between road entry and graveyard entry at Carran Church November 2017.
