## Visitor Management Proposal

# Poulnabrone

**GeoparkLIFE:** Tourism for Conservation

## SECTION THREE: BASELINE SITE CONDITION ASSESSMENT (2014)

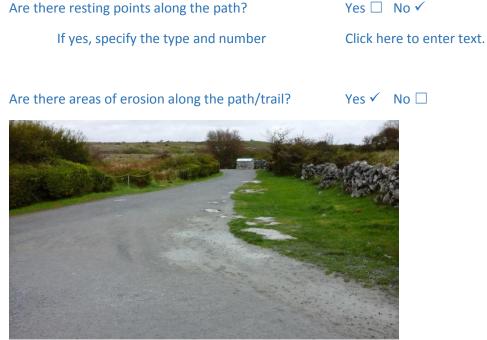
Photograph 6: Areas of erosion along access path to monument

There is an area of erosion as the access path turns right after the descent from the car park. This point is close to the first OPW interpretive panel. Visitors tend to keep close to the right hand verge at this turn and move onto the grass area when there are a large number of visitors moving along this section of the path. This behaviour is causing erosion of the vegetation and the rock surface in this area.

A second area of erosion is in the area immediately surrounding the monument. Visitors move around the monument for viewing purposes. The monument is cordoned off with a rope. The limestone pavement beneath the rope shows smooth, eroded surface with abrasions on the outer

side of the rope due to footfall. The limestone surface on the inner side, protected from visitor footfall by the cordon, is less worn and shows vegetation recovery.

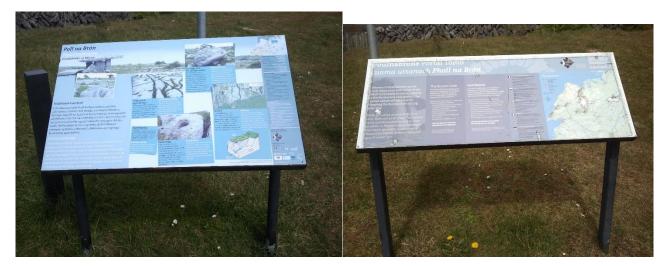
Photographs 13: Burren Connect Interpretive Panels in car park

There are a large number of signs present in the car park area. Some of these are damaged and need to be removed. Before any replacement the amount of signage and content should be reviewed and a rationalisation undertaken to prevent duplication of information and excessive use of signage.

Issue 7	Outdated and damaged signage						
Agreed Action	Review signage at the site and replace duplicated and damaged signs						
Tasks	1. Carry out signage review						
	2. Remove damaged signs						
	3. Replace with new signage where required						
Responsible person/group	GeoparkLIFE						
Date Action Completed	September 2017						
Results	A review of signage was undertaken in August 2016, identifying where signs needed to be rationalised or replaced. Preparation of text and images for the GeoparkLIFE Poulnabrone sign began in August 2016. Design completed and sign installed in September 2017 following the removal of previous Burren Connect/Geopark interpretive panels from the site.

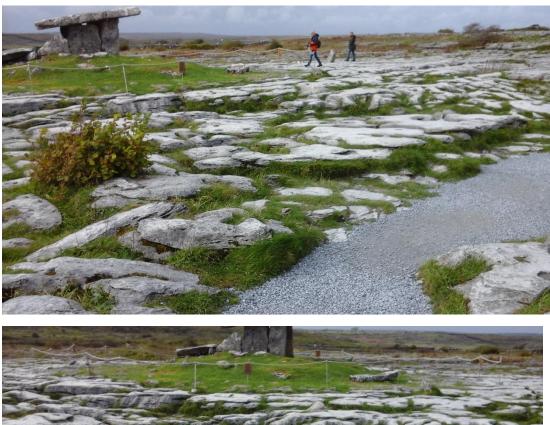
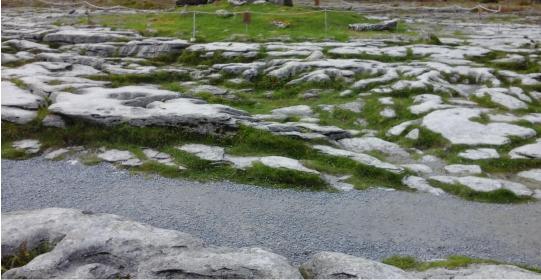
Photographs 14-15: Access over limestone pavement to monument

Description of restriction to access	Location (ITM E; ITM N)	Difficulty caused	Action Required	Timescale for Action
From the access path the visitor must cross the limestone pavement to reach the monument viewing area.	523574 700391	The uneven surface and slippy nature of the rocks can cause access difficulties for the less abled bodied and a trip and slip hazard.	Warning sign as to slippy nature of rock surface	Immediate
