# **AN RATH-CAHERMORE SITE ASSESSMENT REPORT**

**Prepared by**

**December 2014**

**(Updated February 2015 to include Visitor Surveys data)**

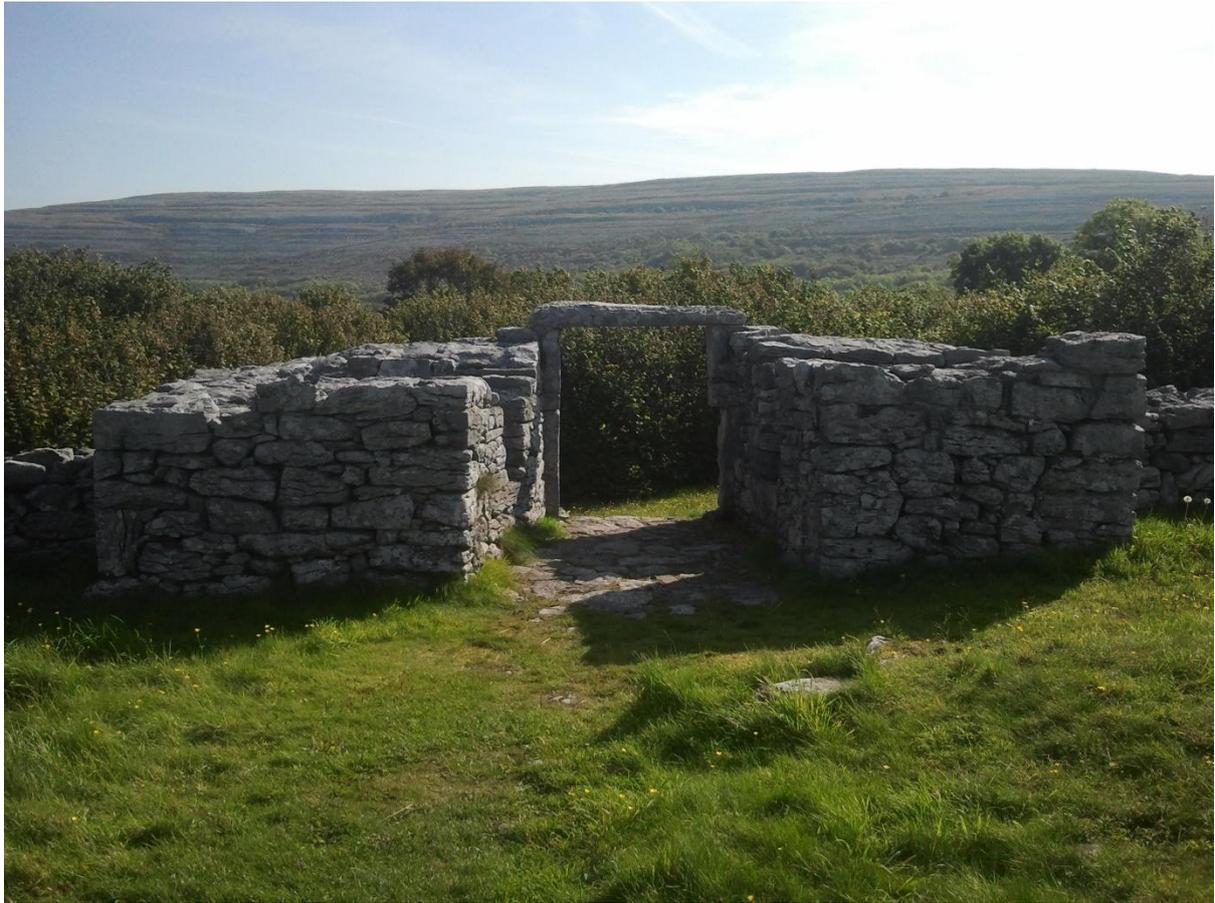
Cahermore is a medieval stone fort or *caher*. It is located at a slightly higher elevation than An Rath and is on limestone pavement. It is enclosed by two concentric walls approximately 30-45m apart with radial walls extending from the inner to the outer wall at the north-west, west and south-west. The inner wall is up to 2-3m in thickness and is built of two faces of fitted blocks with rubble stone centre. It encloses the lios which is approximately 50m in diameter. Within the inner lios are the foundations of several structures. In the south, close to the inner wall, are the remains of a sub rectangular building. A possible hut site, consisting of a number of grass covered stones, is located in the north of the lios. The collapsed remains of a possible two rectangular enclosures are located against the wall in the north-west. The outer concentric walls of the caher are less substantial than the inner and are largely collapsed and hidden by hazel scrub. A lintelled stone and mortared gateway (width 1.6m), with a single small chamber at each side, provides entrance to the interior of the caher from the east. This gateway was excavated in June 1999 following the collapse of the lintel. The excavation revealed that the structures around the entrance were a 14<sup>th</sup>/15<sup>th</sup> century addition to the pre-existing fort. A scallop shell from below the foundations was radiocarbon dated to AD 1308. The lintel was replaced and the entranceway consolidated in 2001. In recent years the OPW installed a wooden viewing platform in the west section of the fort which provides a view over the Ballyvaughan valley.

Photo 1: Reconstructed medieval gateway at Cahermore

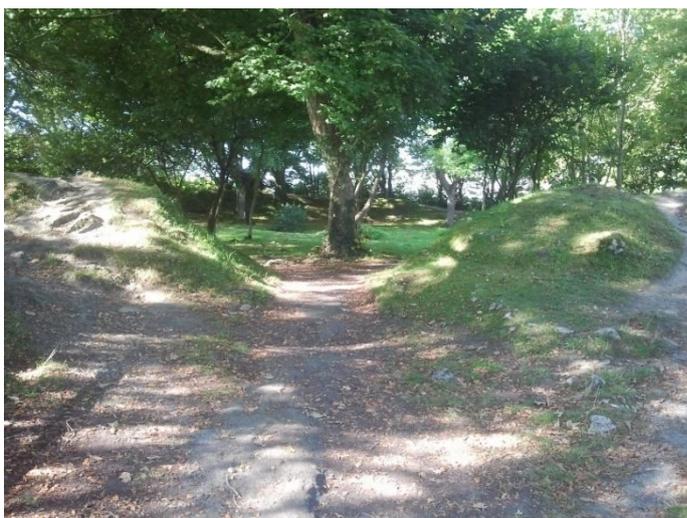
Photo 2 : Eroded entrance to the centre of An Rath

Due to visitor footfall the entrance to the interior of the ringfort and the top of the surrounding bank have been badly eroded and are generally devoid of vegetation. The roots of the trees are exposed along the enclosure bank due to this visitor pressure.

- Due to the design of the two step stile entrance to the site, there are physical access limitations for the less abled bodied visitors.
- The erosion of the embankment enclosing the interior of the fort due to footfall appears to have increased in recent years and could cause serious damage to the monument if allowed to continue. Damage is also being caused to the ecology of the site due to this visitor pressure.

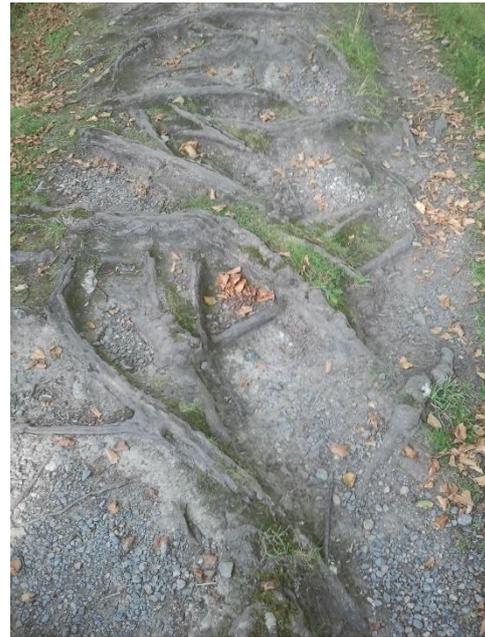
A treeline of mature Beech (*Fagus sylvatica*) trees grows on the top of the earthen enclosing bank of the ringfort. The trees are approximately 150 years old. It is likely that these were planted by a local landowner creating a landscape feature of the ringfort.

Photo 3: Exposure of tree roots due to footfall pressure on enclosing bank of An Rath

*At An Rath there is a well defined pathway around the top of the earthen mound which is devoid of vegetation but is being contained by the exposed roots of the mature beech trees that line the ringfort. While the roots are showing some signs of surface damage, this is superficial and will not impact on the longevity of the trees. The vegetation within the ringfort is of low species diversity due to the heavy shade and is also mown regularly by the OPW. The vegetation surrounding the ringfort consists of a wetland community in the peripheral ditch with scrub adjacent scrub. These show no evidence of impact.'*

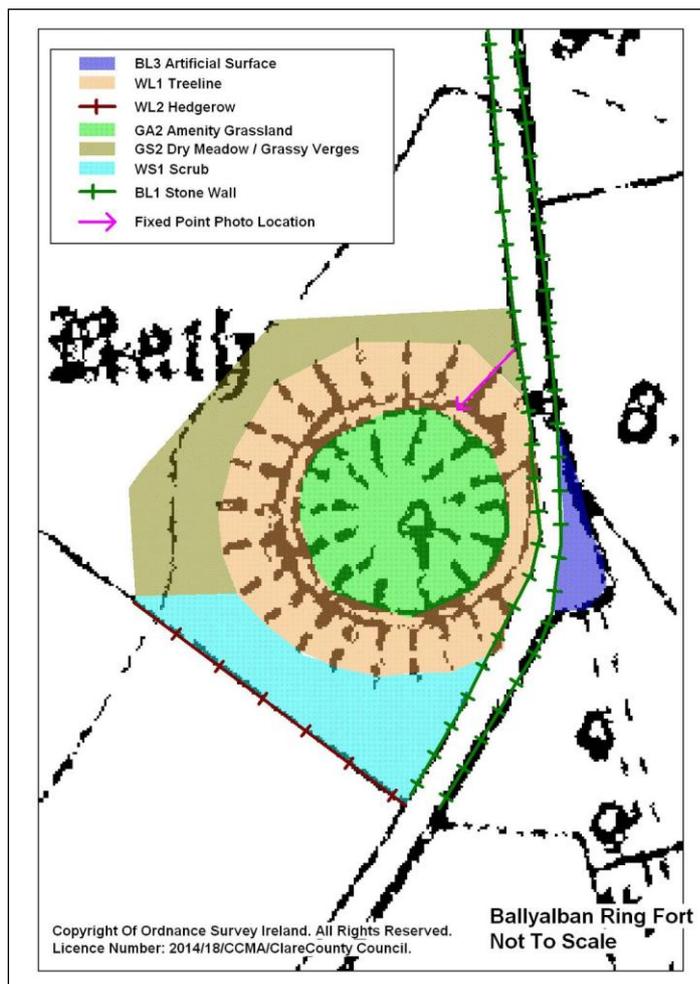
Figure 5: Habitat Map of An Rath, Ballyalban (EirEco Ecological Consultants 2014) produced for GeoparkLIFE

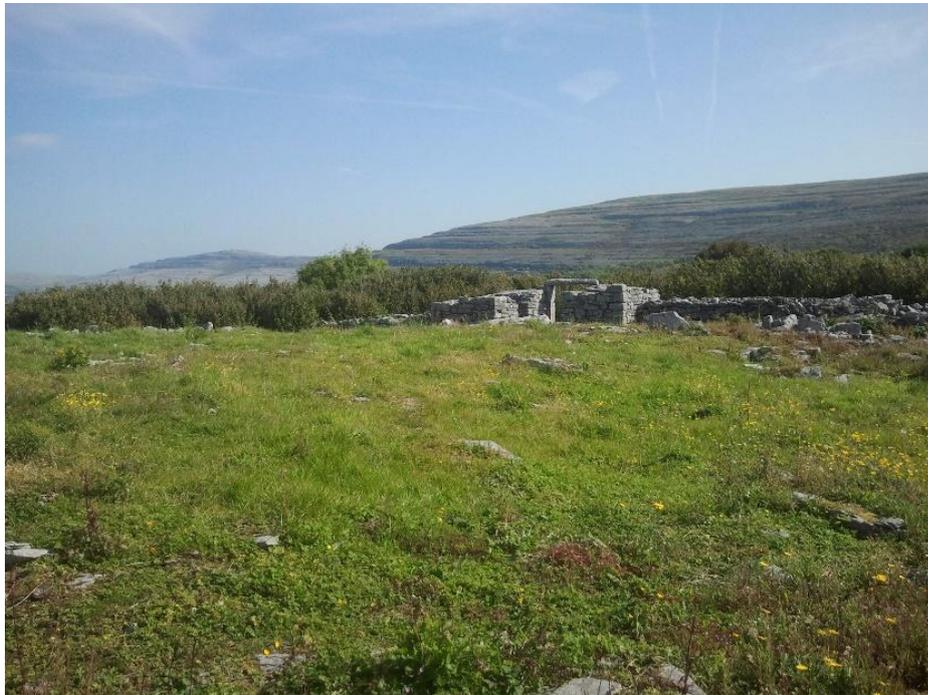
Cahermore is located on limestone pavement with a shallow soil covering. The site is surrounded by hazel scrub interspersed with ash and holly and rock outcrops. The interior of the monument supports dry calcareous grassland, briars and hazel scrub. The grass is regularly cut and the hazel scrub has been cut back in recent months.

Photo 4: Vegetation cover in the interior of Cahermore

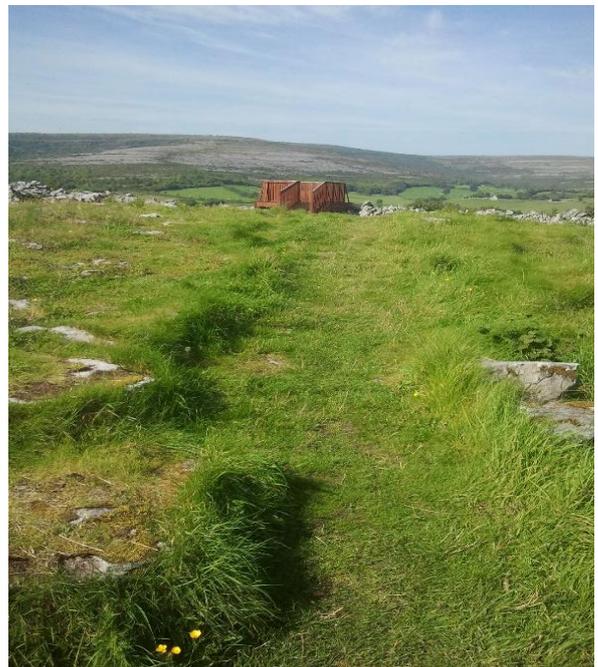
.Photo 5: Grass worn path through interior of Cahermore from entrance gate to viewing platform.

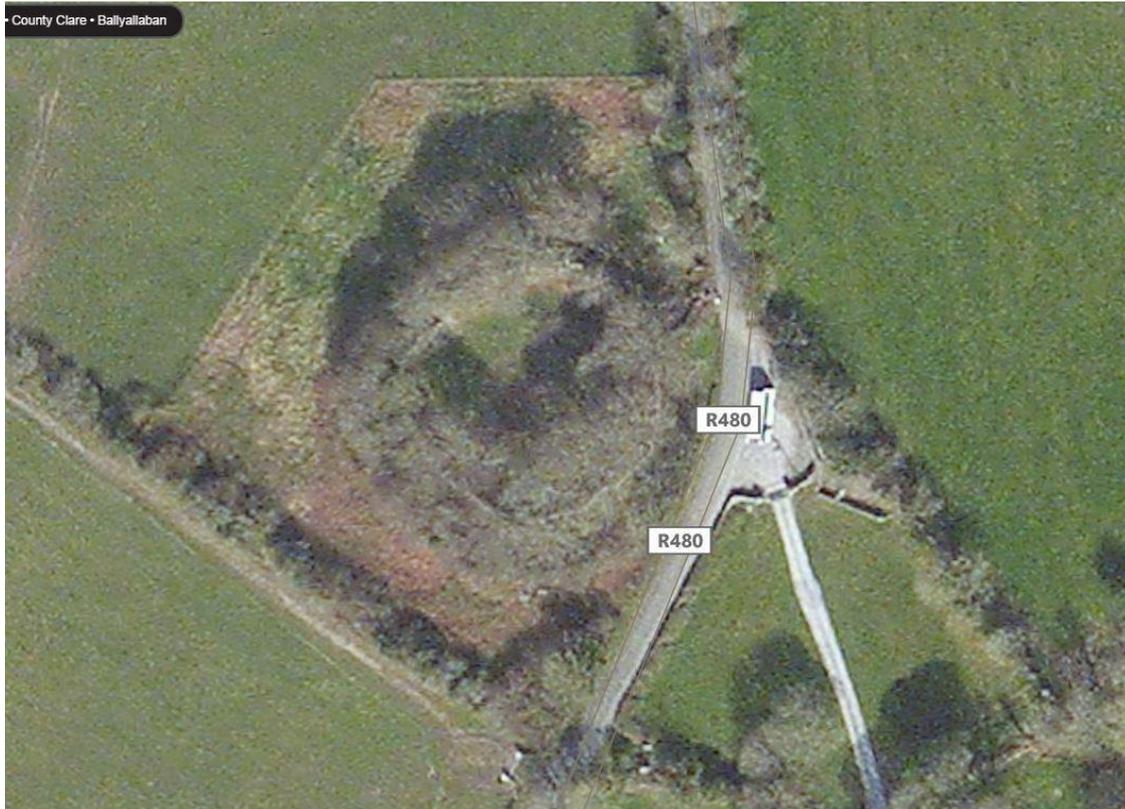
There is no official parking area for either monument. Visitors to An Rath generally park on the hard shoulder opposite the site, in an area which is part of a private entrance area to a residential house. Approximately three cars or one coach can park in this area at any one time, but may cause obstruction to the house entrance gateway.

Figure 6: Aerial view of An Rath with coach parked opposite the site, on hard shoulder in front of private entrance.

- The current roadside parking at the site is inadequate and dangerous
- There is a serious health and safety issue with regard to visitors crossing the road to enter the site from unofficial parking on the hard shoulder, as sightlines are inadequate and up to 45 people can be crossing at any one time if a coach tour is visiting the site. As the site is on a very busy tour route a number of coaches can visit this site in any one day.

ISSUES	RECOMMENDED ACTIONS
Due to the lack of parking facilities at this site visitors park along the hard shoulder of the R480 road at each site. This is a serious health and safety issue due to the limited sightlines available at each site. Dangers arise where visitors cross the road to enter An Rath and vehicles from the north must cross the road to park on the hard should at Cahermore.	Pursue action of developing car/coach park between both sites with off road access from this park to each monument.
Both sites present physical access limitations for the less abled visitor, due to the two step stile entry to An Rath and the very narrow stone gap entrance to Cahermore.	Develop universal design access to each site from new parking area
Visitor footfall pressure is creating erosion of the earthen bank at An Rath resulting in removal of vegetation and exposure of tree roots.	Carry out ecological and archaeological survey to inform proposed planning of new access system.

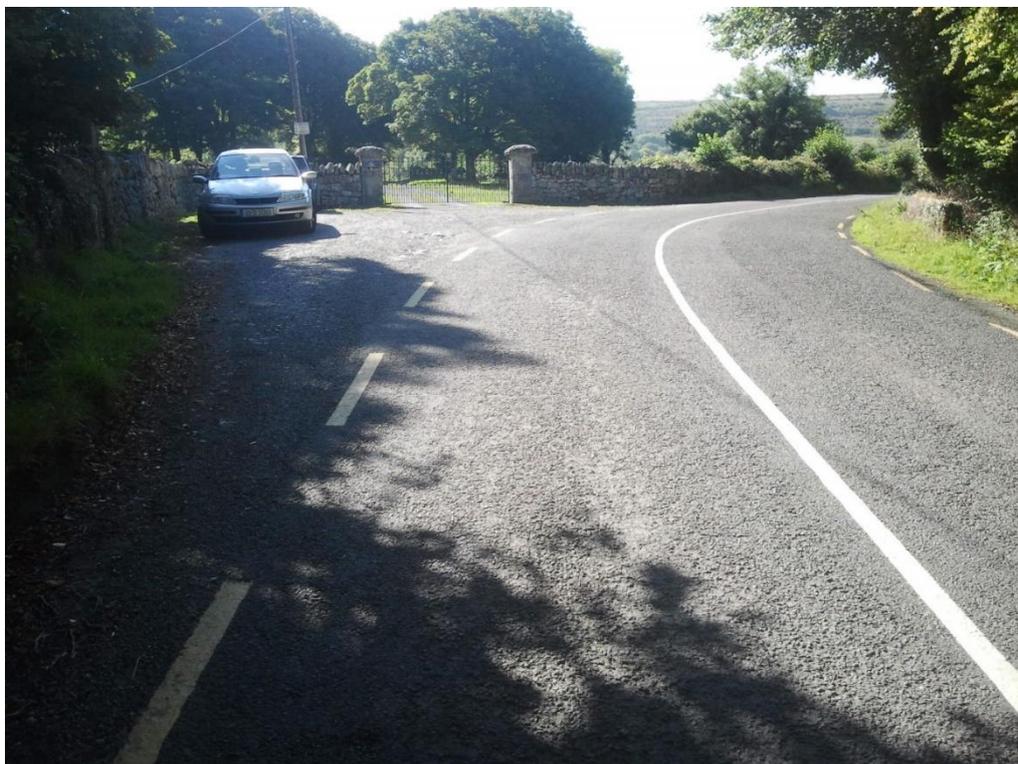
Photo 6: Hard shoulder outside private entrance gate opposite An Rath..

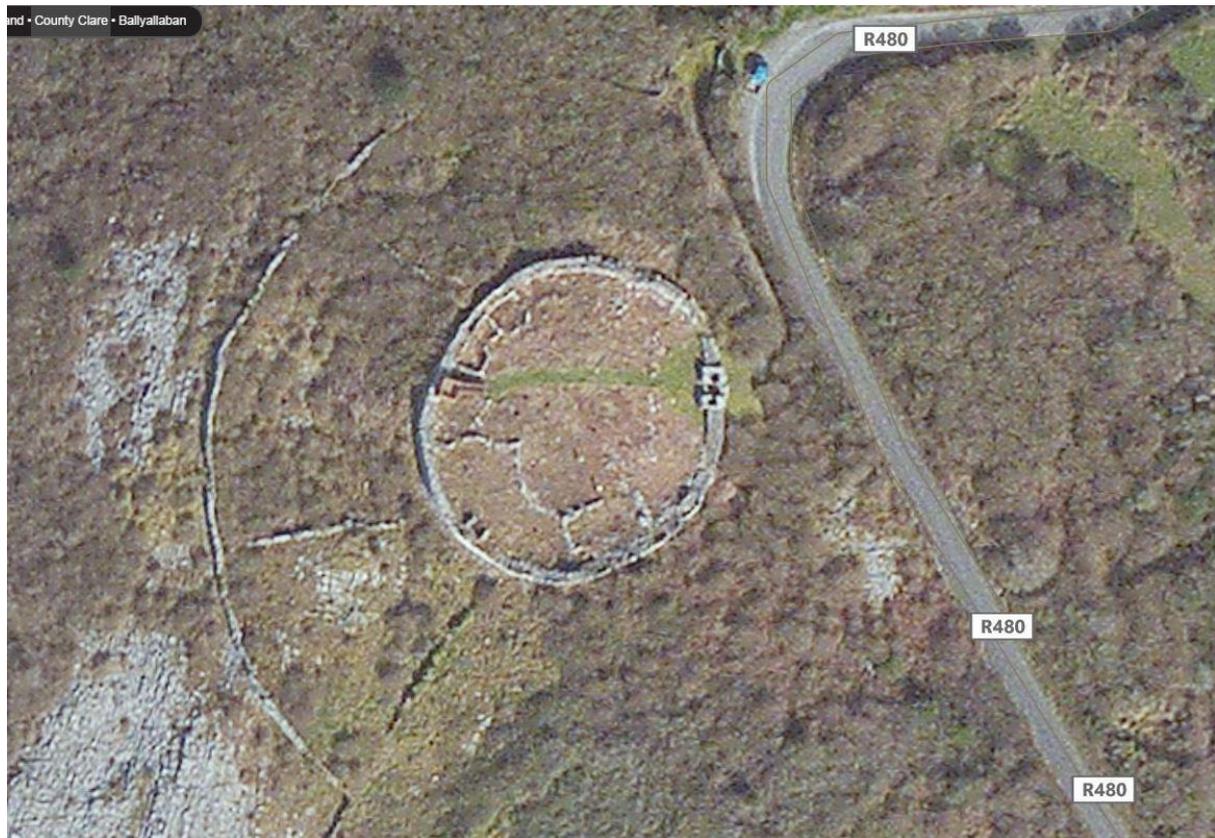
The entrance to the Cahermore monument is located on a sharp bend in the road. There is a small gravelled hard shoulder area directly outside the entrance stile to the site. This area can accommodate up to three cars or one coach.

Figure 7: Aerial view of Cahermore with vehicle parked on hard shoulder of sharp road bend adjacent to stile entrance to site.

- Due to the lack of an official parking area, the hard shoulder area outside the entrance is in use and due to its location on a sharp bend with lack of adequate sightlines it poses a serious Health and Safety issue.
- There are physical access limitations to the site due to the narrow entrance gap in the stone wall
- The on-site interpretive panel is faded and provides very superficial interpretation of the monument.
- The provision of the viewing platform in the caher interior appears to attract the visitor to walk directly across the site from the medieval entrance gate. This is creating a worn grass pathway but is lessening a wider dispersal impact of visitors on the vegetation of the monument interior.

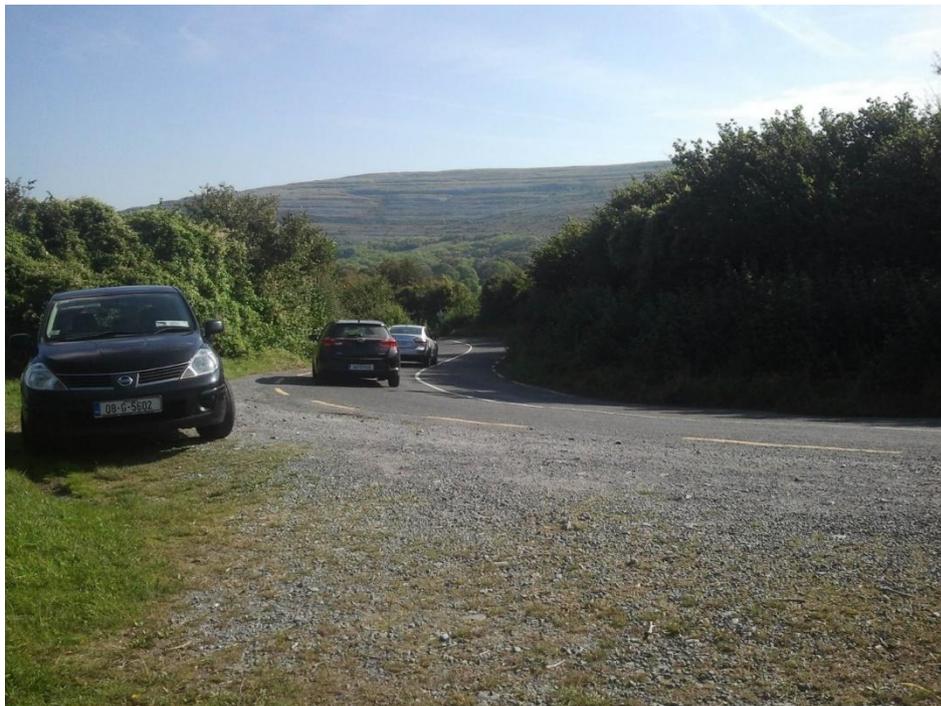
Photo 7: Unofficial hard shoulder parking area outside roadside entrance to Cahermore.

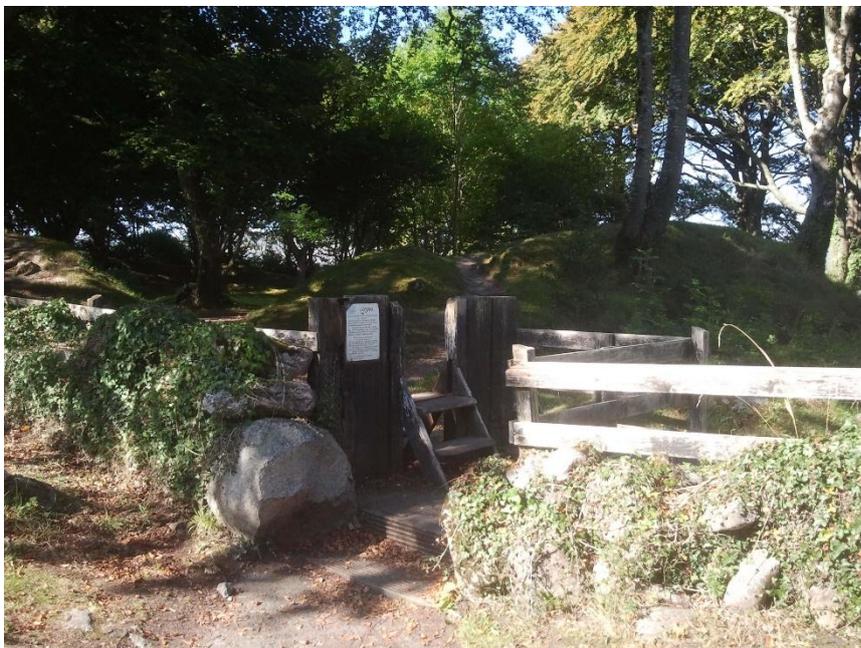
Visitors access An Rath by climbing over a two-step wooden stile into the north-east of the site. They then can pass through the gap in the earthen bank to the interior of the fort. The site entrance is located on a winding corner and visibility is limited for visitors crossing the road.

Photo 9: Two-step stile entrance from R480 into An Rath

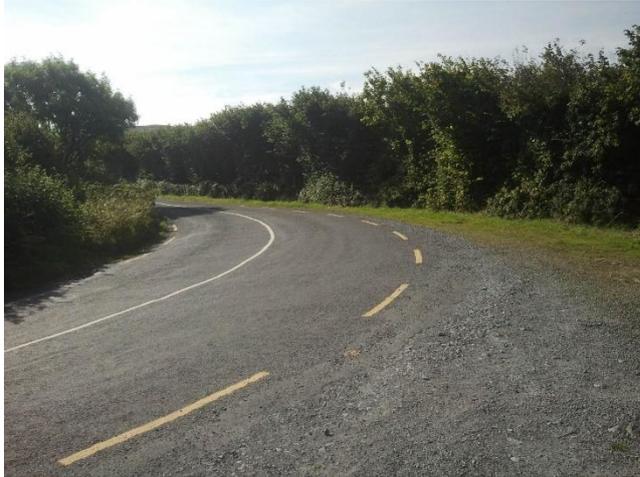
Cahermore is located on a very sharp almost 90<sup>0</sup> bend in the road. Traffic approaching from the north must cross the road to the hard shoulder to park. As they do this they are not visible to approaching traffic from the south as the sightlines are too tight.

Photo 10: Sightline looking south on R470 from hard shoulder at Cahermore

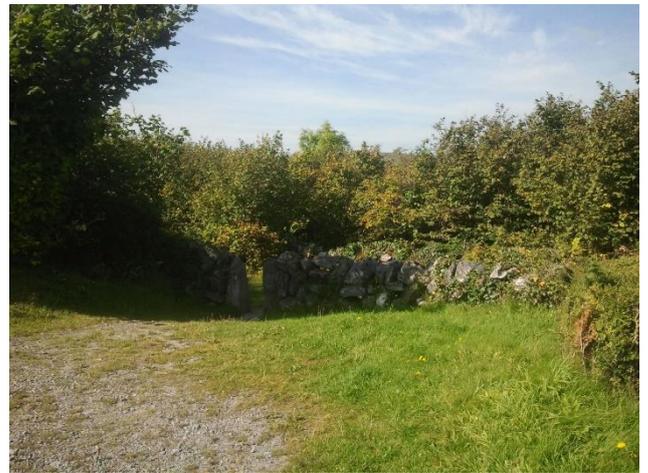
Photo 11: Narrow gap entrance from hard shoulder to Cahermore site

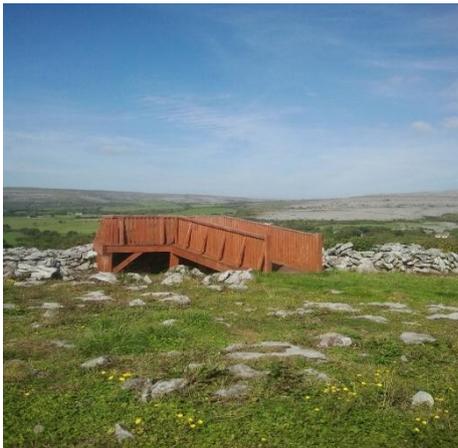
Photo 12: Viewing Platform at Cahermore

The only recreational facility provided at either site is a wooden viewing platform in the interior of Cahermore. It provides the visitor with a commanding view over the Ballyvaughan Valley.

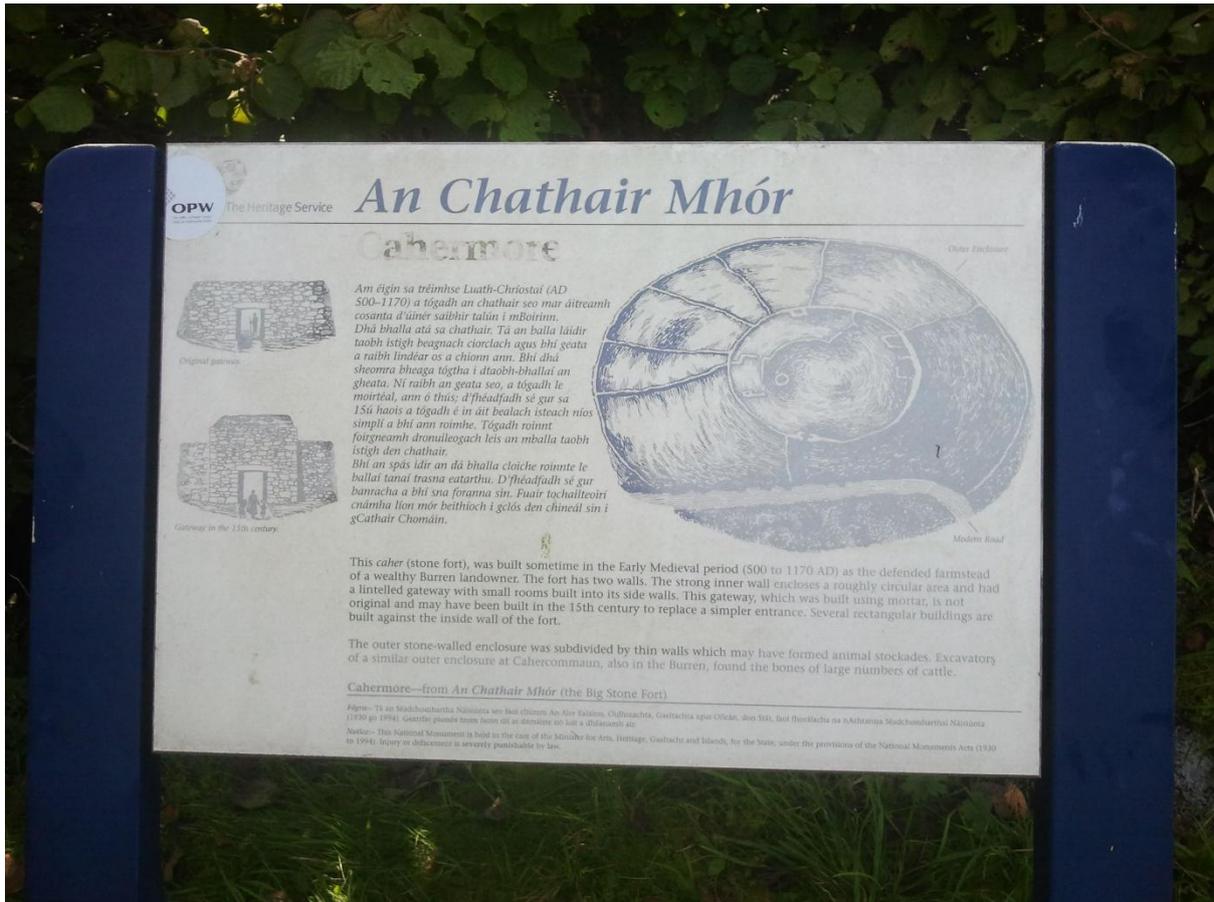
A standard OPW lectern style interpretive panel is located close to the medieval entrance gateway into the interior of Cahermore. The text is bilingual (Irish and English) and provides a brief account of the date, function and structure of the monument with line illustrations of the original gateway and an aerial plan of site. The text and illustrations are faded and the panel needs updating.

Photo 13: Interpretive panel at Cahermore

There is no interpretation of the site available at An Rath. Interpretation provided at Cahermore is limited and in need of upgrading.	Provide good interpretation of both sites within new access proposals and include message on environmental and archaeological sensitivities of the site to influence visitor behaviour.
There is no directional signage at either site. Visitor numbers to An Rath would appear to have increased in recent years due to increased coach tourism along this touring route but Cahermore receives very few visitors.	Direct visitors to both sites from new parking area.

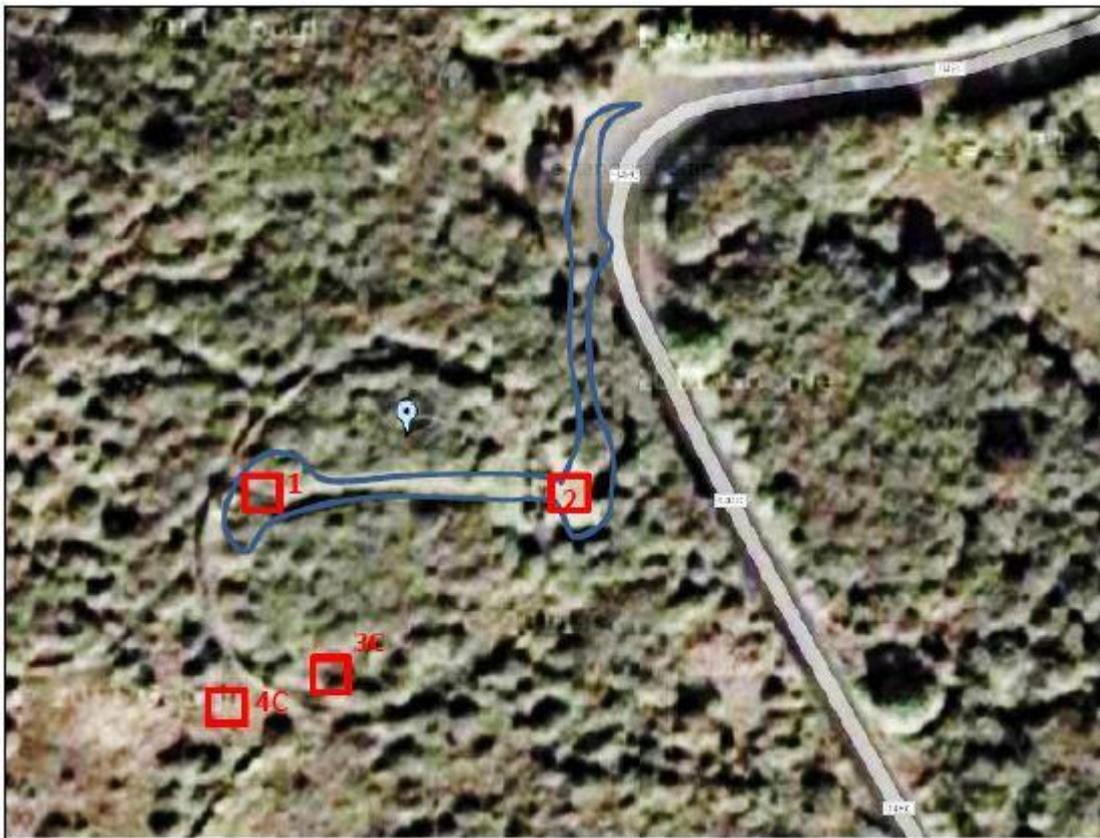
As part of the CAAS Visitor Observation Study, EirEco Environmental Consultants were commissioned to carry out vegetation monitoring at the GeoparkLIFE demonstrations sites between October 21, 2014 and December 2, 2014. Vegetation was analysed in 1m<sup>2</sup> quadrats at pre-selected locations identified by CAAS in each site. Four quadrat surveys were conducted at the Cahermore site as illustrated in Figure 8. A quadrat survey was not conducted at An Rath.

Figure 8 : Ecological survey quadrat locations Cahermore

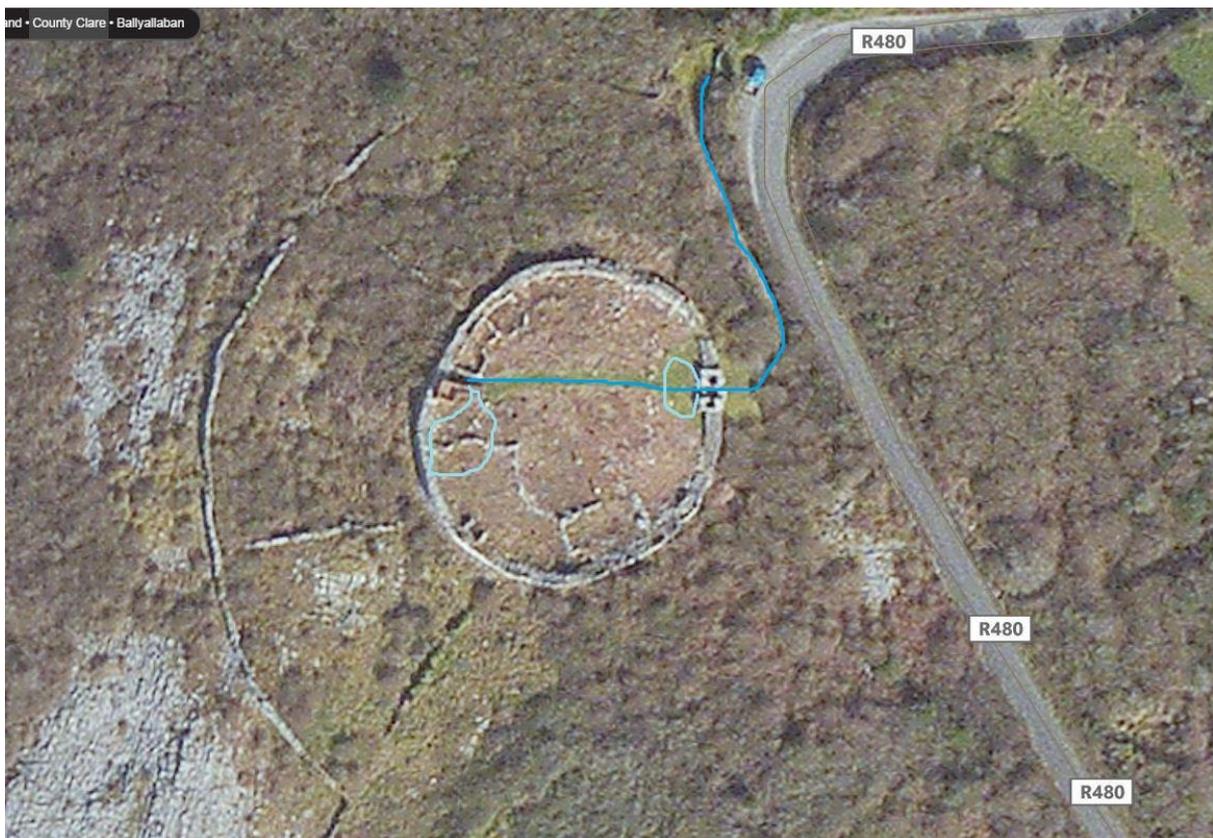
Observed movement patterns – dark blue line show core movement area; lighter blue peripheral
