SLIEVE CARRAN
SITE ASSESSMENT REPORT

December 2014

(Updated February 2015 to include Visitor Survey data)

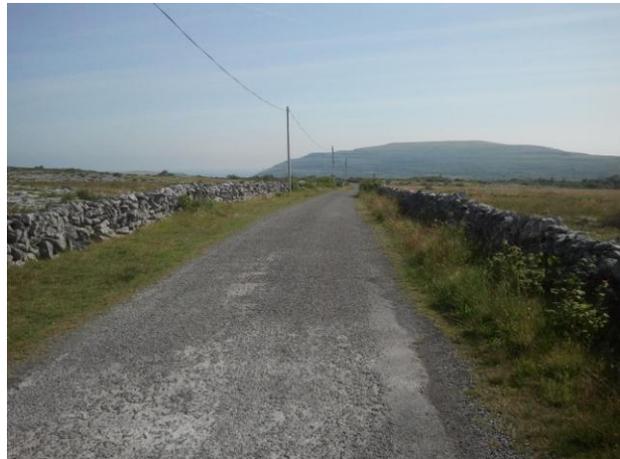
Photo 1: Approach road to Slieve Carran (25-7-2014)

The approach road to the site is designated third class. It is narrow and winding. Cars approaching each other have difficulty in passing and there are several small areas where cars pull in to allow passage by others. The road is entirely unsuitable for coach traffic. Encroaching roadside vegetation in sections increases difficulty with sightlines.

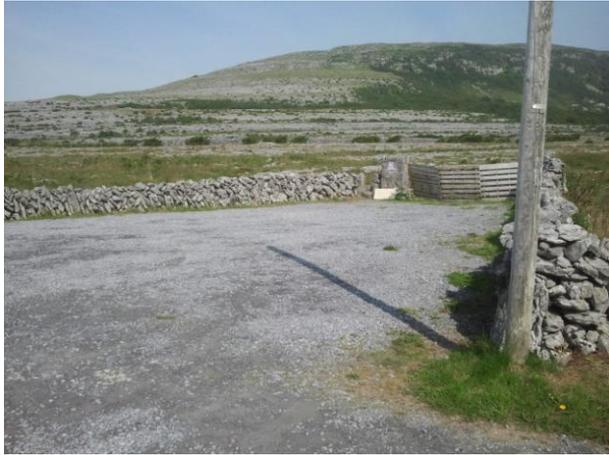
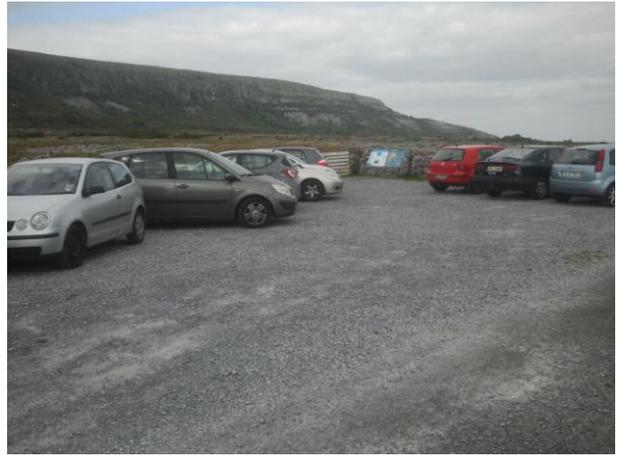
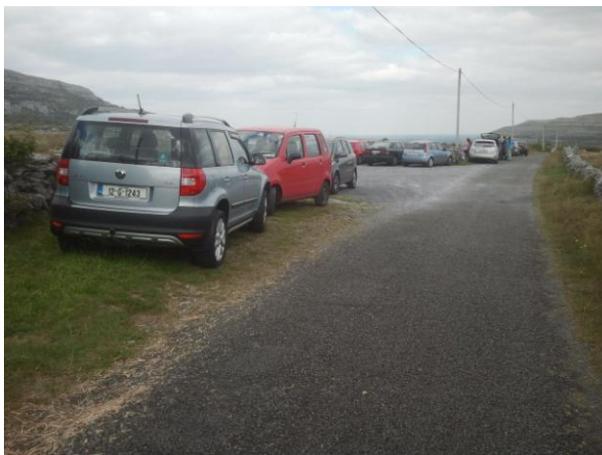
Photos 2, 3 & 4: Parking at Slieve Carran

A small gravelled car park is located outside the entrance to the Nature Reserve on the west side of the road. It consists of a pull in area within the bell mouth of the gateway. There are no designated parking zones and parking can be haphazard. The area can accommodate approximately 20 cars if parking is orderly with all vehicles parked parallel with ends into the boundary wall. On occasion when an organised event is taking place, such as a guided walk, large numbers of vehicles are present at the site, parking extends along the roadside and can result in traffic disruption and ecological damage to the grass verge vegetation. This may occur once or twice a year. Coaches do not generally use this road or bus tours visit this site due to the narrow approach roads.

A second small pull-in area is located on the roadside at the southern entrance to the BNP parcel of land. It can accommodate approximately seven to eight cars maximum. This is sufficient space as very few vehicles park in this area.

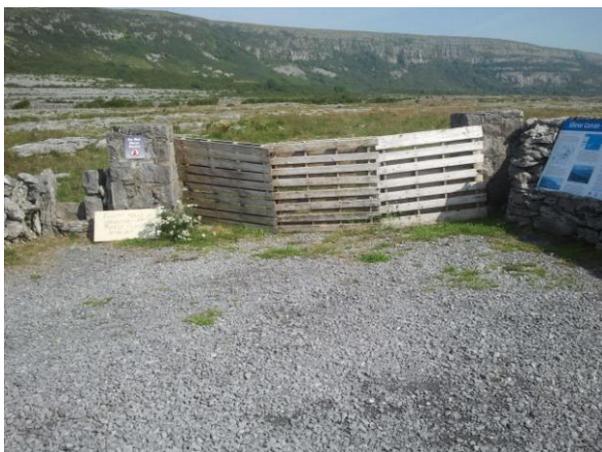
Photo 5: Entrance gate to Slieve Carran (photo taken 25-7-2014)

Proceeding from the car park, the visitor enters the Nature Reserve over a narrow stone stepped stile located to the left of the entrance gateway. The gate (absent at the time of survey – entrance temporarily blocked by wooden pallets) is kept locked and so is not an option for entry.

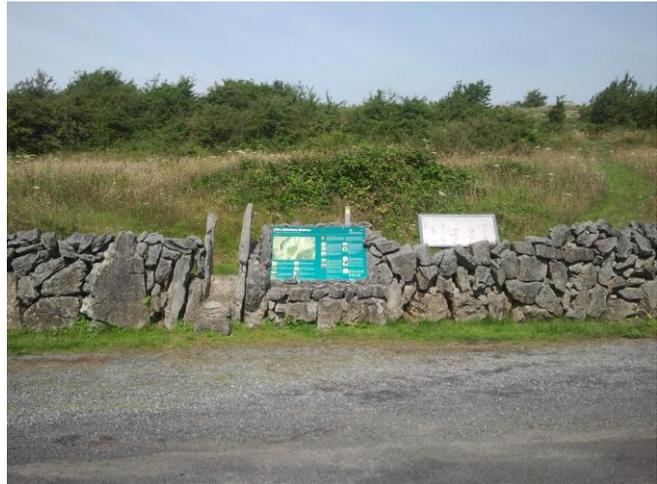
Photo 6: Lower parking lay-by entrance to Slieve Carran (photo taken 25-7-2014)

The second entrance to this parcel of land is located on its southern boundary and consists of a narrow stone stepped stile, from the parking pull-in area.

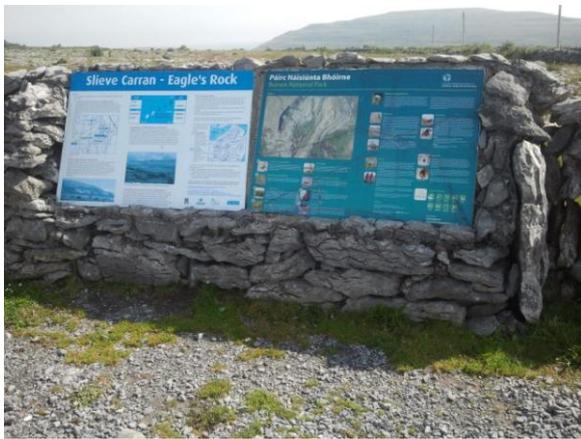
Photo 7: Interpretive panels at main parking lay-by Slieve Carran (photo taken 25-7-2014)

The first provides a description of Slieve Carran- Eagle's Rock (Keelhilla Nature Reserve), the origin of limestone and the formation of the Burren illustrated with geological maps of the area and photographs. The panel was created by the original Burren Geopark Committee in conjunction with Clare County Council, Shannon Development, the Heritage Council and the Geological Survey of Ireland. The graphics and text have faded. The interchanging use of three placenames – Slieve Carran, Eagle's Rock and Keelhilla may cause confusion without proper explanation. The information provided would benefit from updating and simplifying of geological language for general visitor use.

The second is a general BNP sign with a map of the Nature Reserve and descriptions of numbered ecological points of interest.

Both of these signs are degraded and damaged in places.

- The five interpretive panels located around the site provide duplication of some information. Some are in bad condition. A review of signage and a rationalisation should be considered.

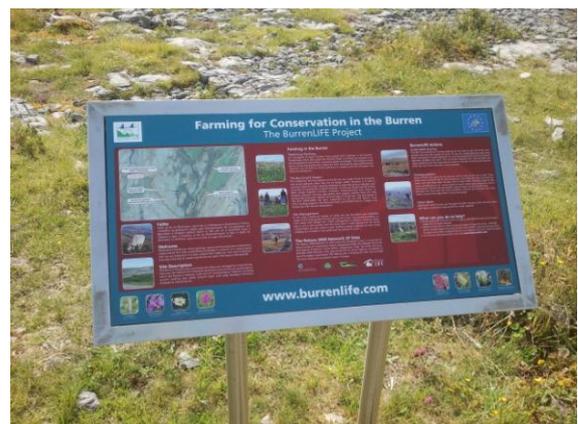
Photo 8: Burren LIFE interpretive panel at Slieve Carran (photo taken 25-7-2014)

At the northern entrance to the land to the east of the road is a BurrenLIFE panel providing information with regard to the now completed Burren LIFE Farming for Conservation programme; the use of this parcel of land as a demonstration site for that project, the Natura 2000 network of sites and the ecological and archaeological features of interest present are indicated on a map of the site. This sign is in good condition.

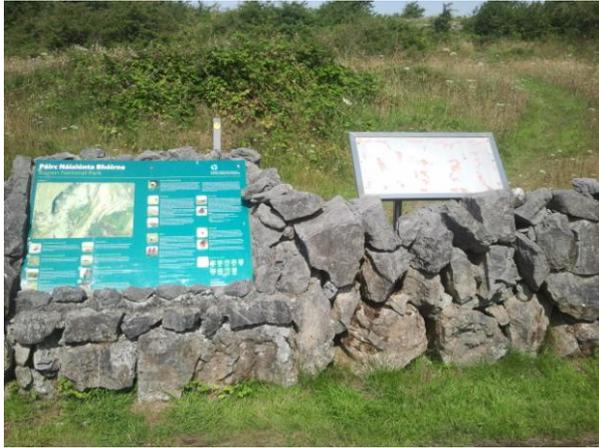
Photo 9: Interpretive panels at lower lay-by Slieve Carran (photo taken 25-7-2014)

At the southern entrance is a BurrenLIFE panel (the panel insert had been removed at time of survey and only the panel frame remained) and a BNP Panel, both as described above.

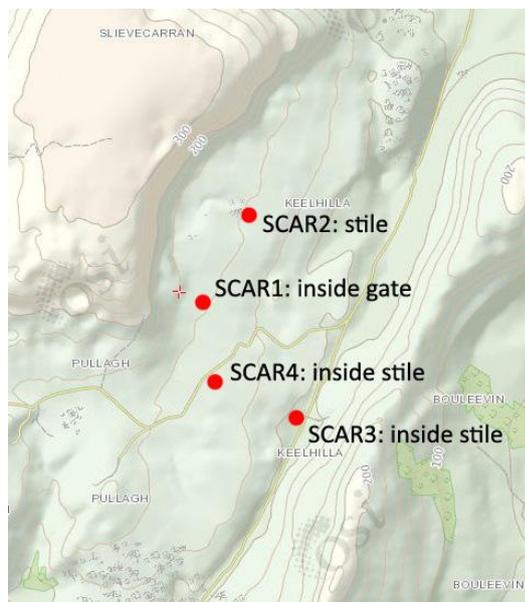
Figure 5: Location of footfall counters at Slieve Carran demonstrations site

Through the GeoparkLIFE initiative four footfall counters were installed on September 11, 2014 two on the brown (SCAR 1 and SCAR 2) and two on the orange (SCAR 3 and SCAR 4) walking trails to measure visitor numbers and times of visit.

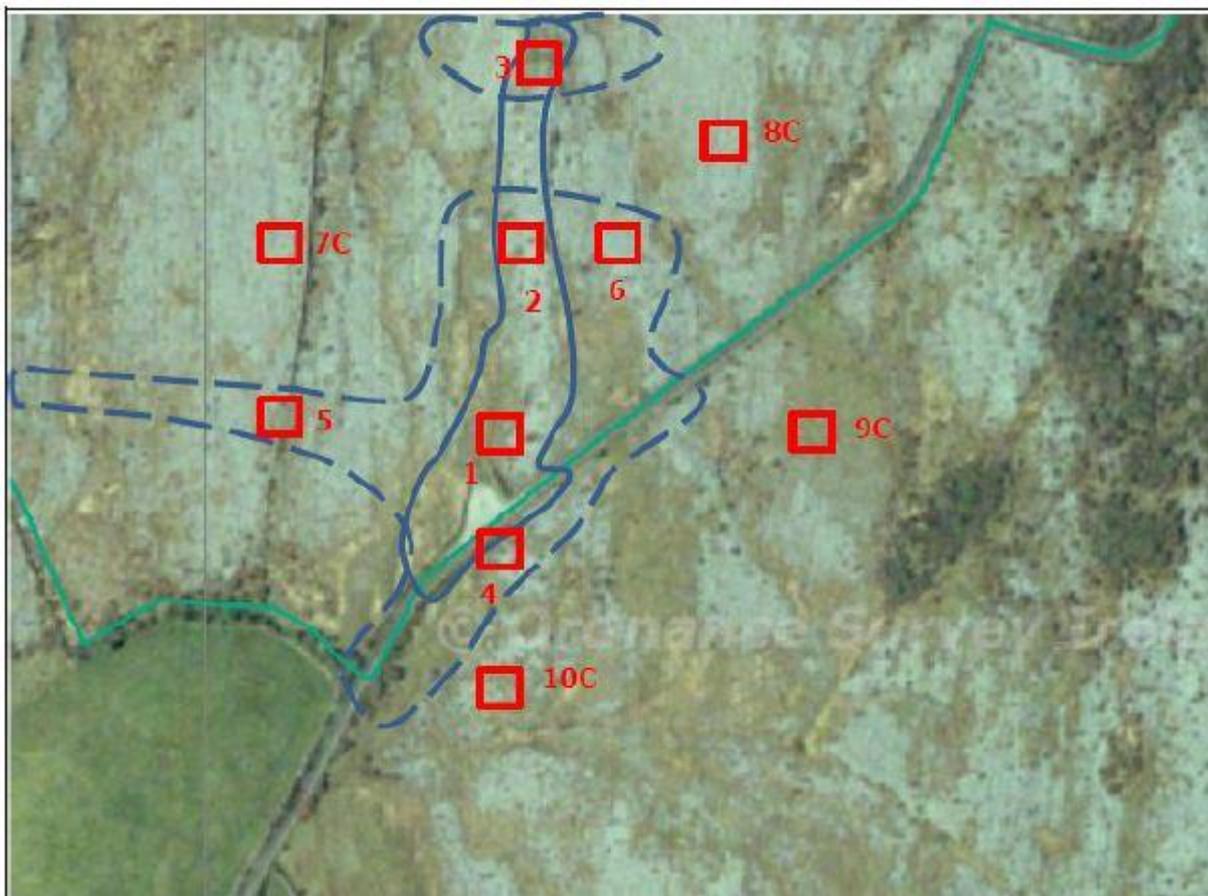
Figure 8 : Location of quadrats for ecological sampling at Slieve Carran Nature Reserve (EirEco 2014)

Ten quadrat surveys were conducted at the Slieve Carran Nature Reserve as illustrated in Figure 8.

'The main trail is a well defined track that leads across limestone pavement where vegetation is primarily confined to within the grikes. Some compaction of vegetation and bare soil is evident along the trail though elsewhere there is no evidence of impact on the vegetation by visitors.'

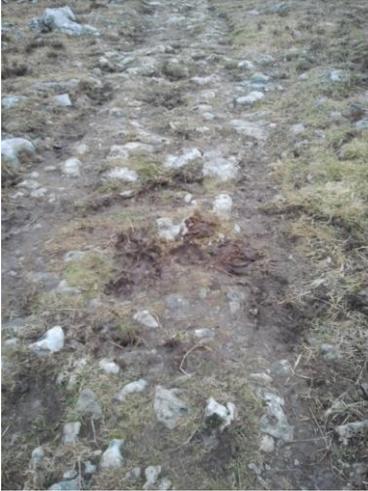
Photo 10: Erosion on path possibly due to combination of both human and livestock footfall (photo taken 18-10-2014).

- Footfall – some eroded areas are visible along sections of the walking trails. However, these areas are minimal and seasonal, with ground cover generally improving during the dry weather. As this site is also used for grazing by cattle, it is difficult to determine how much disturbance on trails is caused by visitors as opposed to livestock. At present very little baseline information is available to assess the effectiveness of works carried out on the trail e.g. gravel laying. The footfall counters, visitor observations and ecological survey undertaken by GeoparkLIFE will help to inform this process and develop a site monitoring system.

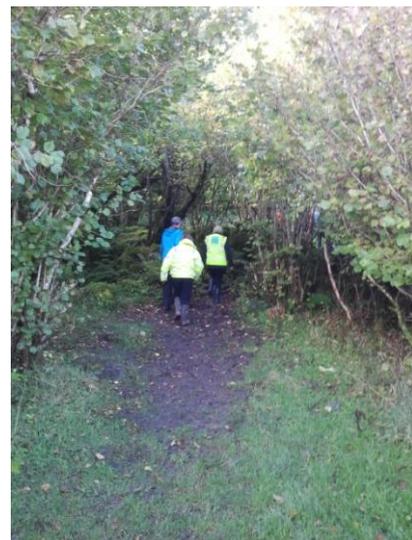
- The entrance to MacDuagh’s oratory site is eroded in places and can be muddy and slippery during wet weather. This can make access difficult for certain visitors.
- The site is grazed by livestock and the visitor should be informed as how to behave when agricultural animals are present.
- Directional signage along the walking trails can be confusing and needs review and upgrading.

Photo 11: Entrance to MacDuagh oratory site (photo taken 18-10-2014).

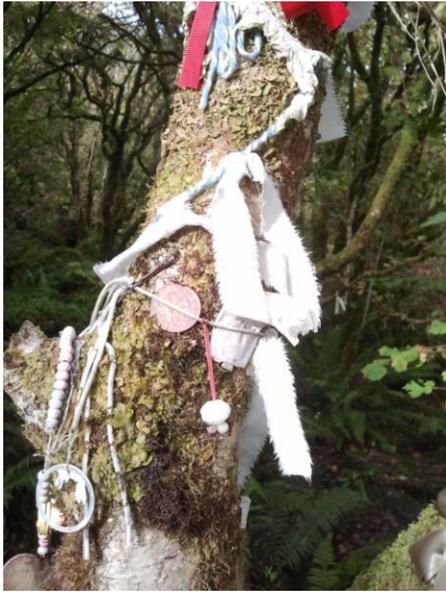
Photo 12: Detail of votive offerings on tree at Slieve Carran (photo taken 18-10-2014)

- Several Votive offerings are attached to several trees in the oratory complex surrounding the holy well and in the woodland area approaching St Colman's Cave.

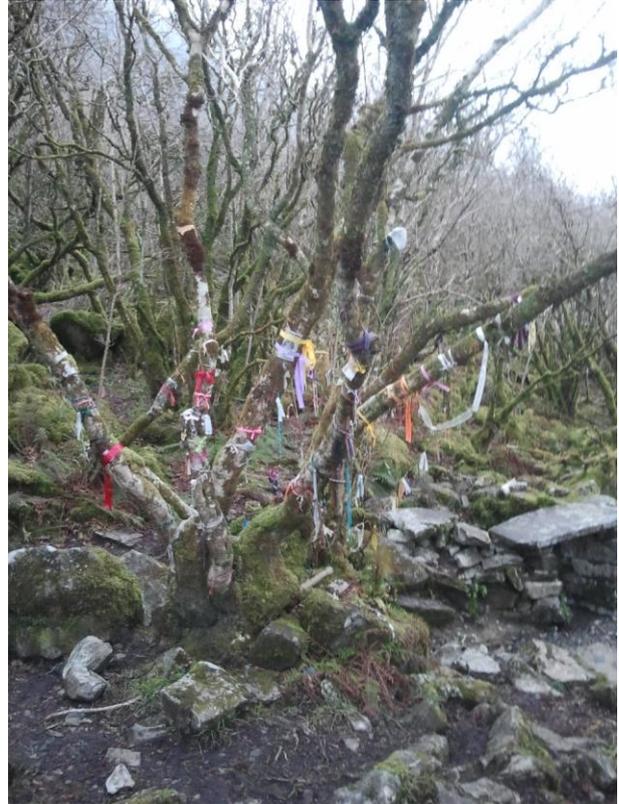
Photo 13: Votive offering deposition on tree adjacent to Holy Well at Slieve Carran (photo taken 18-10-2014)

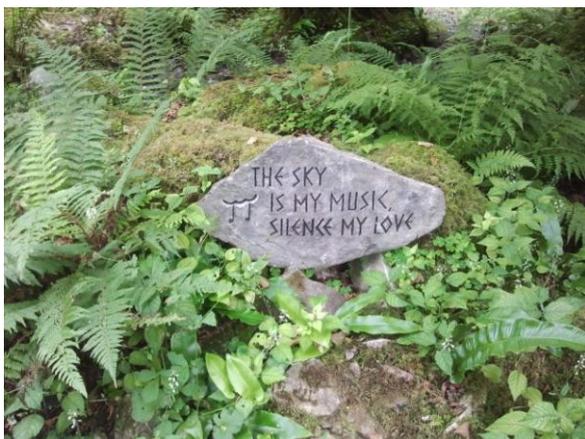
Photo 14: Mantra stone Mac Duagh's Oratory site Slieve Carran (photo taken 7-8-2014)

- A stone inscribed with a 'Mantra' was placed adjacent to the Holy well in the late summer of 2014. It was uncertain who placed the stone but it was done so without the site management approval.
- The NPWS manage the demonstration site but the ownership and management of the important cluster of archaeological sites around MacDuagh's Oratory is unclear. This needs to be clarified and an integrated management plan developed.
