Visitor Management Proposal

An Rath - Cahermore

GeoparkLIFE:
Tourism for Conservation

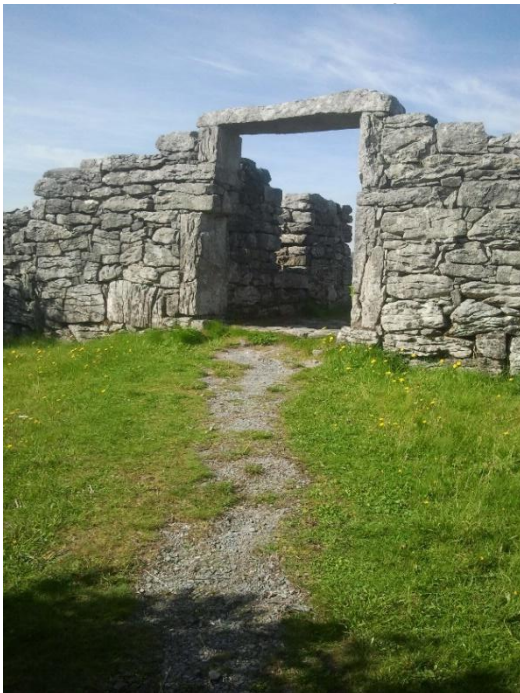
Photo 1: Lintelled medieval gateway at Cahermore

A lintelled stone and mortared gateway (width 1.6m), with a single small chamber at each side, provides entrance to the interior of the Caher from the east. This gateway was excavated in June 1999 following the collapse of the lintel <https://www.excavations.ie/report/1999/Clare/0003919/>. The excavation revealed that the structures around the entrance were a 14th/15th century addition to the pre-existing fort. A scallop shell from below the foundations was radiocarbon dated to AD 1308. The lintel was replaced and the entranceway consolidated in 2001. In recent years the OPW installed a wooden viewing platform in the west section of the fort which provides a view over the Ballyvaughan valley.

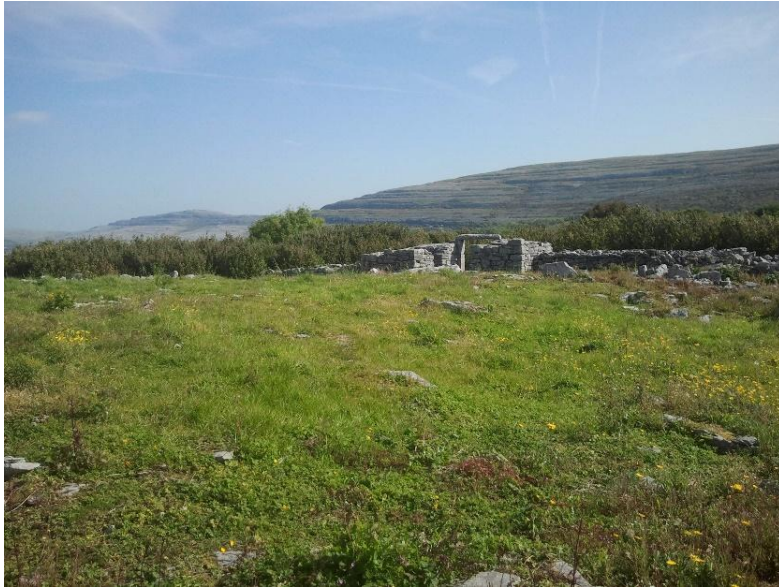
Cahermore is located on limestone pavement with a shallow soil covering. The site is surrounded by hazel scrub interspersed with ash and holly and rock outcrops. The interior of the monument supports dry calcareous grassland, briars and hazel scrub. The grass is regularly cut and the hazel scrub has been cut back in recent years.

Photo 2: Vegetation cover in the interior of Cahermore

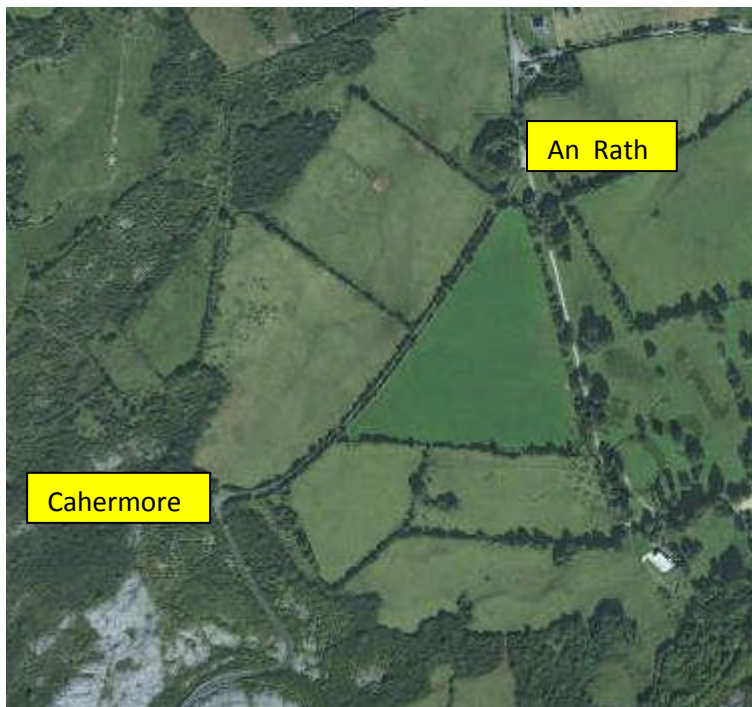
Figure 2: Aerial view of An Rath-Cahermore site

Both monuments (An Rath and Cahermore) are located on the west side of the regional road R480 and are separated by two pasture fields. The northerly start of the R480 is located approximately 1.5km south of Ballyvaughan, as a branch off the N67. An Rath is located approximately 1km south of this point and Cahermore is a further 0.6km south.

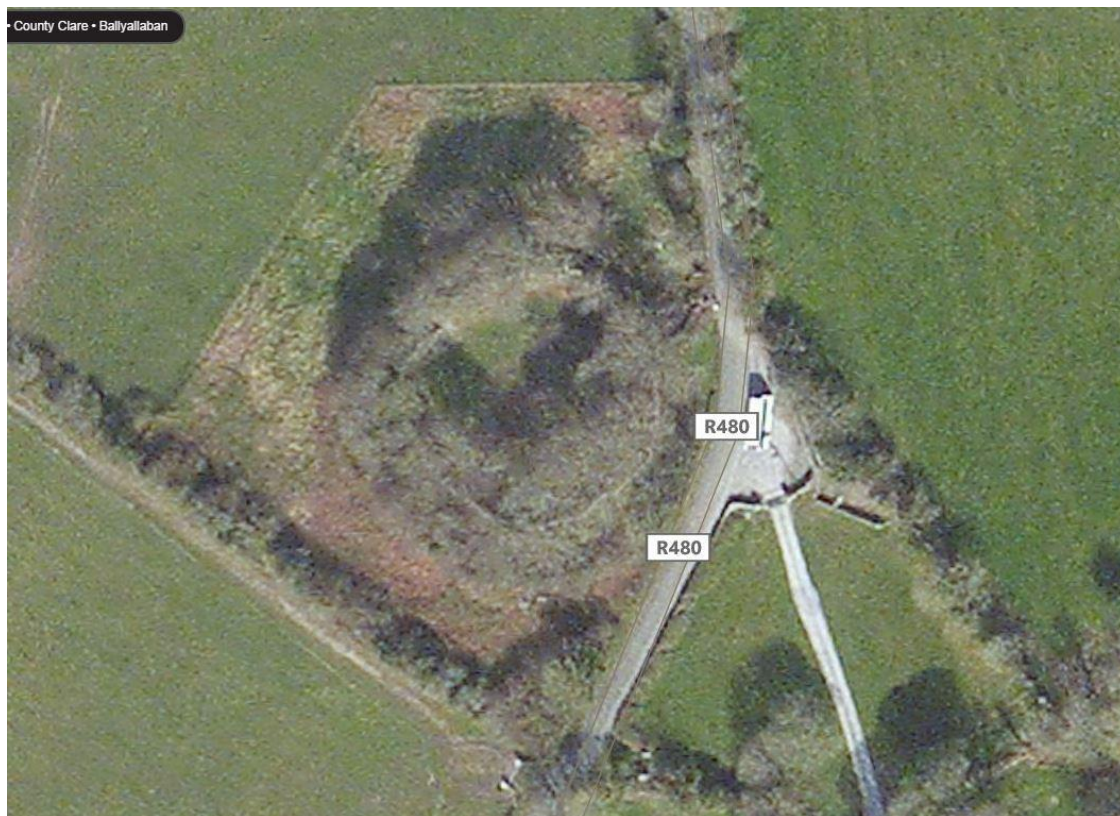
There is no official parking area for either monument. Visitors to An Rath generally park on the hard shoulder of the road opposite the site, in an area which is part of a private gateway entrance to a residential house. Approximately three cars or one coach can park in this area at any one time, but may cause obstruction to the house entrance gateway.

Figure 3: Aerial view of An Rath with coach parked opposite the site, on hard shoulder in front of private entrance.

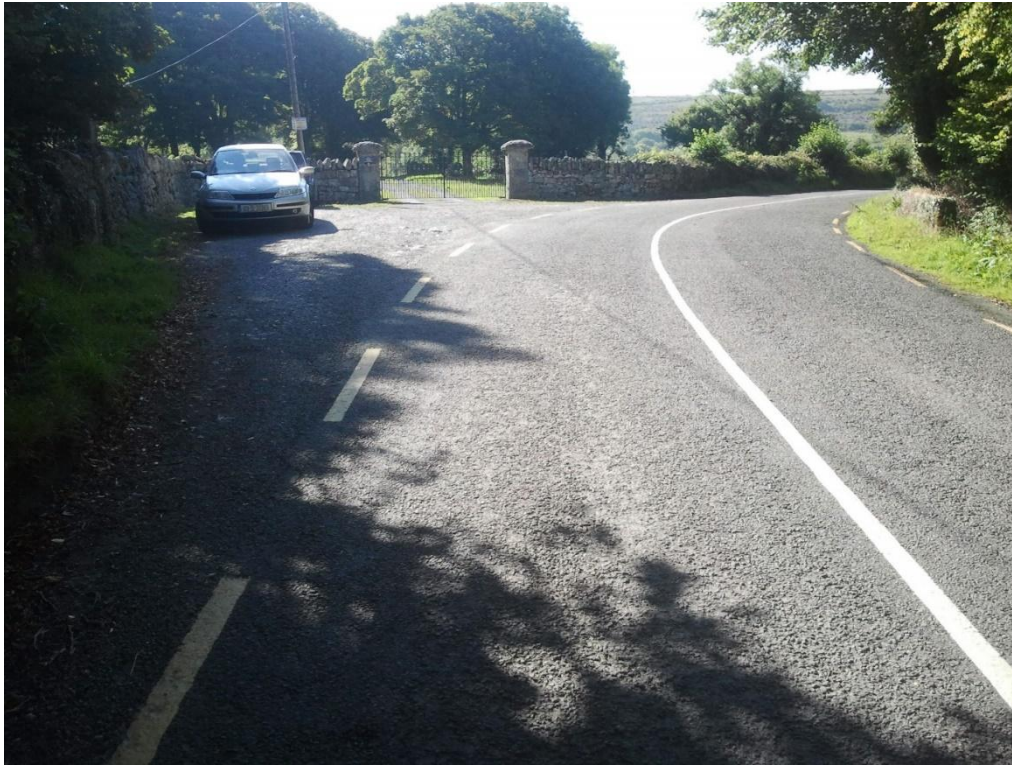
Photo 3: Unofficial parking space on hard shoulder outside private entrance gate opposite An Rath.

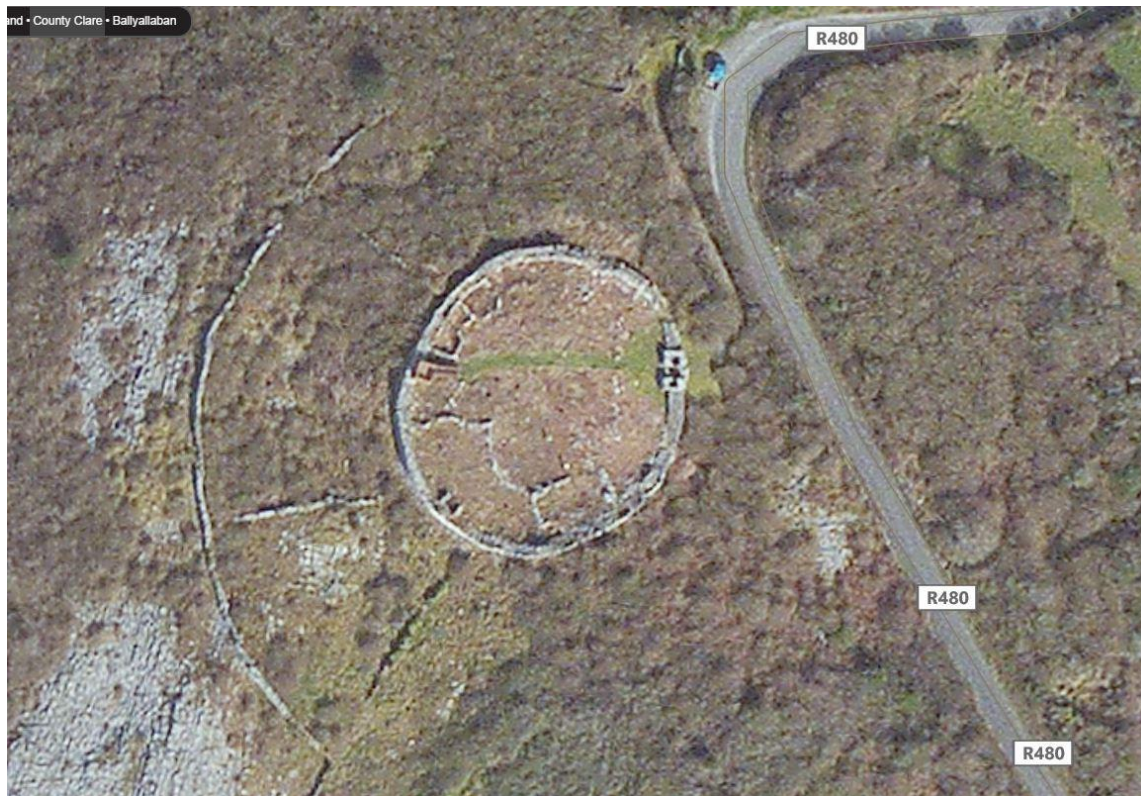
The entrance to the Cahermore monument is located on a sharp bend in the road. There is a small gravelled hard shoulder area directly outside the entrance stile to the site. This area can accommodate up to three cars or one coach.

Figure 4: Aerial view of Cahermore with vehicle parked on hard shoulder of sharp road bend adjacent to stile entrance to site.

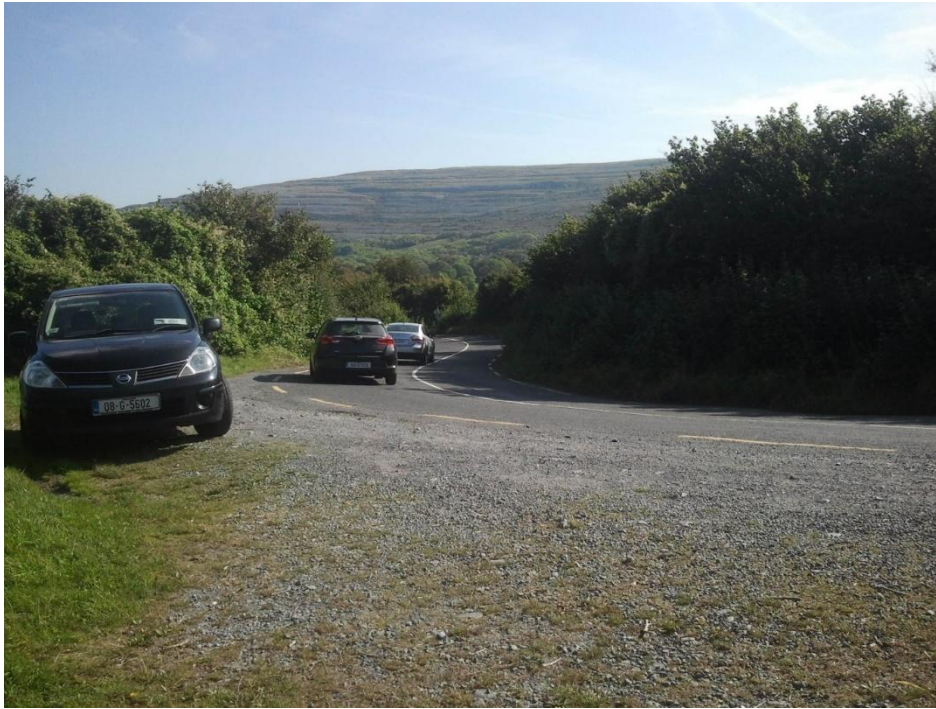
Photo 4: Unofficial hard shoulder parking area outside roadside entrance to Cahermore.

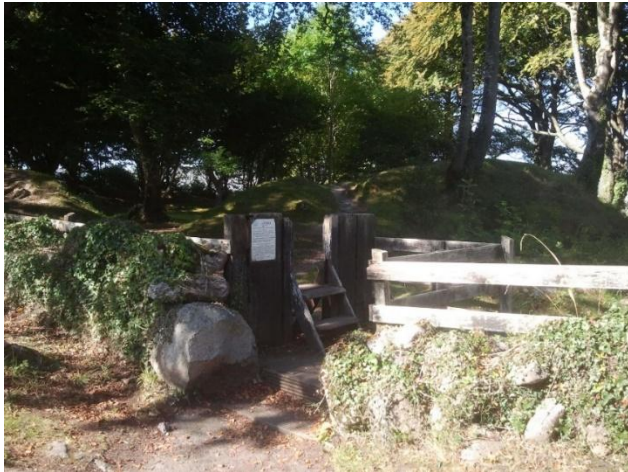
Visitors access An Rath by climbing over a two-step wooden stile into the north-east of the site. They then can pass through the gap in the earthen bank to the interior of the fort.

Photo 5: Two-step stile entrance from R480 into An Rath

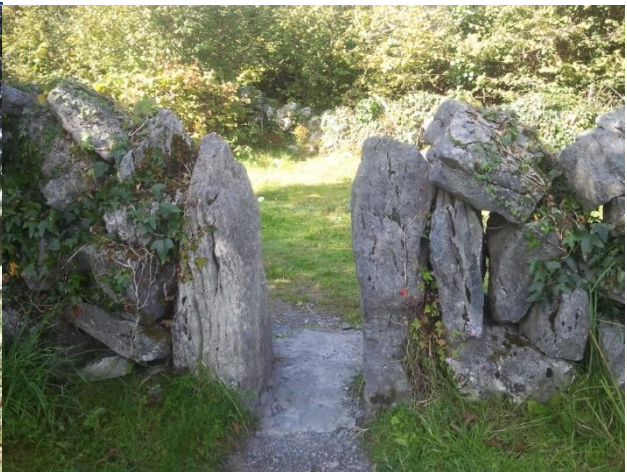
Access to Cahermore from the roadway is via a narrow gap in the surrounding stone wall. The visitor then walks along a medium incline gravel path to the medieval entrance gate into the interior

Photo 6: Narrow gap in wall entrance to Cahermore

| Description of restriction on access | Location (ITM E; ITM N) | Difficulty caused | Action Required | Timescale for Action |
|--|---|--|---|---|
| Narrow entrance gap at road entrance to Cahermore | 522009 704550 | Difficult for less abled bodied to enter due to narrow nature of gap in stone wall | Review entrance style and replace with more universally accessible design | 6-12 months |

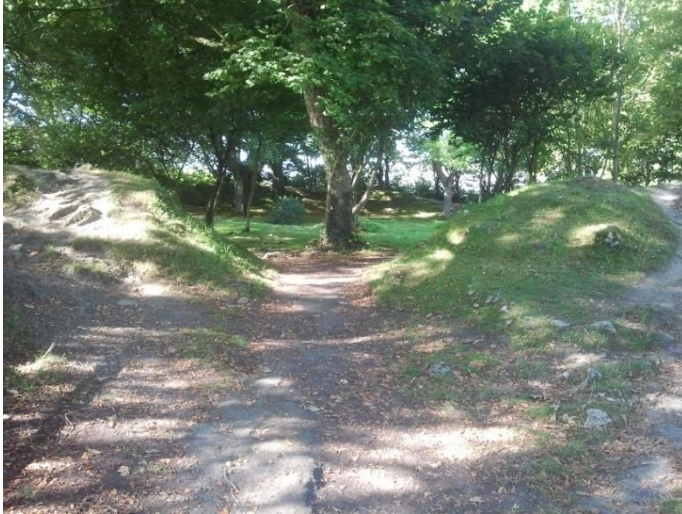
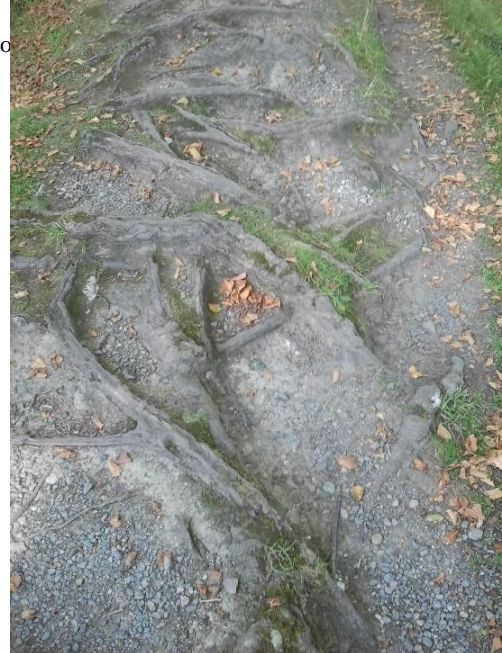
Photo

Due to visitor footfall the entrance to the interior of An Rath and the top of the surrounding bank of the ringfort have been badly eroded and are generally devoid of vegetation. The roots of the trees are exposed along the enclosure bank due to this visitor pressure.

| | Issue | Detail |
|---|--|---|
| 7 | Erosion of embankment at An Rath due to visitor footfall | The erosion of the embankment enclosing the interior of An Rath due to footfall appears to have increased in recent years. Damage is being caused to the ecology of the site due to this visitor pressure. |

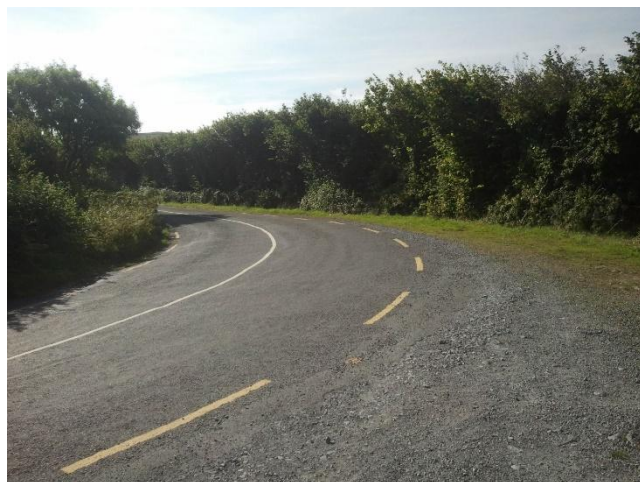
The entrance to Cahermore is located on a very sharp almost 90° bend in the road. Traffic approaching from the north must cross the road to the hard shoulder to park. As they do this they are not visible to approaching traffic from the

south as the sightlines are too tight.

Photo 10: Sightline looking south on R470 from hard shoulder at Cahermore

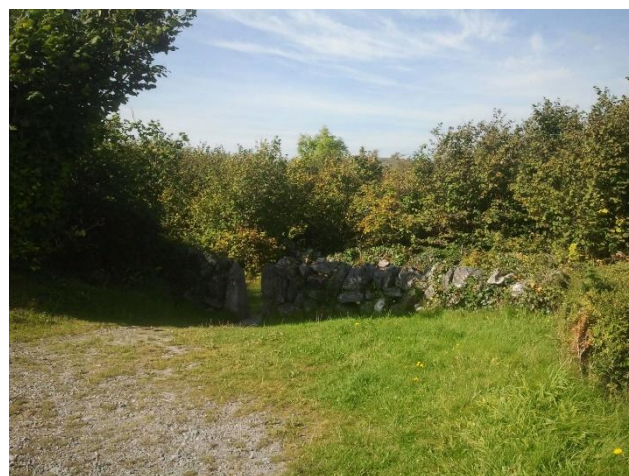
Photo 11: Narrow gap entrance from hard shoulder to Cahermore site

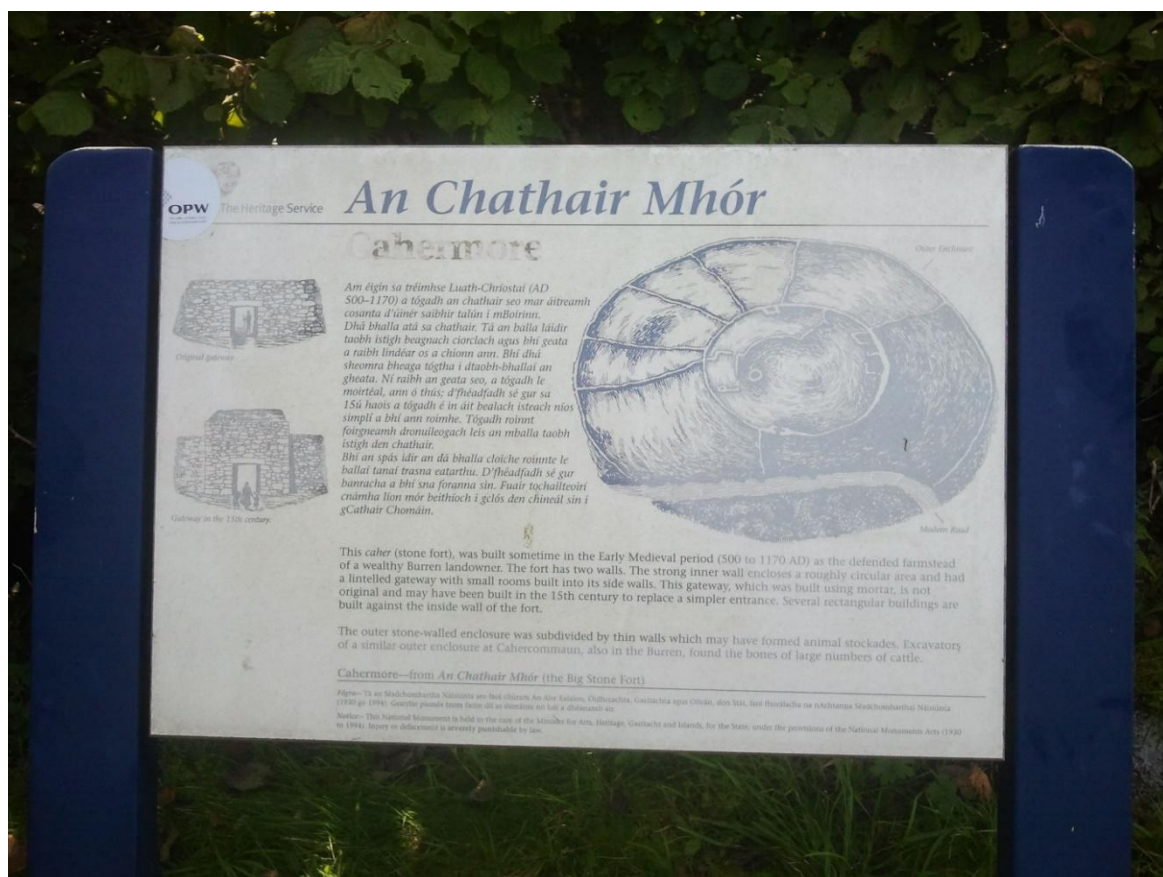
| Type of sign | Location (ITM E; ITM N) | Damage description | Source of Damage | Action Required | Timescale for Action required |
|---|---|---|---|---|---|
| Interpretive | | Text is faded and sign is discoloured | Natural | Replacement of sign with updated interpretation | 2-6 months |

Photo 12: Interpretive panel at Cahermore (2014)

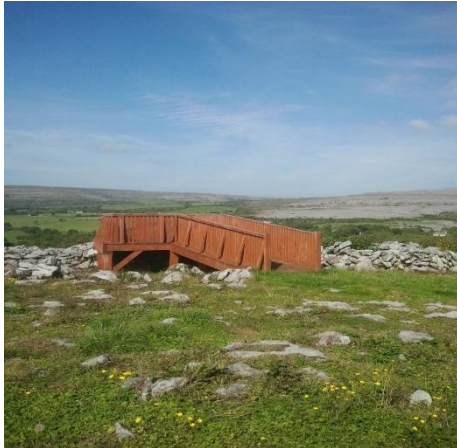
A viewing platform is provided within the main enclosure at Cahermore. This provides the visitor with a view across the Ballyvaughan valley.

Photo 13: Viewing Platform at Cahermore

The viewing platform is in good condition (2014).

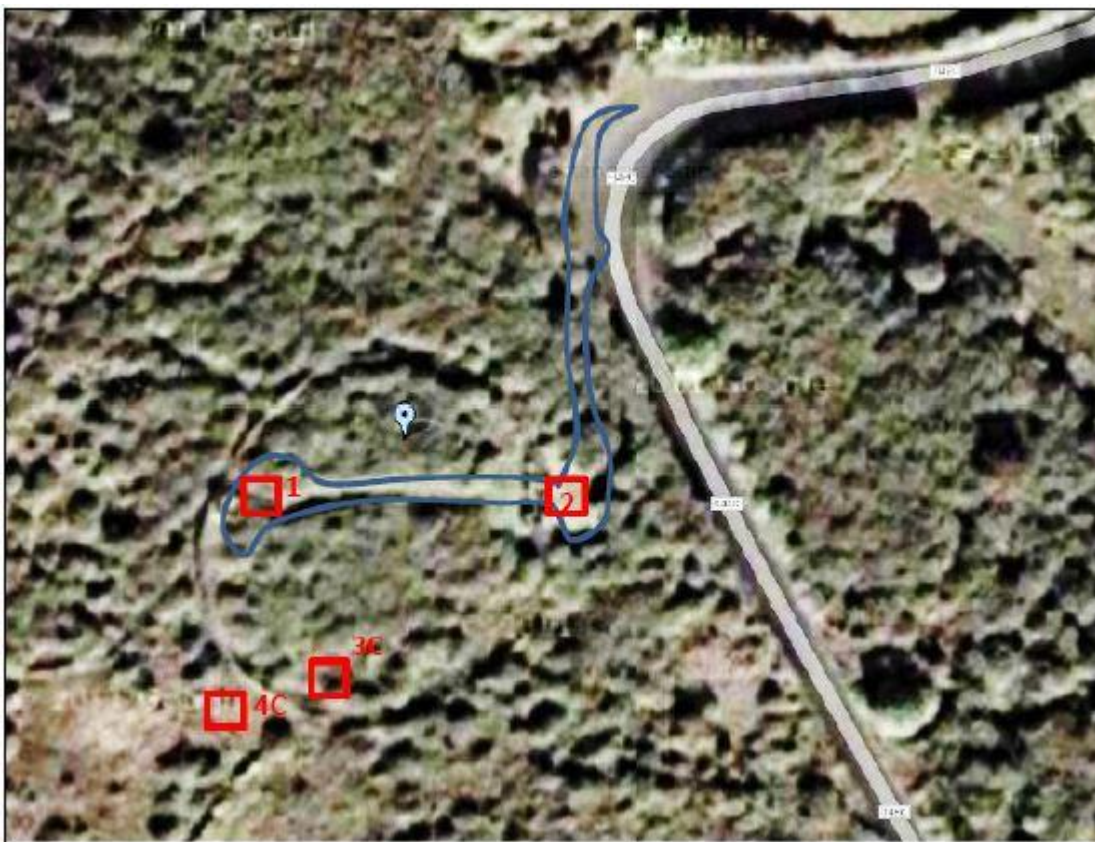
As part of the CAAS Visitor Observation Study, EirEco Environmental Consultants were commissioned to carry out vegetation monitoring at the GeoparkLIFE demonstrations sites between October 21, 2014 and December 2, 2014. Vegetation was analysed in 1m² quadrats at pre-selected locations identified by CAAS in each site. Four quadrat surveys were conducted at the Cahermore site as illustrated in Figure 5 below. A quadrat survey was not conducted at An Rath.

Figure 5: Ecological survey quadrat locations Cahermore

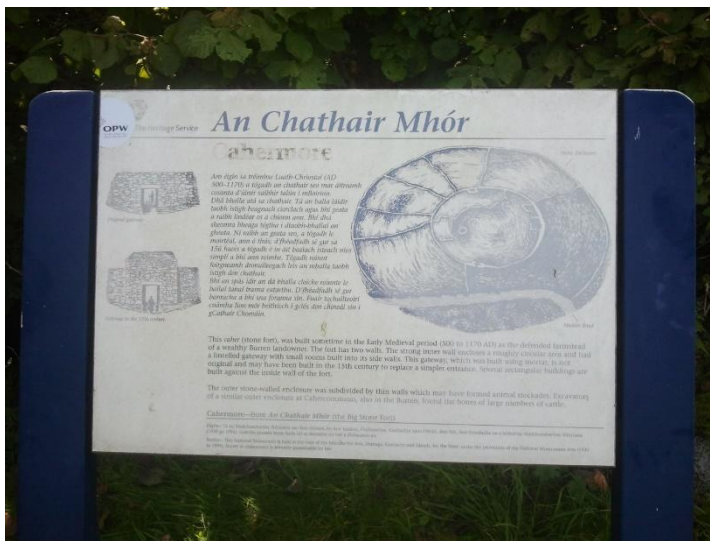
| | Issue | Detail |
|---|--|---|
| 5 | Outdated and damaged on-site interpretation at Cahermore. Lack of information at An Rath. | The current interpretive panel located at Cahermore is faded and outdated. It carries the 'Dúchas' symbol for a state agency which is no longer in operation. There is no on-site interpretation provided at present for An Rath. |

Photograph 13: Dúchas Interpretive Panel at Cahermore September 2017

| Results | New updated GeoparkLIFE/OPW branded panel installed on existing supports to minimise ground disturbance to archaeological site. Installing the panel on existing posts did not require ministerial consent to be obtained. Advice was sought through the OPW. |

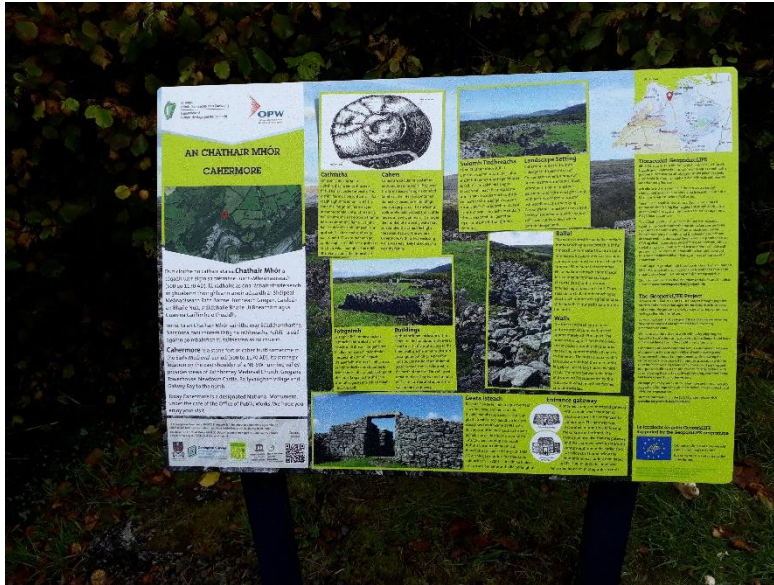
Photograph 14: Replacement GeoparkLIFE Interpretive panel at Cahermore October 2017
