# Visitor Management Proposal

## Slieve Carran

**GeoparkLIFE:**  
Tourism for Conservation

### SECTION THREE: BASELINE SITE CONDITION ASSESSMENT

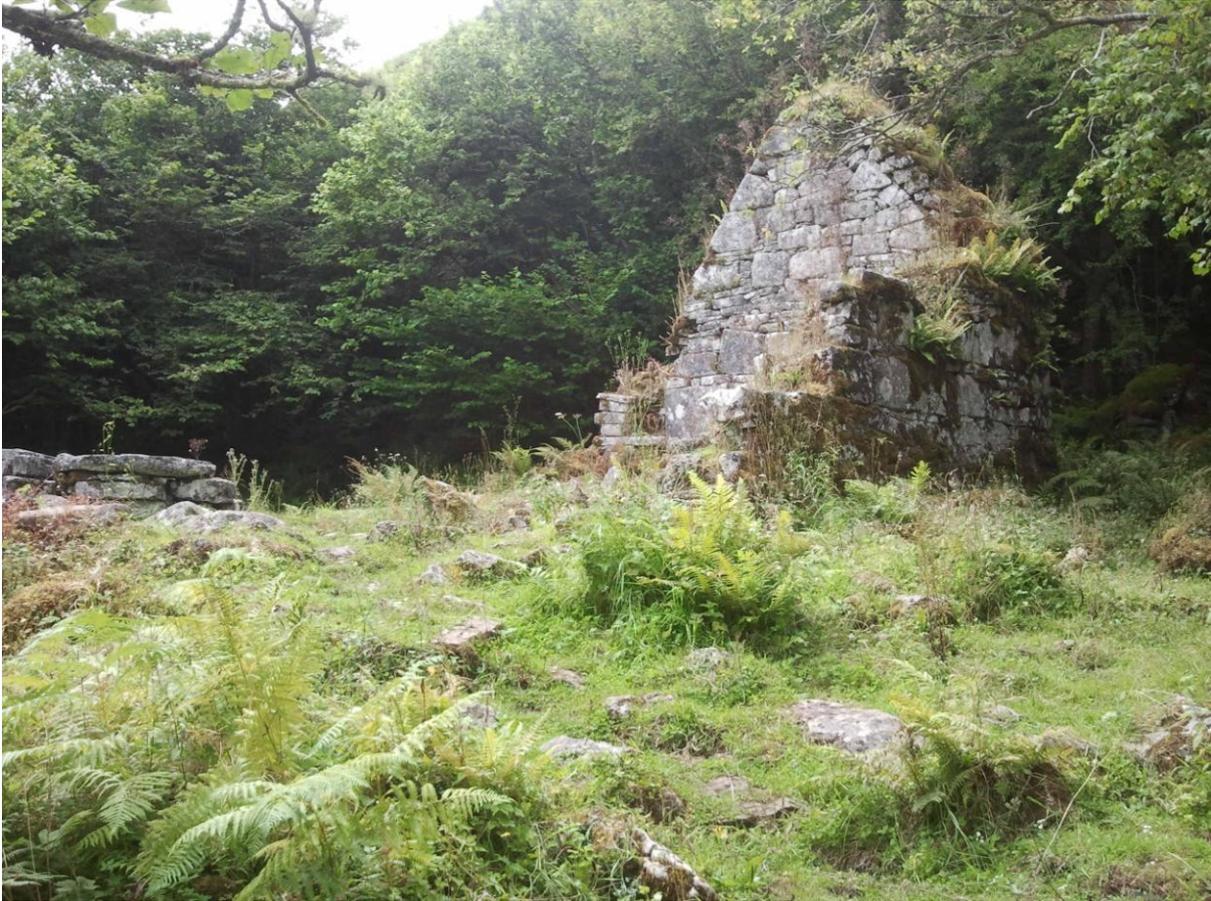
Photograph 1: The ruins of St Colman MacDuagh's oratory Slieve Carran

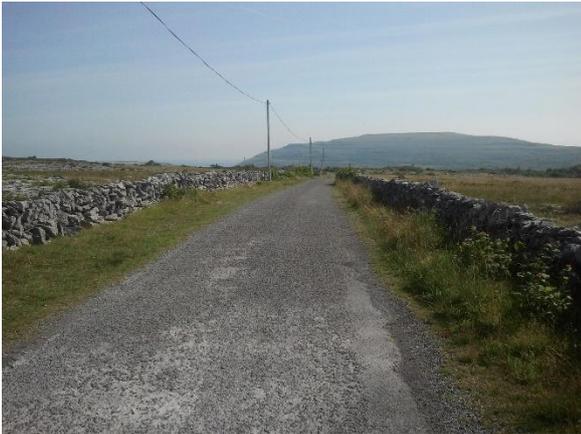
Photograph 2: Approach road to Slieve Carran

The site can be approached via two roads, one leading to a parking area outside the west portion of the site and one to a parking area at the eastern edge of the site. They are both designated third class roads and are narrow and winding. Cars approaching each other have difficulty in passing and there are several small areas where cars pull in to allow passage by others. The roads are unsuitable for coach traffic. Encroaching roadside vegetation in sections increases difficulty with sightlines.

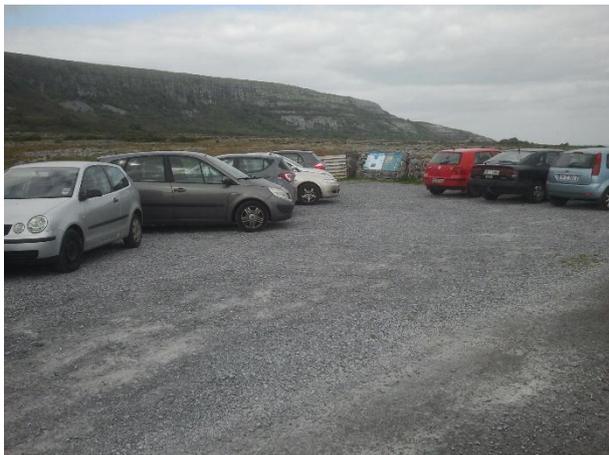
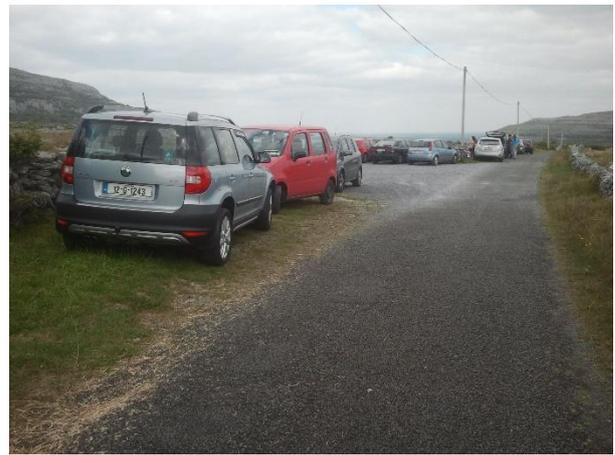
A small gravelled car park is located outside the entrance to the Nature Reserve on the upper road. It consists of a pull in area within the bell mouth of the gateway. There are no marked parking spaces and parking can be haphazard. The area can accommodate approximately 20 cars if parking is orderly with all vehicles parked parallel with ends into the boundary wall. On occasion when an organised event is taking place, such as a guided walk, large numbers of vehicles are present at the site, parking extends along the roadside and can result in traffic disruption and ecological damage to the grass verge vegetation. This may occur once or twice a year. Coaches do not generally use this road nor do bus tours visit this site due to the narrow approach roads. A small parking area which is located at the eastern boundary of the site on the lower road can accommodate 5 cars. This road is extremely narrow and very little traffic uses this parking area.

Photographs 3 & 4: Parking at the upper car park during an organised event.

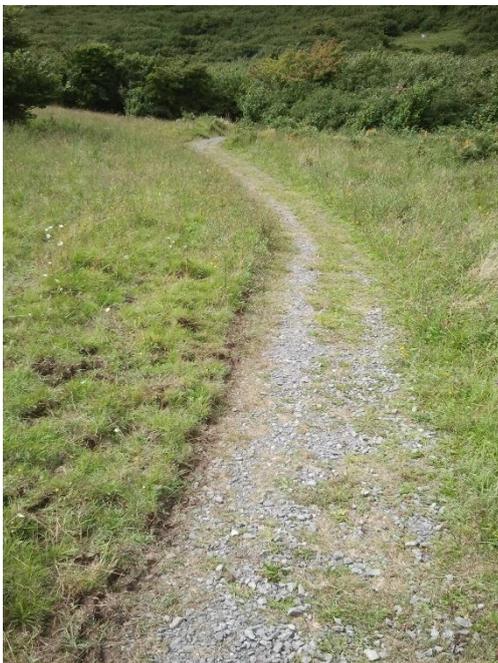
Photograph 6: Graveling of path completed in 2011/12

Conservation Ranger of the trail condition in 2010/11 indicated the need for gravel infill in certain points along trail where rutting had occurred. An identified area that was particularly prone to damage was an area of grassland known as 'the meadow'. The path across the meadows is used by cattle in winter as well as providing visitor access to Mac Duagh's oratory site. Due to this continuous usage the path had extended in width as visitors walk on the grass verges to avoid muddy sections. The NPWS gravelled about two thirds of the track in 2011/12 and the site managers' state that this has resulted in a decrease in impact of trampling by visitors and cattle along this access trail. However no baseline information is available by which to measure this improvement.

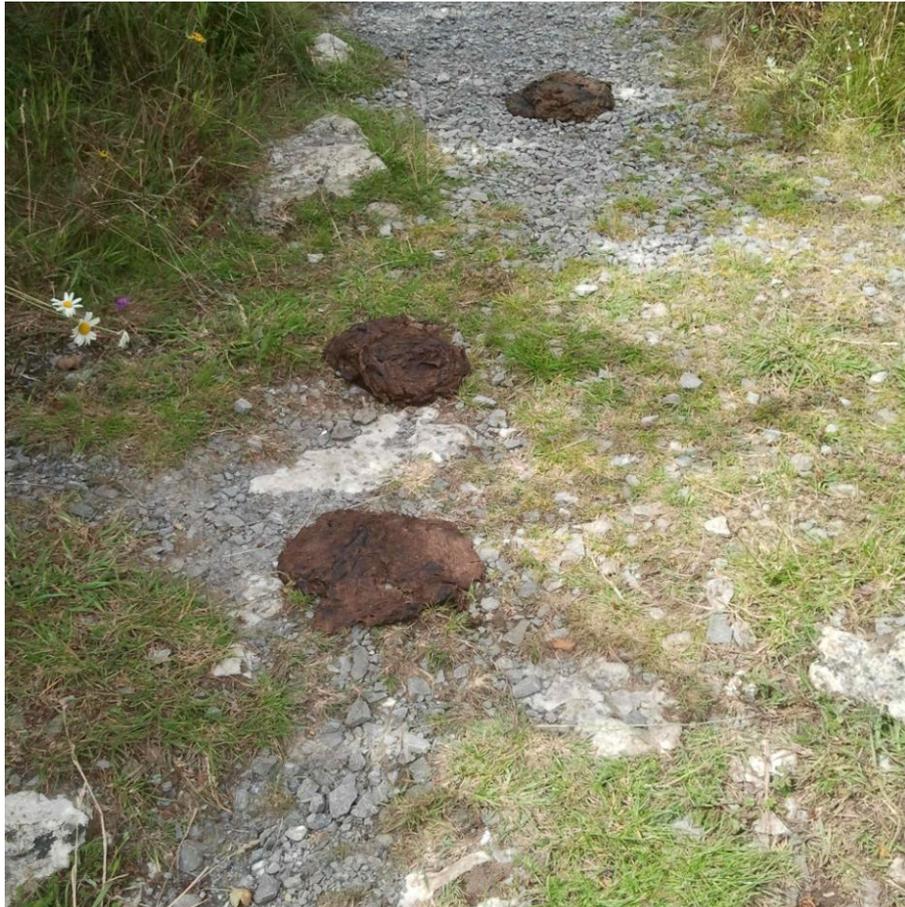
The overall result to date indicate that due to livestock movement in the winter months areas along the trails can become muddy. However these areas usually recover during the drier months and there is likely to be no long term ecological damage. The site must be grazed by livestock to maintain the unique Burren flora and the management approach adopted it that the Reserve if foremost an ecological reserve and secondly a visitor attraction.

Photograph 7: Evidence of usage of paths by livestock

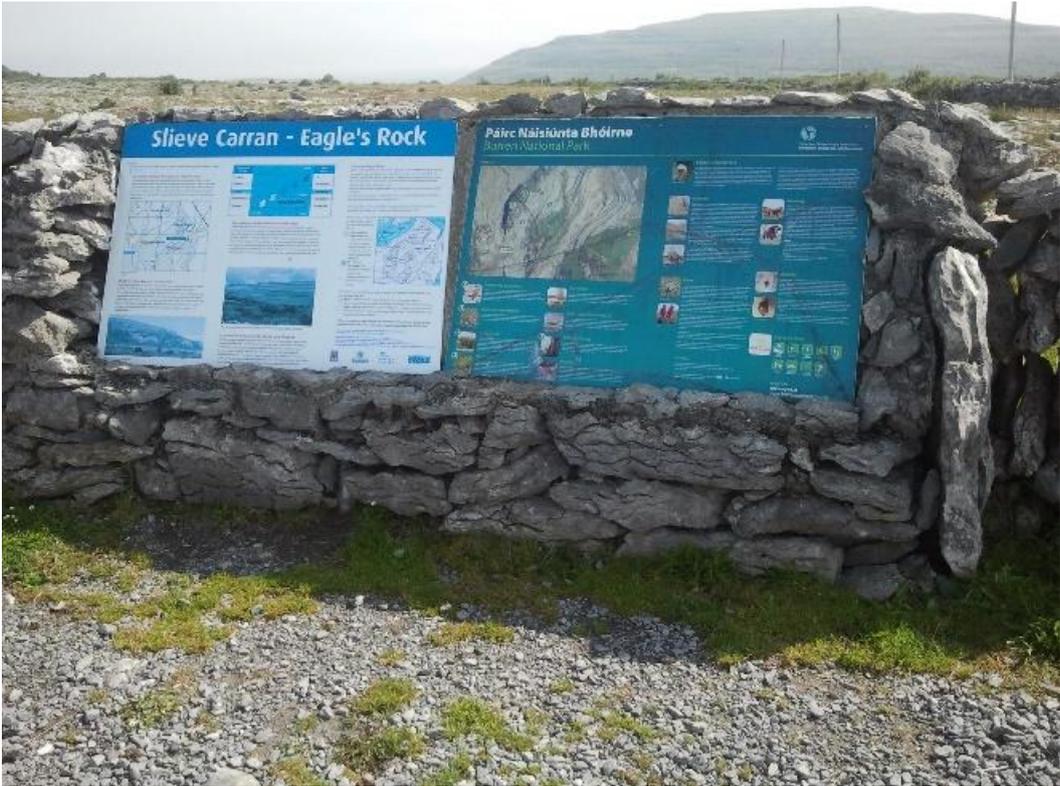
Type of sign	Location (ITM E; ITM N)	Damage description	Source of Damage	Action Required	Timescale for Action
Interpretive (Burren National Park panel) in upper car park	533073 703344	The sign is cracked and text is difficult to read in places	Unknown	Removal and replacement with updated signage	2-6 months
Interpretive (Slieve Carran Geology) in upper car park	533073 703344	The information is outdated and the sign is faded and damaged at the edges.	Natural	Removal and replacement with updated geology information	2-6 months
Interpretive (BurrenLIFE project) in lower car park	533142 703081	The panel insert has been removed and all that remains is the frame and supports.	Unknown	Removal of structure. The BurrenLIFE project is now complete.	Immediate Photograph

Photograph 8: Damaged and outdated interpretive panels in upper car park at Slieve Carran (August 2014)

<b>Issue 3</b>	<b>Damaged, outdated and duplicated site interpretation</b>
Agreed Action	Review signage, agree design and content for new signage, remove old signage and install new.
Tasks	<ol style="list-style-type: none"> <li>1. Carry out review of present signage in terms of content of information and condition of sign</li> <li>2. Propose new uniform interpretive signage design for all Burren sites with site managers</li> <li>3. Compile bi-lingual text, photographs and illustrations for sign in conjunction with site managers</li> <li>4. Design layout and agree with site managers</li> <li>5. Manufacture signs</li> <li>6. Remove old signage</li> <li>7. Install new signage</li> </ol>
Responsible person/group	GeoparkLIFE and NPWS
Date Action Completed	October 2017
Results	New GeoparkLIFE/NPWS interpretive panel installed October 2017.

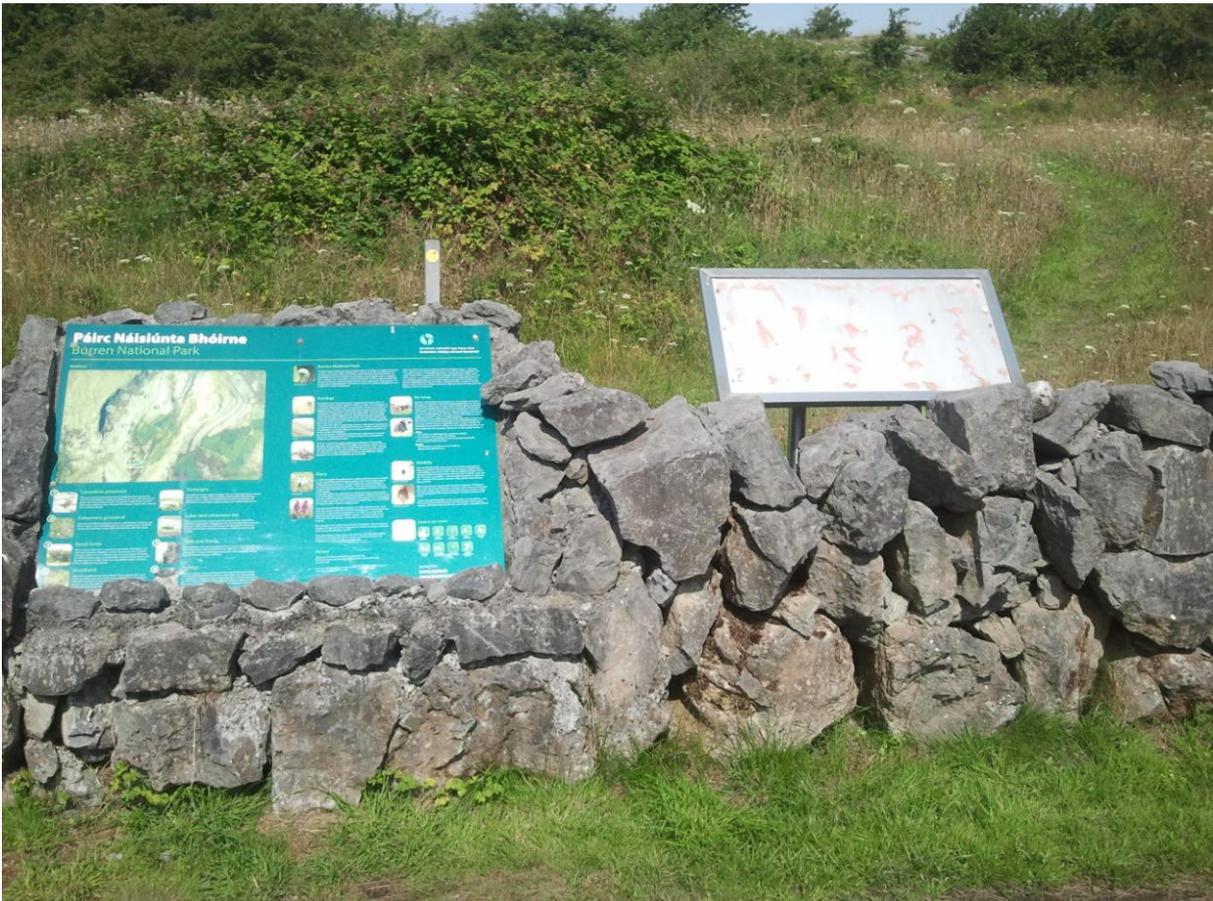
Photograph 9: Damaged BurrenLIFE interpretive panel in lower car park.(August 2014)

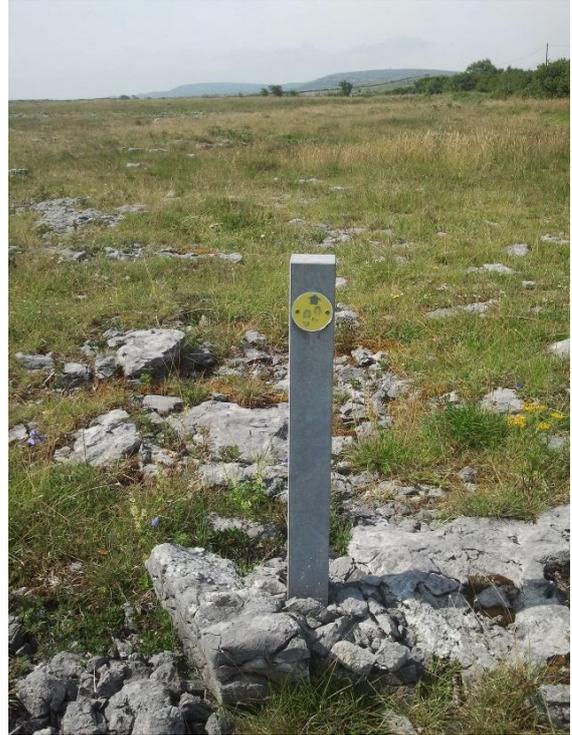
Directional signage along the designated walking trail needs to be reviewed. In some areas, signage is not inter-visible and the walker can stray off the track. The type of signage used can vary in some locations. All signage should be uniform in design to prevent confusion. Trail information signage should be placed at the trail head (i.e. the car park) providing information on the length of trail, terrain conditions and difficulty of access.

Photograph 10: Directional signage on the Yellow Trail (August 2014)

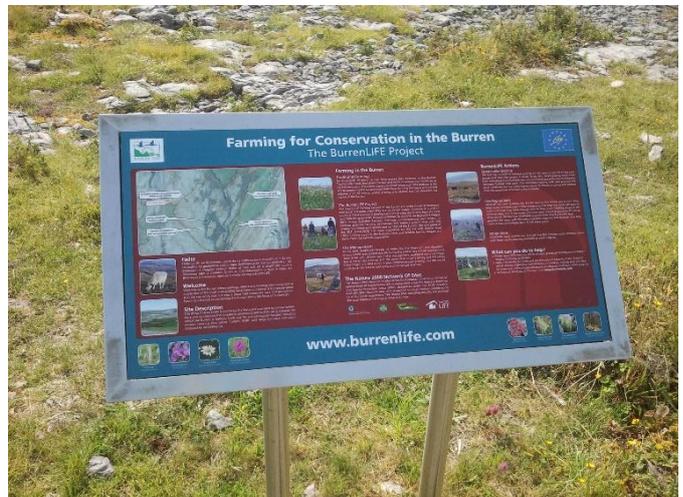
There are five interpretive panels currently (February 2015) at this site. Reduction in the number of panels at this site should be considered, without the loss of important information. This could be achieved through the review of duplication, compaction and simplification of the information provided (at present there is a lot of specialist jargon used on some of the panels)

Photograph 11: Redundant BurrenLIFE interpretive panel (August 2014)

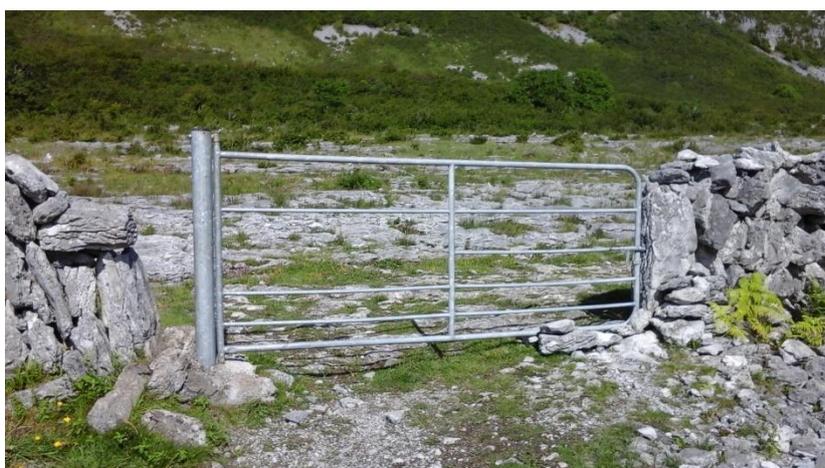
Description of Restriction	Location (ITM E; ITM N)	Difficulty caused	Action Required	Timescale for Action
Entry stiles from parking areas and between fields.	Various	On occasion the field gates can be locked and entry is only available via the narrow stepped stone stiles. This can cause difficulty for the less abled bodied.	Provide stiles which allow access while preventing passage by livestock	6 months – 1 year
Entrance to oratory over collapsed medieval enclosure wall.	532886 704256	The oratory is accessed by climbing over a collapsed section of the medieval wall boundary. This area is shaded by trees and can become very muddy and slippery after wet weather causing hazardous conditions for the less abled bodied.	Discussion with National Monuments Service as to possible solutions to access which do not interferes with archaeological structures.	6 months- 1 year
A wooded area along the brown walking trail can become very muddy during wet weather.	533002 704369	This wet area can cause access problems for all users.	Improvement to track surface for all weather conditions.	6 months- 1 year

Photograph 12: Gate and adjoining stile entry point on brown trail (August 2014)

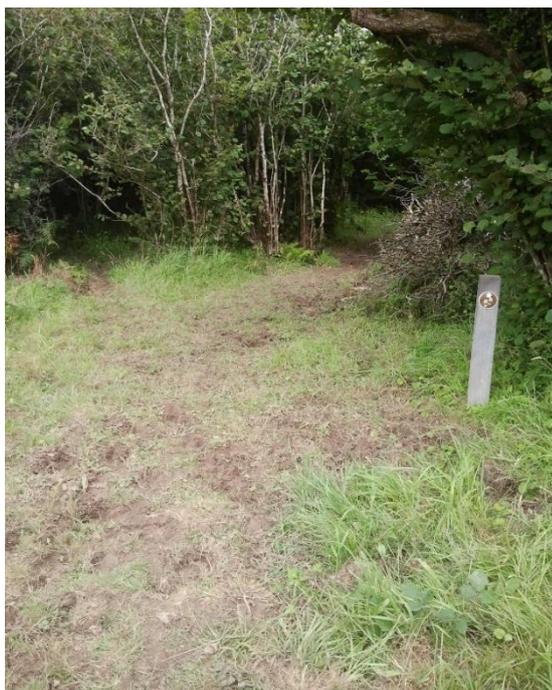
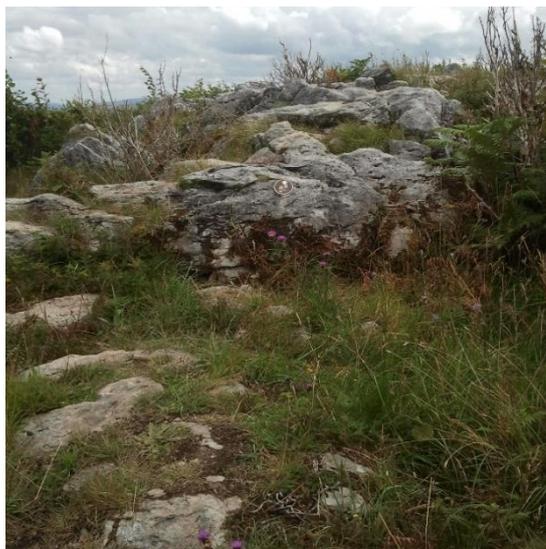
An elevated area of limestone outcrop along the brown trail including a steep climb and pitted karst underfoot.	533086 704350	Track users must climb onto the elevated area and move over karst rock which is rough underfoot.	This area and the difficulty of access should be highlighted on track information signage at trail head and on the immediate approach to this section.	6 months- 1 year

Photograph 13: Muddy pathway entrance to  
Photograph 14: Steep climb onto higher ground on  
Brown Trail (August 2014)

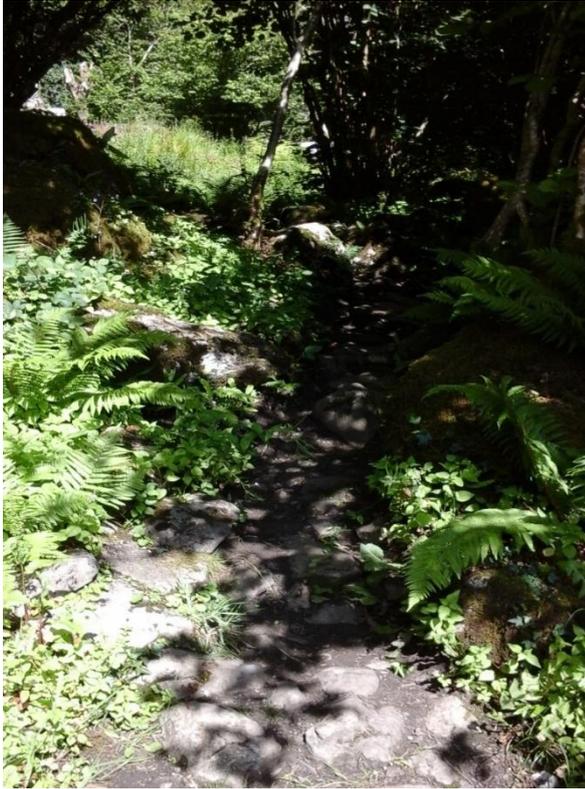
- Access to the site (over stile) is difficult for some. This could be improved.
- With regard to the immediate access to the church site, there were differing opinions as to balancing the improvement of access in terms of the wet underfoot conditions and maintenance of the atmosphere of the site provided by its closed in nature. Some felt the trees provided a closed peaceful atmosphere while others saw the benefit of improving the safety of the entrance path and opening out the view as was more likely the situation in the past. Safety was not thought to be a major problem – as the pilgrims are used to visiting old ruined sites and have an awareness of the hazards.
- It was generally felt that the building could do with some consolidation but overall its condition added to the atmosphere of the site and should not be sanitised.

Photograph 15: Muddy underfoot conditions at entrance to oratory (August 2014)

Issue 6 (A)	Restrictions to visitor access to oratory site
Agreed Action	A staged approach was agreed to address the issue of visitor access at the oratory site where the path can be hazardous during wet weather conditions. Each stage (as detailed in tasks section below) would be implemented and monitored to determine whether the impact of footfall has been lessened and whether there is a need to move onto the next stage. If the first stage does not improve the situation departmental approval must be obtained before progressing to stage 2.
Tasks	<ol style="list-style-type: none"> <li>1. Cut back the hazel on either side of the pathway to let light and air in to dry out the soil</li> <li>2. Monitor site over 1 year and if no improvement is evident obtain departmental approval and move to task 3</li> <li>3. Install a narrow path (1 metre wide) with geotextile base and gravel top layer</li> <li>4. Monitor and if visitors are moving beyond the limit of the path causing erosion move to task 5</li> <li>5. Widen path if necessary.</li> <li>6. Monitor site</li> </ol>

Responsible person/group	GeoparkLIFE/NWS
Date Action Completed	2017 and ongoing
Results	The hazel trees were cut back in March 2015. Monitoring through the summer showed that the condition of the path had improved. Regrowth was cut back again in 2017 and the path is showing continuing improvement. It is agreed that there is no need at present to move to task 3.

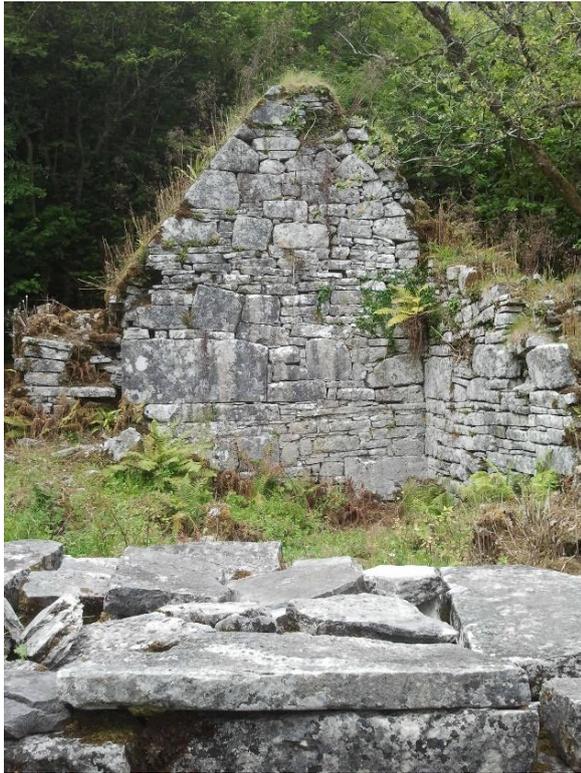
Photograph 16: West gable and remaining north wall of MacDuagh's Oratory (August 2014)

St Colman MacDuagh's oratory (10.6m E/W by 5.3m N/S) consists of the ruins of a small church with west gable (height 4.5m. Pitch 53 degrees) and about half of the original north wall (height 2.5m) intact. The line of the original foundations of this building are visible on the ground. It contains few features with the exception of the remnants of a small splayed window on the north wall and well cut barge stones on the gable, which appears to have been crudely raised in the past.

The masonry of the church comprises roughly dressed, limestone, field stones in a lime mortar, finished to a smooth surface on their outer faces. They are set in irregular and erratic courses, using small pinnings in narrow joints, as is the practice in early Christian Churches. One large, thin flagstone, in the interior leaf of the gable, is standing on its edge and supporting most of the gable, above it. All the material behind it has been taken out, leaving the structure in a very precarious condition.

The little oratory is in need of remedial works to conserve the ruin and reduce the risk of collapse and loss of historic, masonry fabric. A method statement should be prepared, to ensure that works are carried out to the highest standards of conservation practice. The following works are recommended:

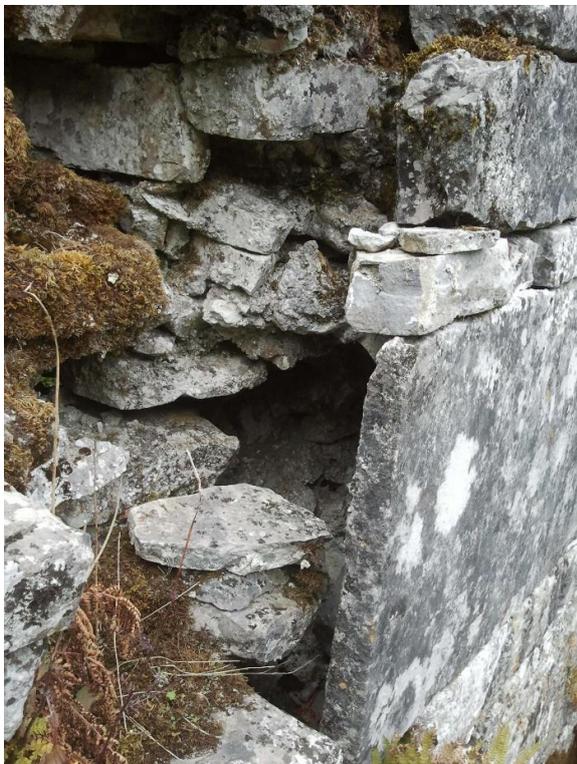
Photograph 17: Supporting flagstone on interior leaf of gable (August 2014)

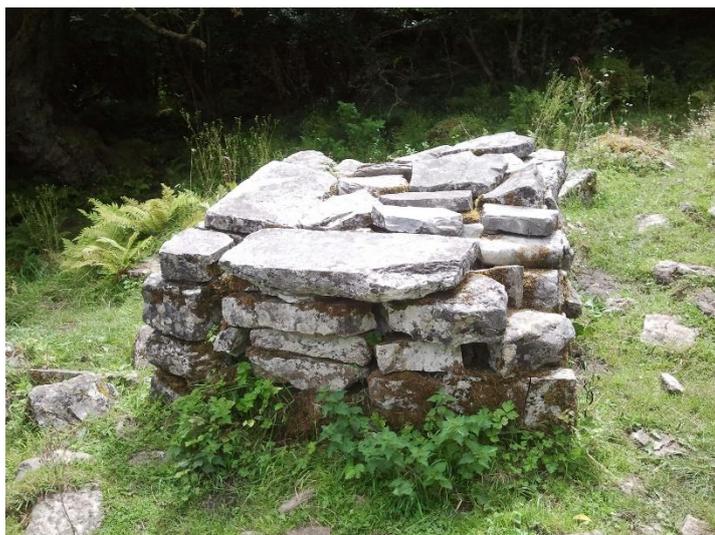
There are dressed stones and architectural fragments strewn around, including a window cill and a door jamb with a cut recess for an iron gudgeon, to carry the iron door pintle or hinge. There are a pair of almost square, dry-stone altars, one within the church and one without, to the north, comprised of cuboids of dry-stone blocks, probably built from collapsed masonry rubble, during the 17<sup>th</sup> or 18<sup>th</sup> centuries.

Photograph 18: Drystone altar at MacDuaghs oratory (August 2014)

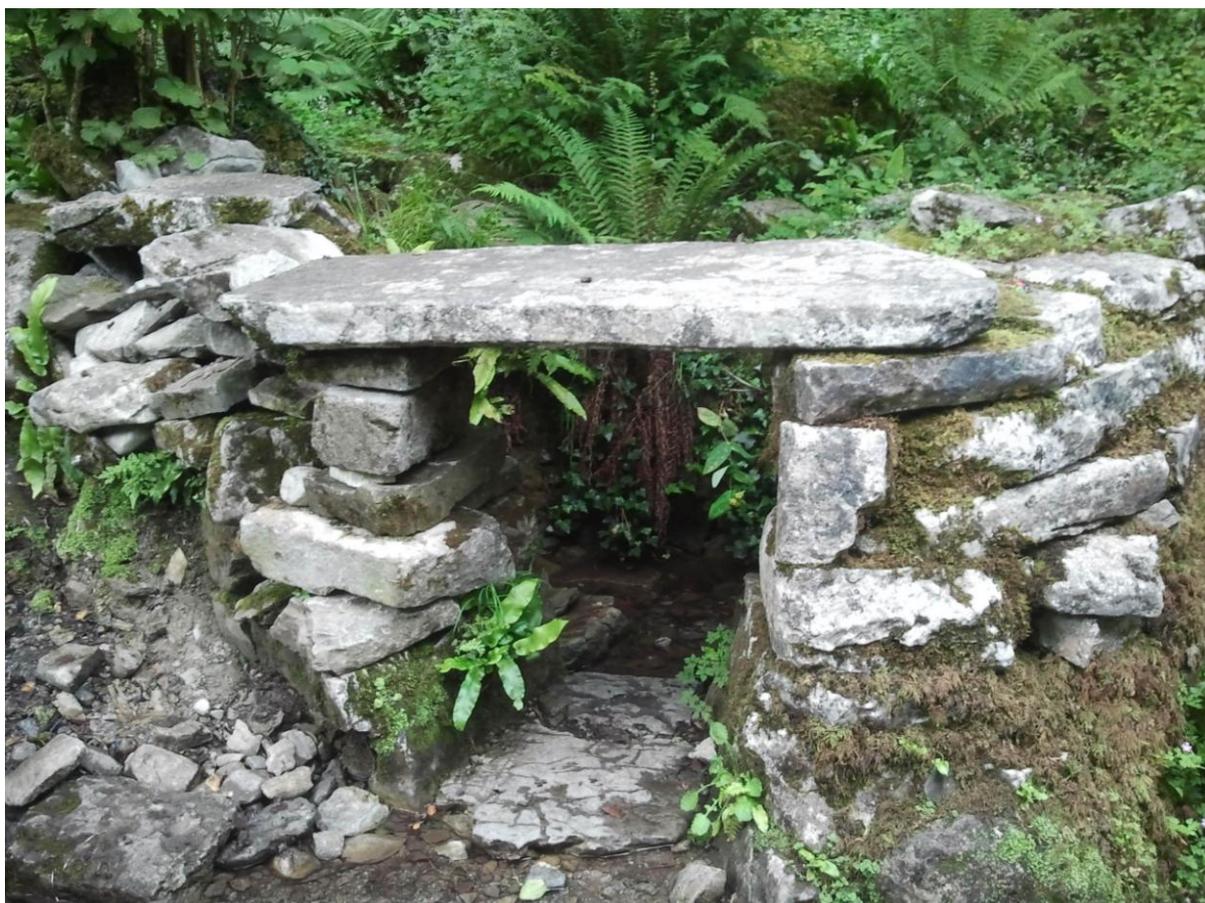
The rear wall of the gable is covered with moss obscuring any features that may exist. To the north, beside a stream, at about 20m. distant, is a sub-circular holy well with dry-stone wall and a flagstone lintel over the entrance. The church site contains mounds of masonry rubble from various collapses. Due to the distance from the road it is likely that most of the original building stone remains on site.

Photograph 19 : Drystone well enclosure at Colman MacDuaghs oratory (August 2014)

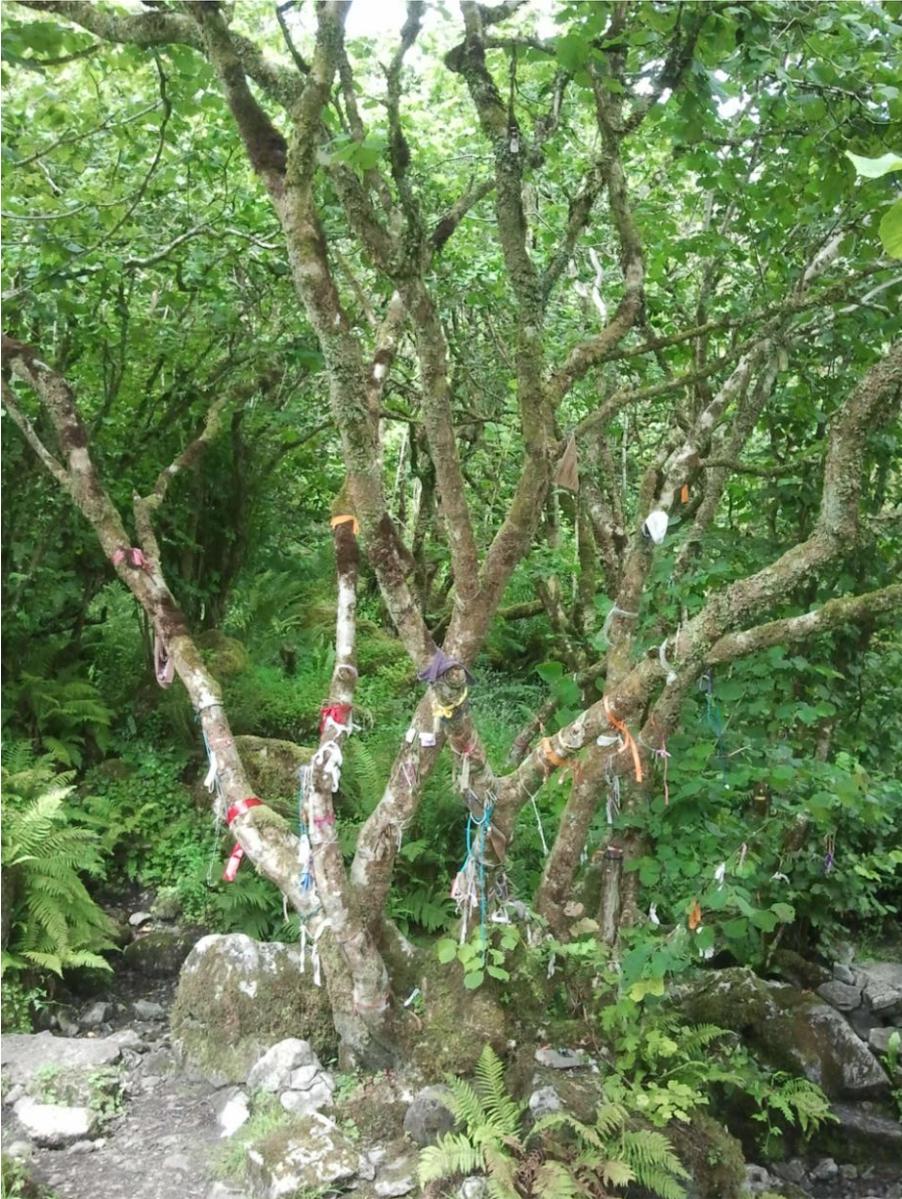
A recent increase in the deposition of so-called 'votive offerings' on the trees surrounding the holy well at Mac Duaghs oratory was noted during GeoparkLIFE monitoring of the site. Such depositions are generally associated with a tradition of pilgrimage to 'holy' sites in Ireland and would generally be left by the 'pilgrim' while undertaking a 'pattern' at the site perhaps once a year, on the Saints Day or an annual festival day. However, recently, such 'offerings' as rags, toys and personal items are being tied to the trees at the site throughout the year. Due to the increase in numbers and the nature of these 'offerings', they are causing a litter issue.

Photograph 20: Votive offerings on tree at MacDuagh's oratory site (August 2014)

Date Action Completed	June 2017
Results	<p>The Votive offerings report completed March 2016 indicated that the deposition of votive offerings is a recent activity and not connected to any ancient pilgrimage tradition. The majority of the items identified during the research were of a non-religious type and were located over a large portion of the site.</p> <p>All 'offerings' were removed from the site in May 2016. No objections were received from the public. Any depositions which occur are now monitored and removed on a regular basis by NPWS staff.</p> <p>A "Leave NO Trace in the Burren" leaflet was produced under the GeoparkLIFE project in June 2017 which specifically refers to the practice of leaving 'offerings' on trees and other places around the Burren and requesting that the visitor refrain from this activity.</p>

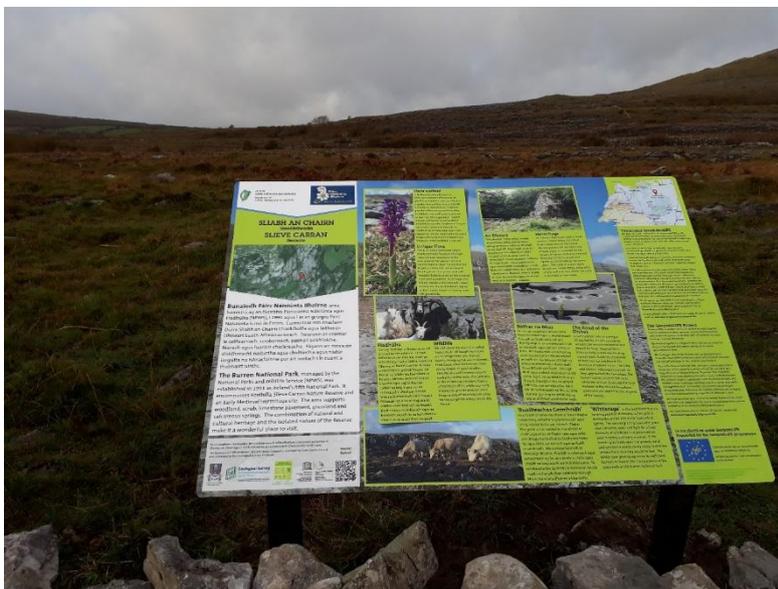
Photograph 21: GeoparkLIFE and NPWS integrated interpretive panel installed at Slieve Carran October 2017

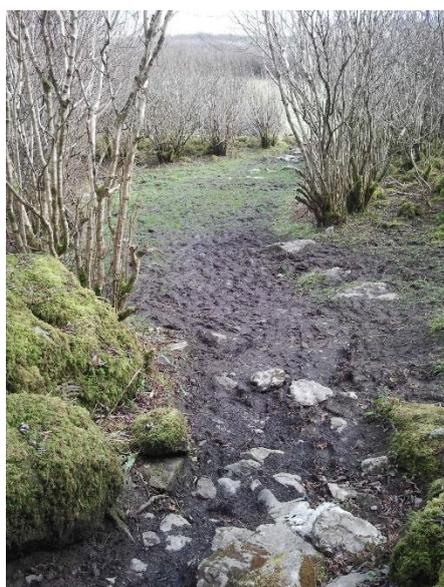
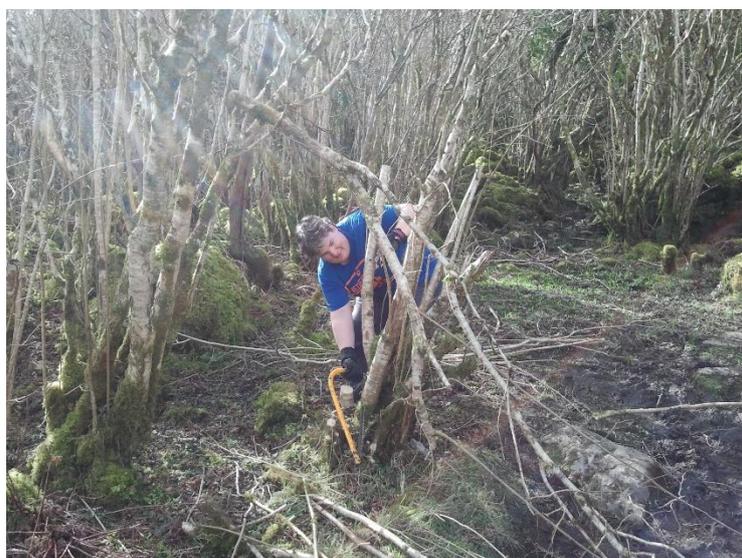
Photograph 26 & 27: Condition of entrance to oratory March 2015 prior to cutting back of hazel trees.

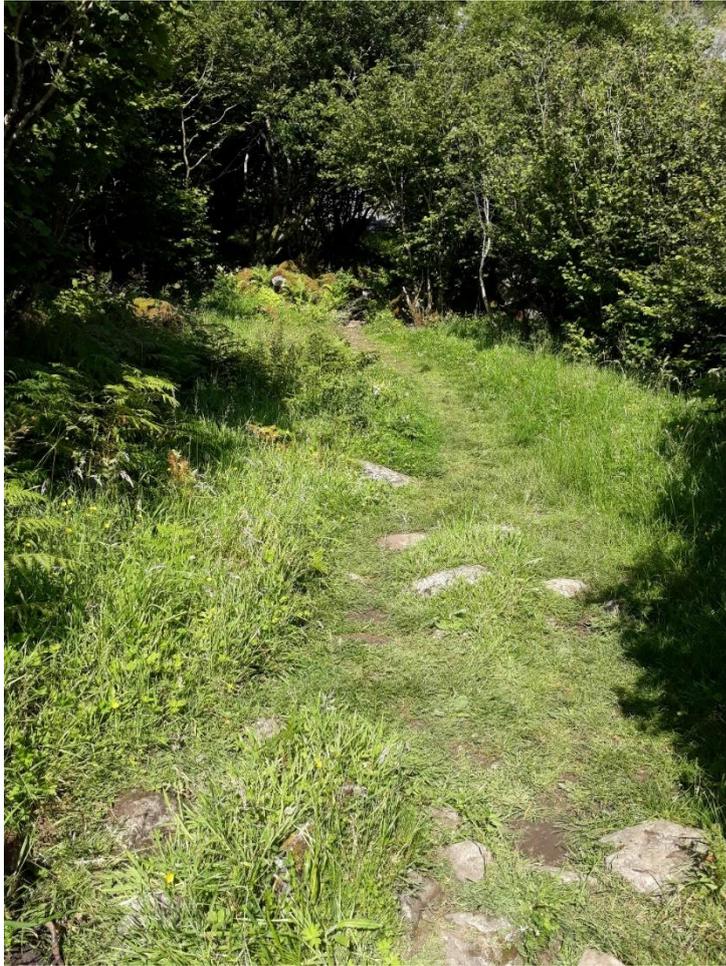
Photograph 28: Entrance to oratory July 2017

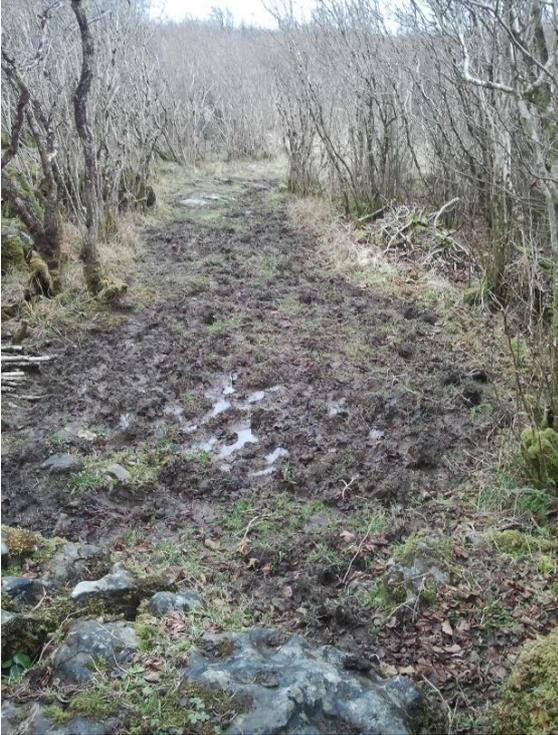
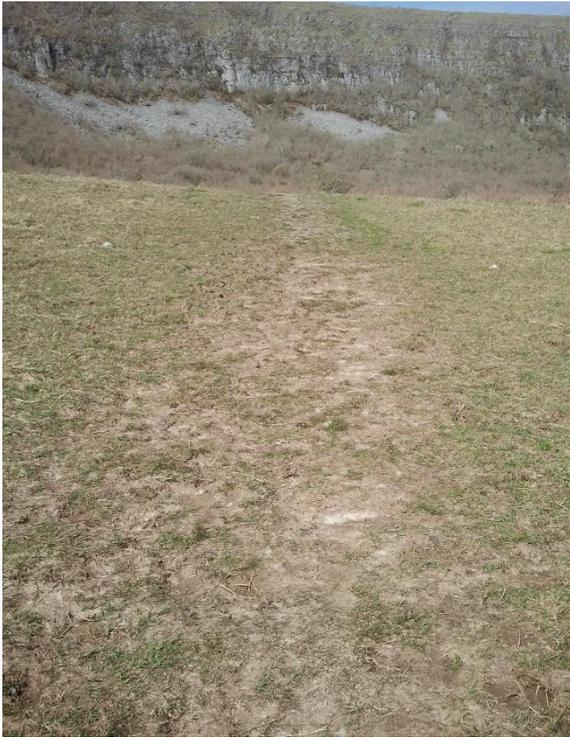
<b>Issue 6 (B)</b>	<b>Restrictions to visitor access in wooded area of brown trail</b>
Agreed Action	Two areas which were noted to be prone to erosion due to footfall were the grass pathway through the meadow and the wooded area along the brown walking trail. A gravel overlay would be applied to the grass approach pathway to and through the wooded area
Tasks	Lay gravel
Responsible person/group	NPWS
Date Action Completed	Maintenance work on brown trail pathway was completed in November 2016.
Results	Both these areas identified as vulnerable to erosion were gravelled in November 2016 by the NPWS to provide a firmer underfoot surface and prevent walkers straying off the designated pathway to avoid muddy areas. These areas will continue to be monitored using fixed point photography and width measurements. Use of the GeoparkLIFE Monitoring app will allow this work to be undertaken in a comprehensive and efficient manner. The area has shown improvement and will continue to be monitored.

Photographs 29 & 30: Entrance to wooded area and track through meadow

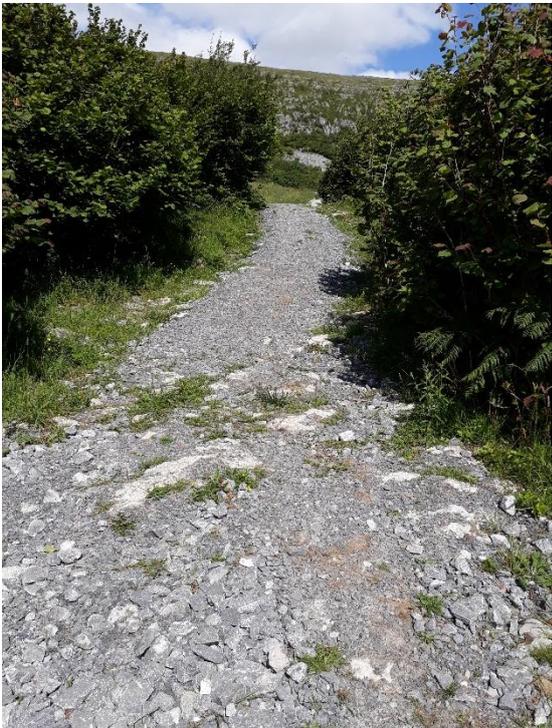
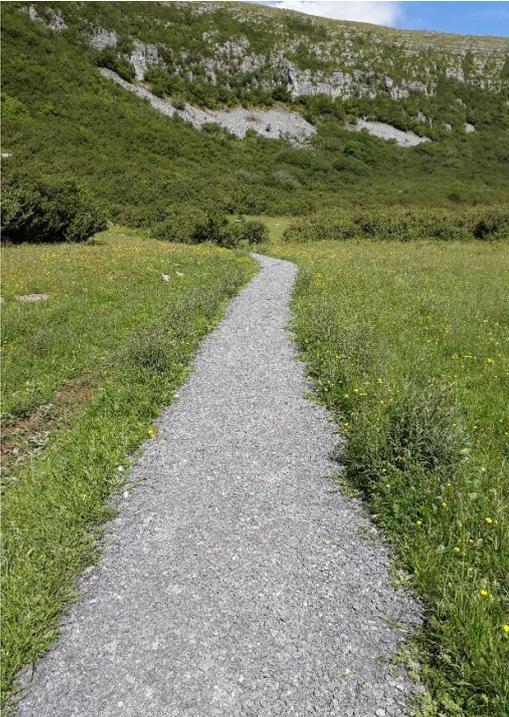
Photographs 31 & 32: Entrance wooded area and track through meadow July 2017.

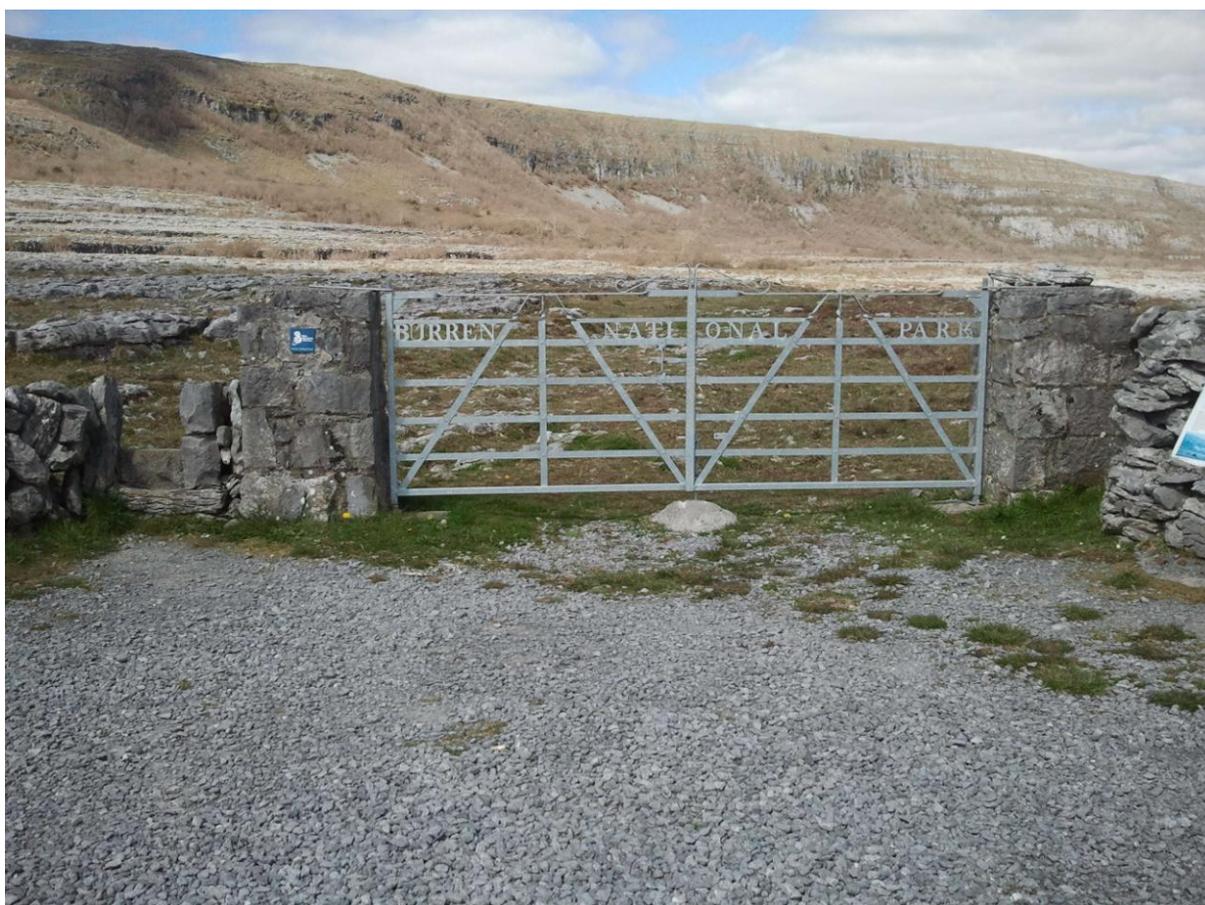
Photograph 33: Burren National Park gate installed at Slieve Carran entrance (photo taken April 216)

<b>Issue 6 (C)</b>	<b>Restrictions at site entry from parking areas for less abled bodied</b>
Agreed Action	Leave gate unlocked.
Tasks	
Responsible person/group	NPWS
Date Action Completed	2015
Results	A new entrance gate was installed by the NPWS in October 2015 which is left unlocked to permit least restrictive access to the site.
