CARRAN CHURCH
SITE ASSESSMENT REPORT

Prepared by
Zena Hctor
December 2014
(Updated February 2015 to include Visitor Survey data)

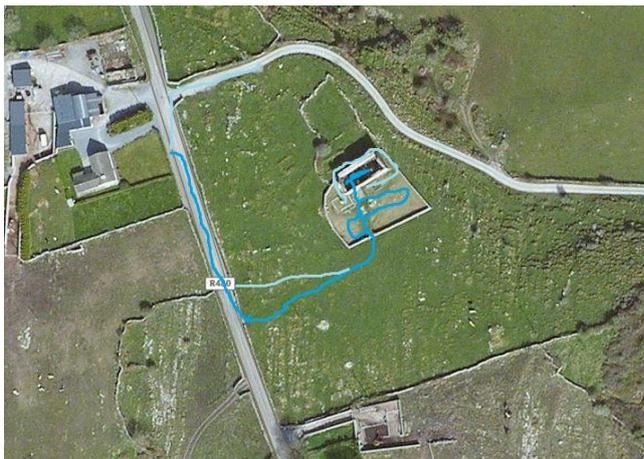
7. Visitor Movement Pattern

Observed movement patterns – dark blue line show core movement area; lighter blue peripheral area.
