Visitor Management Proposal

An Rath - Cahermore

GeoparkLIFE:
Tourism for Conservation

May 2018.

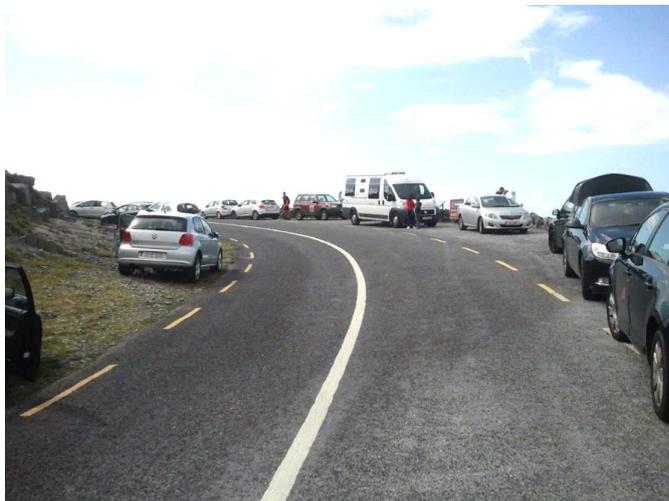
Photograph 2: Parking at Murrooghtoohy Lay-by

An official viewing point with a small parking layby has been created at Murrooghtoohy, just south of Black Head. It can accommodate approximately 8 cars. During the summer months this area can become highly congested with cars and coaches parked on both sides of the road and visitors leaving their vehicles to walk across the pavement areas.

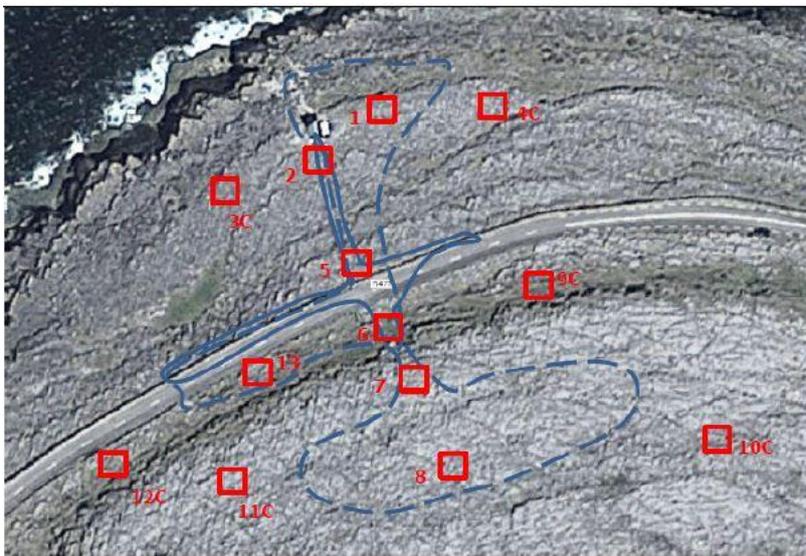
Figure 2: Location of ecological sampling quadrats at Blackhead Lighthouse

'The visual effect of tourist activity on the vegetation at this site is limited on the north of the road as the vegetation is sparse and visitors walk preferentially on the exposed limestone. To the south of the road a few desire lines lead inland to the higher ground though once above the terrace fringing the road, these become indistinct as visitors do not follow any specific route. There is a considerable

amount of mini-dolmen and cairn building on the higher ground south of the road. Litter is also evident in the area adjacent to the road and towards the lighthouse’.

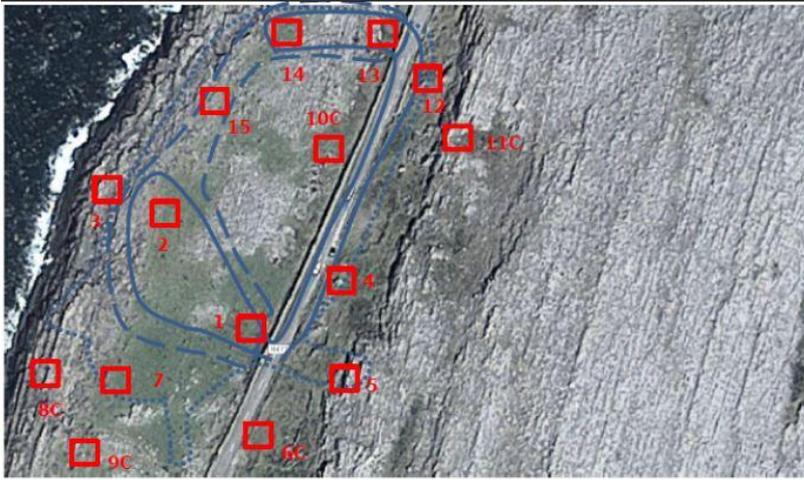
Figure 3: Murrooghtoohy lay-by location of quadrats

‘The visual effect of tourist activity on the vegetation at this site is limited to the immediate vicinity of the access stile leading from the road to the coast and to a lesser extent, a few desire lines lead inland to the higher ground to the east. West of the road there is localised compaction of vegetation in the area immediately adjacent to the access stile. On the east of the road due to the presence of low cliffs, access is confined to a few obvious routes with localised compaction of vegetation. On top of the cliff the visitors spread out over a broader area and there are no discernible trails. As with many sites which have exposed limestone pavement, visitors tend to walk preferentially on the rock thus avoiding trampling the vegetation. Grazing and poaching by over-wintering cattle has a discernible impact on the vegetation at the higher levels. There is evidence of mini-dolmen and cairn building both to the east and west of the road. Litter is also evident along the coastal strip.’

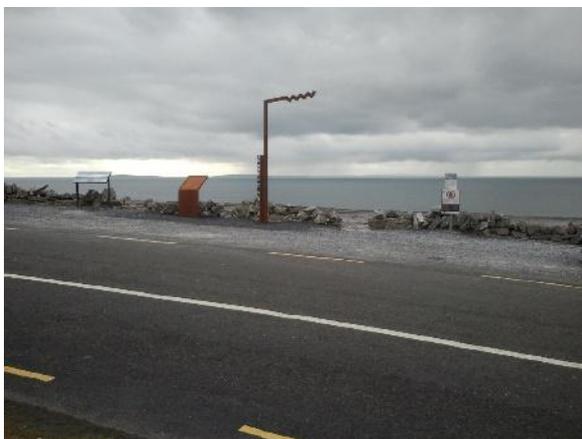
Photograph 10: Signage at Murrooghtoohy Lay-by

A Wild Atlantic Way (WAW) destination pole and a WAW interpretive panel upright (insert not yet installed 2014) are also located at the viewing point.

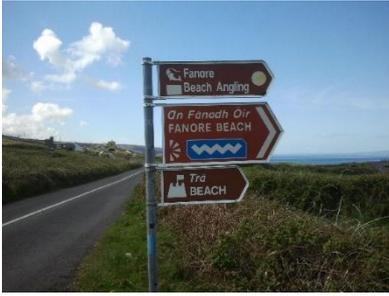
Three directional road signs are located at the entrance to Fanore Beach from the R477.

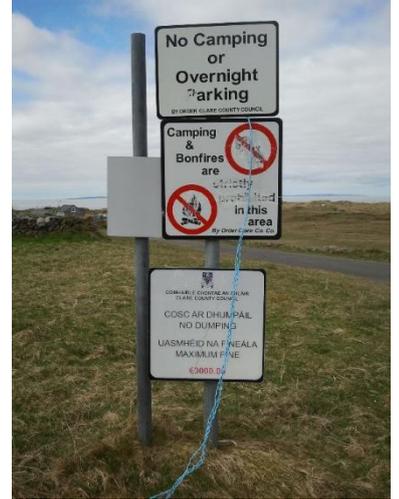
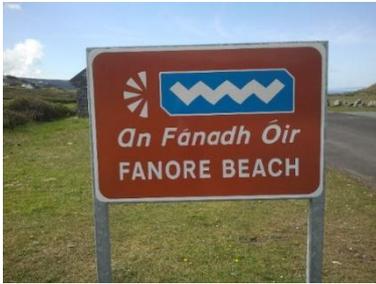
Inside the entrance gateway to the beach, three signs mounted on a pole carry 'No camping, overnight parking, dumping and bonfires' messages. The two upper signs are damaged with text scratched out. To the right of these signs is a second upright pole with a blank A4 size panel attached.

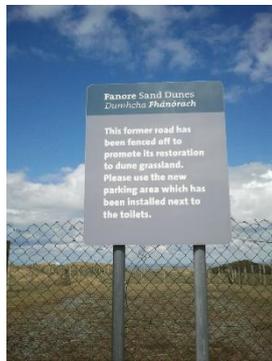
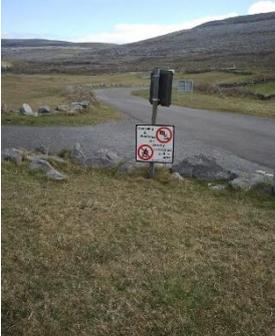
Opposite the toilet block on the boundary of an area fenced off for conservation purposes are two different designs of Conservation signs one at each end of the fence. Attached to the lower section of the pole supporting the sign to the rear of the fence is a 'No Camping/overnight parking' sign which is damaged.

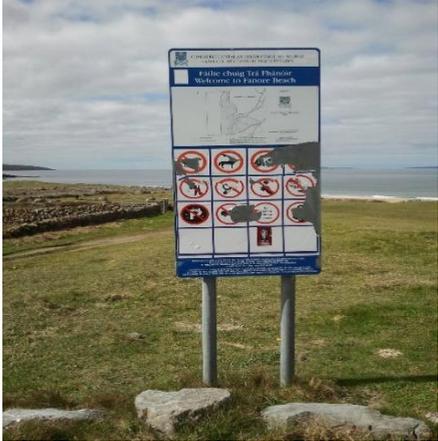
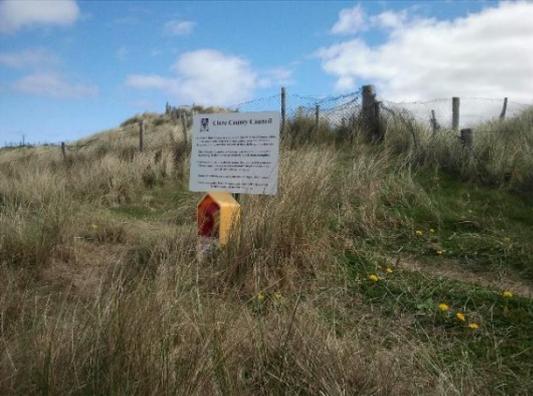
On the opposite side of the shower unit is a double poled upright sign. This carries information on the County Council bye-laws and penalties for non-compliance. This sign is badly damaged with most of the symbols scratched out (13-6-2014)

Close to the board walk entrance to the beach is a pole mounted sign indicating that this is a Special Area of Conservation and use of all-terrain vehicles is prohibited. This sign is badly damaged. It carries the NPWS name and logo.

Type of sign	Location (ITM E; ITM N)	Damage description	Source of Damage	Action Required	Timescale for Action
Burren Connect panoramic interpretive panel at Murrooghtoohy viewing point	514612 710752	Worn damage in top right hand corner and scratching on surface	Human	Update and replace with GeoparkLIFE/Geosite panel	6-12 months
Information signs inside entrance gate to Fanore Beach	514119 708335	Top two of three signs are damaged with text and symbols scratched out. Blank panel on second pole	Human	Revise signage and duplication of information provided. Replace with rationalised signage. Remove blank panel and pole.	6-12 months
Conservation signs on fence boundary opposite toilet block	513886 708341	The No camping or overnight parking sign is damaged with yellow paint smeared on the sign	Human	Replace sign	6-12 months
County Council bye-laws and penalties for non-compliance sign	513800 708178	This sign is badly damaged with most of the symbols scratched out.	Human	Replace sign	Immediate

NPWS Special Area of Conservation sign	513797 708184	This sign is badly damaged with text obliterated.	Human	Remove and explore necessity of the information on this sign and whether it requires replacement	Immediate

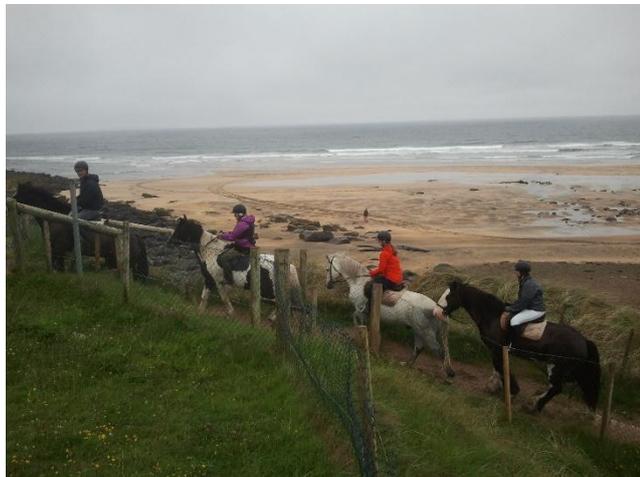
The access boardwalk to Fanore Beach is worn and several of the boards are misshapen or missing in places causing a trip hazard. The sand ladder has been damaged in recent years due to storm events and natural wear. Repairs or replacement of the structures are now urgently required.

Photograph 25: Horses leaving beach via sand ladder (13-6-2014)

Description of restriction to access	Location (ITM E; ITM N)	Difficulty caused	Action Required	Timescale for Action
Damaged access boardwalk and sand ladder to beach		The current condition of the access boardwalk and sand ladder to Fanore Beach can cause access difficulties for the less abled bodied and can be a trip hazard.	Review of condition of structures and the effectiveness of their function. If replacement structures are deemed necessary - exploration of suitable replacement types and installation of same	Immediate

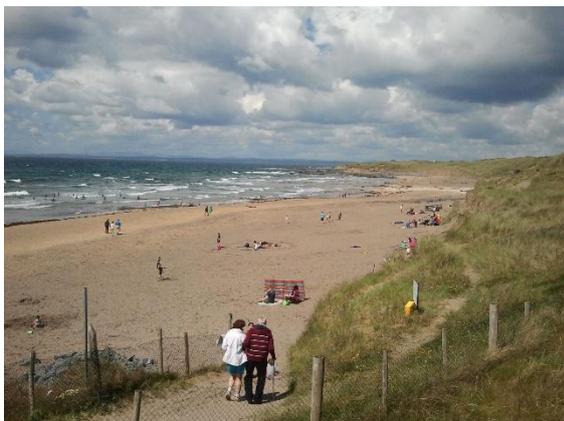
Photograph 26: Elderly visitor accessing beach by sand ladder (7-8-2014)

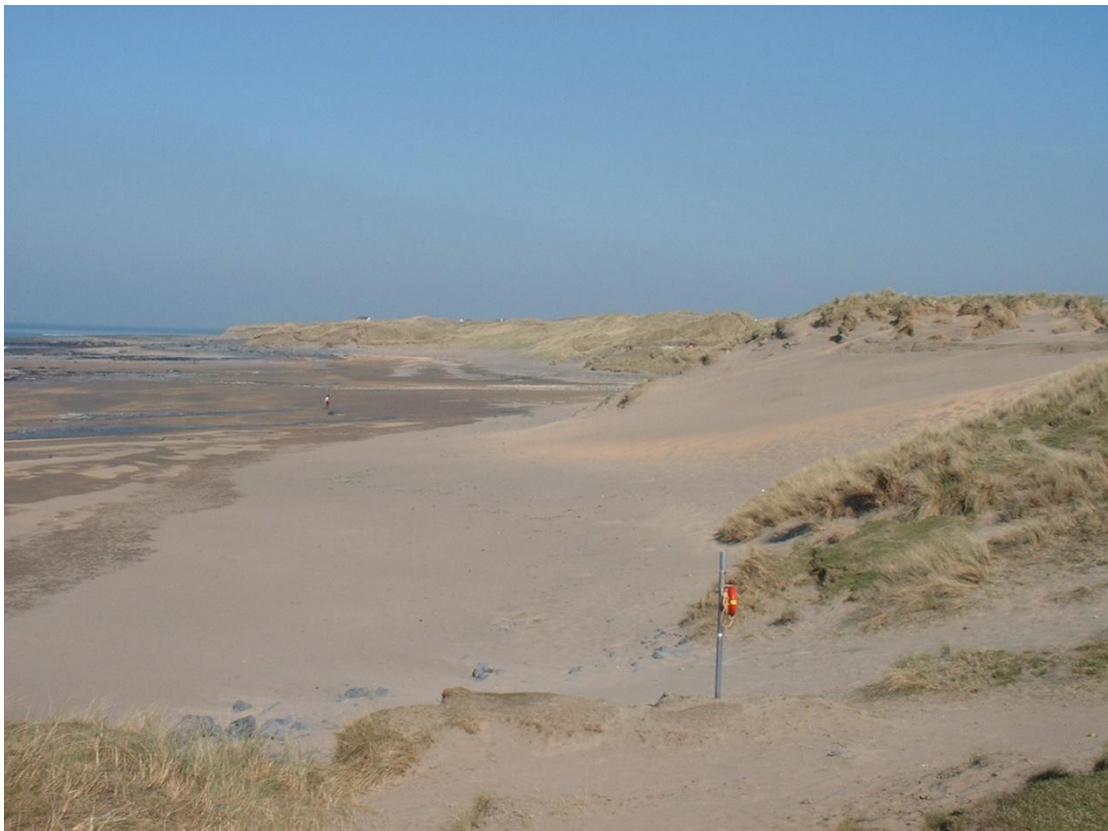
Photograph 32: View of dunes from entrance to beach (March 2003)

'Embryo dune development is absent and marram dune vegetation is patchy along the top of the dune ridge, while the seaward side of the dune consists of a sheer cliff of bare eroding sand. This topographical situation, however is not widespread throughout the surrounding dune hinterland where active dune accretion, embryo dune formation and significant marram dune development is ongoing...the natural occurring processes of erosion have been augmented by pedestrian pressure on the dunes'.

- Single point access to be provided for pedestrians. Fencing along access point may be necessary to prevent straying off path.
- Public awareness campaign with regard to importance of dune resource and necessity of the dune protection measures.

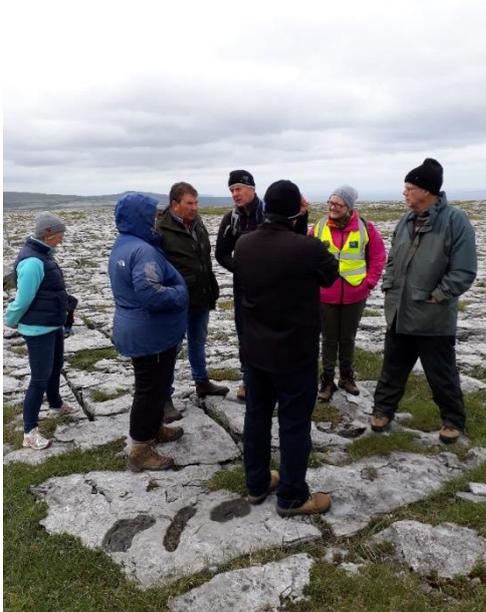
Photograph 40: Site meeting between landowners, Archaeologists and GeoparkLIFE team at Murrooghkilly cairn to agree proposed method statement for repair work (June 29, 2017)

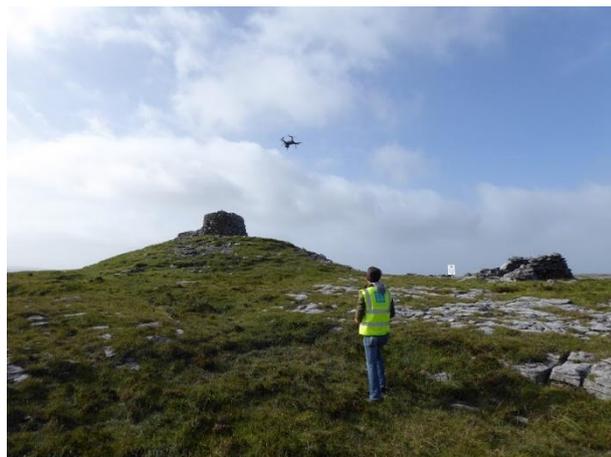
Photograph 41: Drone survey of Murrooghkilly cairn (September 29, 2016)

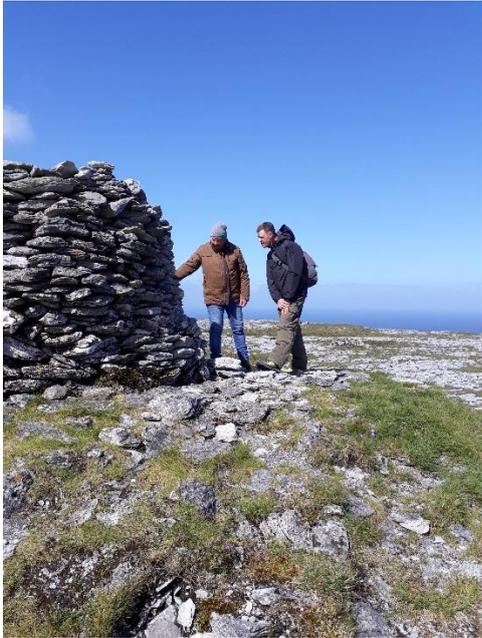
Photograph 42: Site meeting with landowner and stone mason to discuss repair of upper cairn July 2017

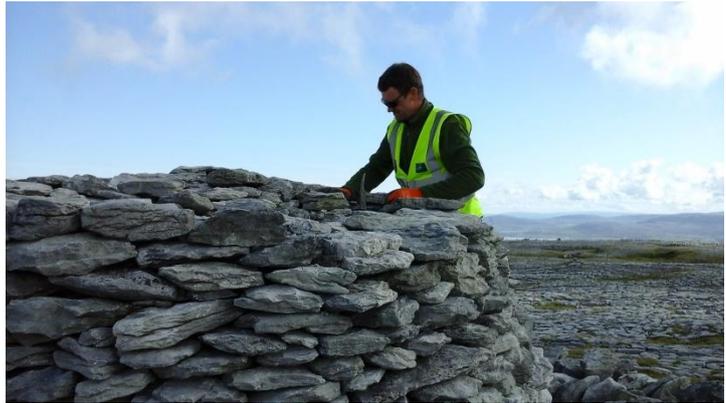
Photograph 43: Stone mason working on Murrooghkilly cairn (September 18, 2017)

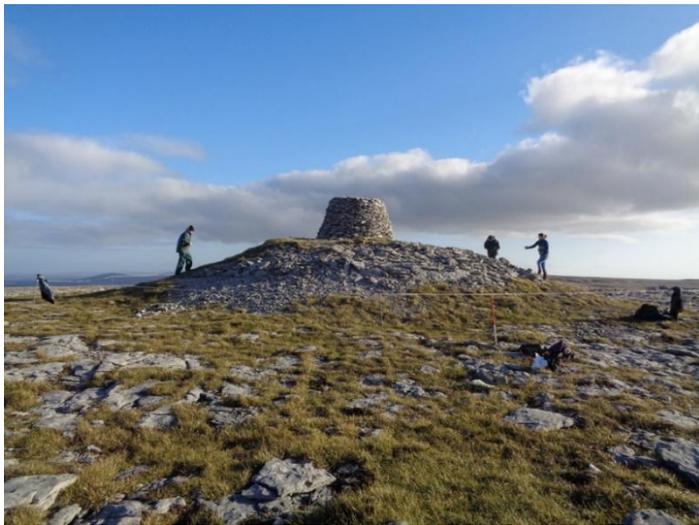
Photograph 46: Archaeologists at work on lower cairn (November 20, 2017)

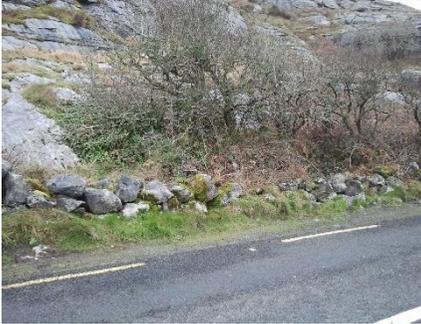
Assigned Number	ITM coordinates	Original mapped area	Original Length at road edge mapped	Geology/habitat site description (ZH 12-2-16)	Photo 12-2-16	Action undertaken	Technical survey results (PJ Carmody CCC)		
							Road measurement	Sightlines	Conclusion
1	517169 711502	45.82m ²	9m	Dip with loose rock, bracken and blackthorn scrub behind drystone wall. No limestone pavement visible in area of length 6m roadside and within depth of 3m from existing road edge. Pavement on either side of this area.

Clearance of bracken scrub to allow further examination of habitat (26-2-16)	Only 6m road length available, due to limestone pavement.	Ok	Unsuitable due to space limitation.
2	517151 711533	48.79m ²	14.5m	Area of bramble and loose rock – with one large boulder covered in vegetation. Not clear whether this is part of pavement or loose.

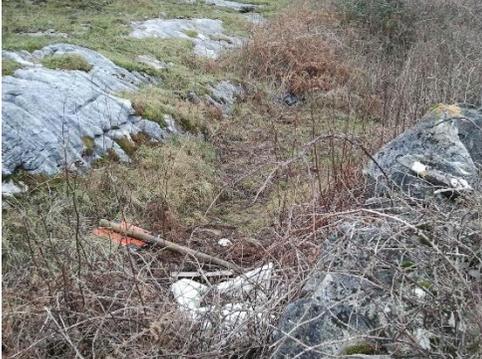
3	517011 711643	49.95m ²	13m	Bramble scrub behind drystone wall.

Removal of bramble to determine pavement extent (26-2-16)	25m road length available, 4m width.	Sightlines of 160m West and 70m East.	Unsuitable location due to sightlines.
4(a)	516947 711672	79.19m ²	22m	Bramble scrub behind drystone wall. Depth from road edge limited before start of pavement.

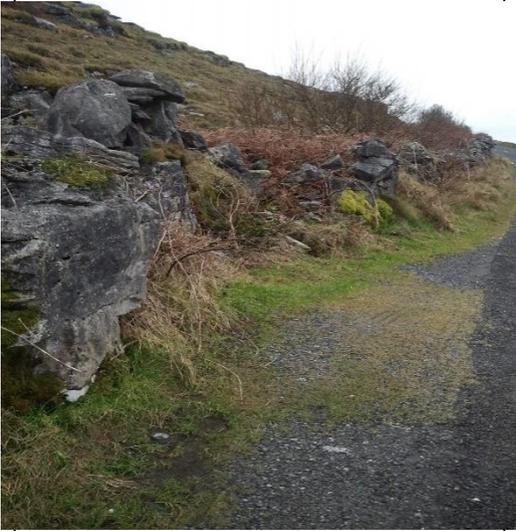
4(b)	516908 711692	22.62m ²	7m	Large blocks of limestone very close to road edge. May be adequate depth for 1 car space but sightlines would appear to make pulling in and out very dangerous.

Sightlines of 70m West and 200m East.	Unsuitable location due to sightlines.
5(a)	516839 711721	25.37m ²	8m			Eliminated 2013 Due to potential habitat loss			
5(b)	516798 711738	89.31m ²	25m			Eliminated 2013

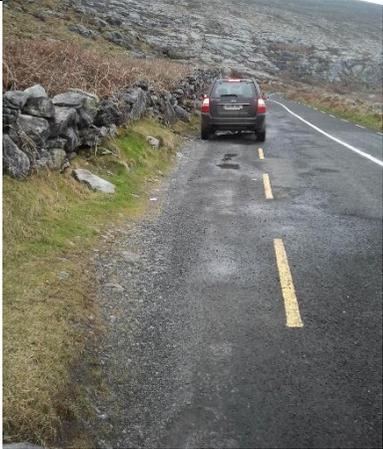
6	516557 711764	89.31m ²	19.5m	Existing space being used for parking. No obvious habitat interference necessary to develop.

25m road length, 2m width.	Sightlines of 150m West and 83m East.	Unsuitable location due to sightlines and limited amount of width space.
7	515984 711913	63.86m ²	20m			Eliminated 2013 - habitat			
8	515967 711933	54m ²	16m	Apparent space for one car. No pavement obvious

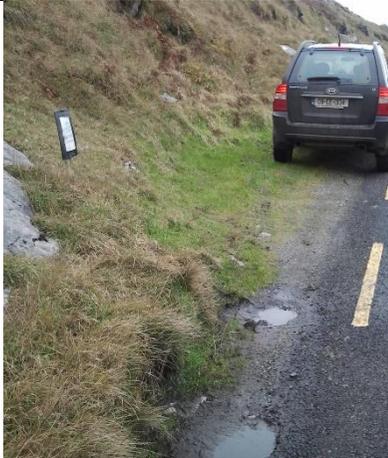
16m road length, 2.5m width.	Sightlines of 180m West and 200m East.	Maybe suitable for 1 car space.
9	515500 712202	54m ²	41m	Eliminated		Eliminated 2013

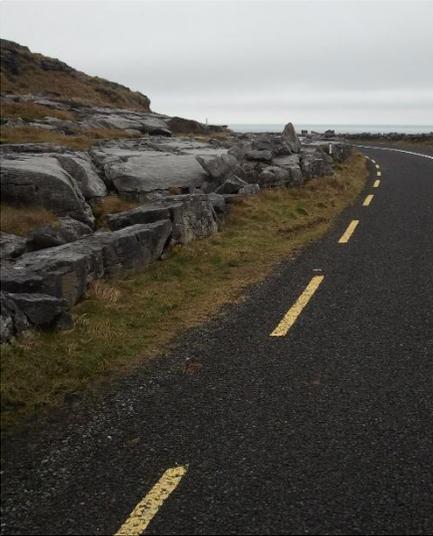
10	515462 712197	51m ²	31m	Limestone pavement present to wall

Area moved in 2013 (addendum doc) – but is this land owned by CO CO – proposed move after acquisition??		Located on a bend. No sightlines available.	Unsuitable location due to bend and lack of sightlines.
11	515152 711914	49.78m ²	16m	Eliminated		Eliminated 2013			
12	515119 711839	76.87m ²	23m	Dry calcareous grassland. Would need to fill in dips on top of grassland to get 2.5m depth from road edge.

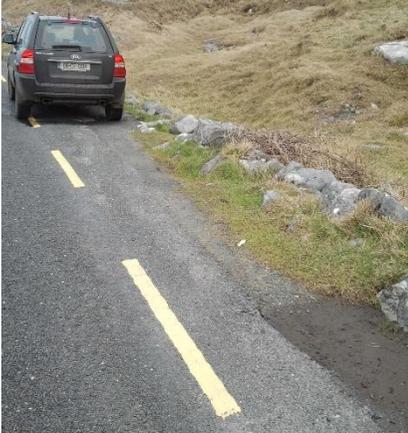
34m road length, 3m width.	Sightlines of 300m+ South and 210m North.	Difference in level of over 400mm. Maybe suitable subject to fill being allowed on top of protected. Further action required: habitat survey and AA grassland. Potential for 4-5 spaces.

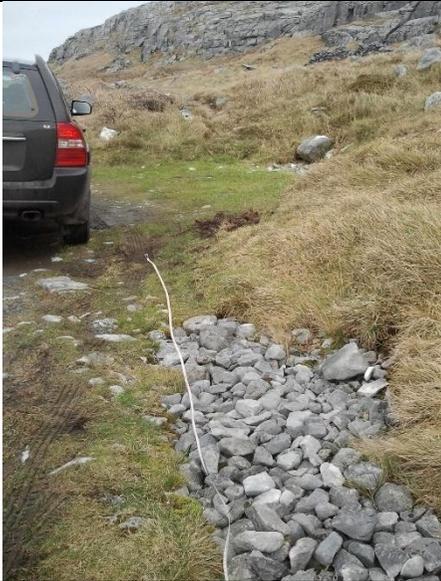
13	515070 711758	74.83m ²	22m	Dry calcareous grassland. Potential length of 9m roadside - pavement beyond this.

27m road length, 2.3m – 3m width.	Sightlines of 250m South and 290m North.	<p style="color: red;">Maybe suitable but subject to filling and habitat as for No. 12. Possible 3-4 spaces if infill allowed. Further action required: habitat survey and AA grassland. There appears to be some water movement in this area and this would require further investigation.</p>
14	514995 711593	68.09m ²	18.5m	Space from road edge to wall 1.8m. Pavement behind wall

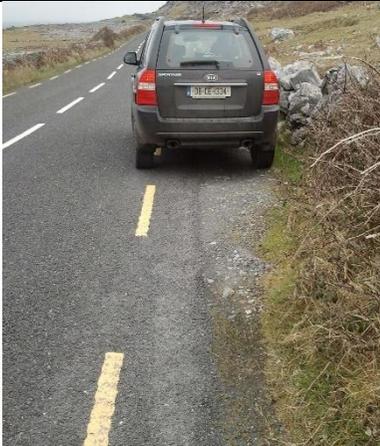
Only 50m sightline available South.	<p>Unsuitable due to sightline.</p>

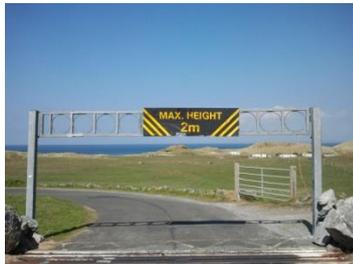
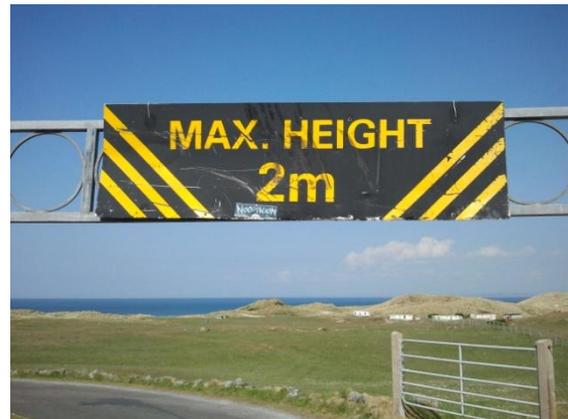
- Entrance gate – overhead sign badly damaged 'Max Height 2m'

- Three signs on one pole inside entrance gate to left

Top sign: No Camping or Overnight parking (45cm X60cm aluminium) – damaged.

Middle sign: Camping & Bonfires are strictly prohibited in this area (60cmx60cm aluminium) damaged

Can these signs be amalgamated?

Adjacent to these signs is an upright pole with a blank aluminium panel attached – **can this pole and panel be removed?**

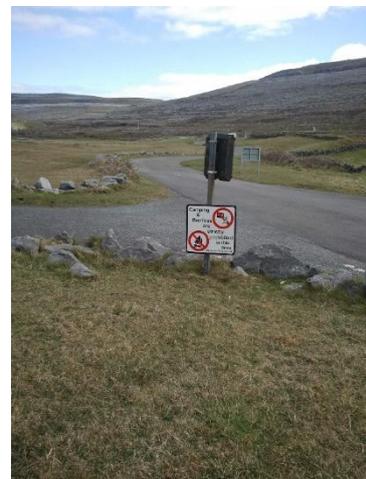
- Opposite toilet block.
Dog gloves box on top of pole.
Bottom sign: Camping & bonfires are strictly prohibited (60cmX60cm aluminium) – damaged. **Replace.**
