**Report on  
Excavation and completion of conservation works.**

**Carran Mediaeval Church, Poulacarran, Carran, Co. Clare.**

Monument Number: CL009-075001

15 December / Nodlaig 2017

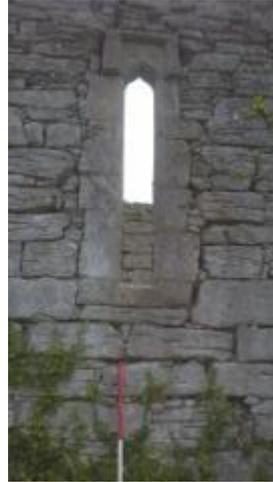
South window,

All three windows in the church have tall narrow openings with cut stone surrounds. The exterior of the ogee headed arch in the most easterly window in the south wall is decorated with floral motifs. The second window in the south wall has been badly damaged with only the sill stone remaining. All of the windows have interior splayed embrasures to maximise
