## Visitor Management Proposal

# Poulnabrone

**GeoparkLIFE:** Tourism for Conservation

## SECTION THREE: BASELINE SITE CONDITION ASSESSMENT (2014)

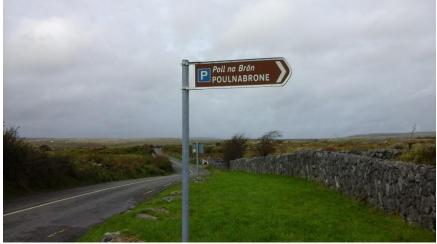
If yes, enter the ITM co-ordinates for its location	522309 706526
What is the condition of the signage?	Good
Timescale for action required	None required
Is there a roadside site name sign present?	Yes ✓ No 🗆
If yes, enter the ITM co-ordinates for its location	523500 700202
What is the condition of the signage?	Good
Is the sign damaged?	Yes 🗌 No 🗸
If yes, describe the damage and its cause	
Timescale for action required	None required

Photograph 1: Road entrance sign to Poulnabrone

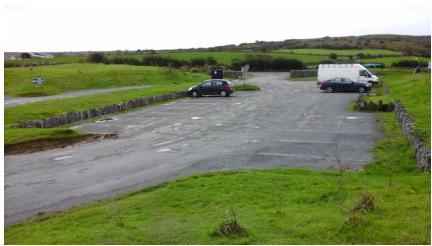
Photograph 2: Car park at Poulnabrone

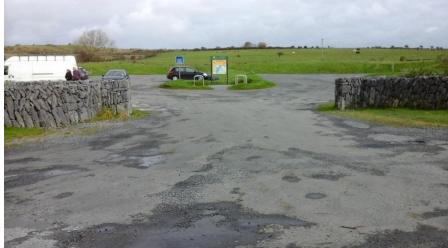
The site entry from the road to the car park is through an open section in the boundary wall. The entry from the car park to the access path to the monument is through a pedestrian gate.

Photograph 3: Entrance to car park

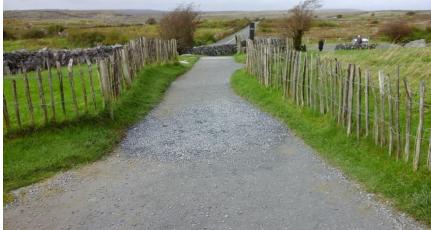
Is there an access Path?	Yes 🗸	No 🗆
If yes, specify		
the surface covering	Gravel	
the incline	Mediur	m
Are there steps present?		No 🗆
If yes, specify how many	14	
inter alle

Photograph 4: Access path from car park to monument

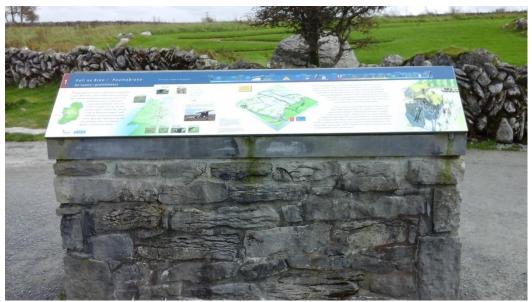
Photograph 7: Interpretive panel on access path to monument

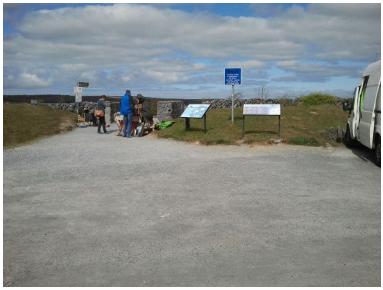
The trader who operates within the car park on a seasonal basis, speaks several European languages and converses easily with tourists very often providing local tourism information and directions to other sites. Although not an official stand, this trader appears to be well liked by the visitors and he also acts as a deterrent to anti-social behaviour such as car break-ins while present at the site.

Photograph 16: Trader and Busker operating in car park area
